Monitoring of cultural deposits below Bryggen in Bergen, Norway

Henning Matthiesen, *in situ* group, National Museum of Denmark
 Rory Dunlop, Norwegian Institute for Cultural Heritage Research
 Jann Atle Jensen, Multiconsult Noteby, Bergen, Norway
 Ann Christensson, Directorate for Cultural Heritage, Norway

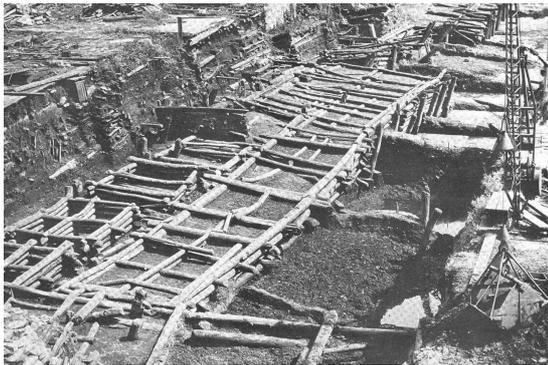
Massive wooden structures are present in the cultural layers below Bryggen. Here a 54-m-long section of quay from c. AD 1200.

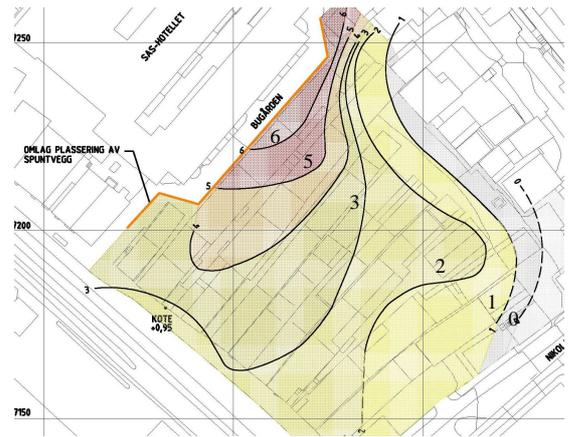
Map of Bryggen showing measured settling rates for the buildings and ground surface in mm/year. Orange line indicates sheet piling between the old wooden buildings and the excavated area (now occupied by new buildings).

The tilting walls of various buildings on Bryggen have long demonstrated that foundation conditions are not ideal. However, it was not until last year that the full extent of the problem became clear. Accurate surveying of the buildings in 2001-2003 and comparison with measurements from the 1950s revealed settling rates of up to 8 mm/year in the Bryggen area. Apart from problems with skewed buildings, the settling may also indicate that important archaeological remains are being either compressed or lost entirely.

An extensive monitoring programme for Bryggen was initiated in 2001, both in order to understand the settling and to map preservation conditions for and threats to the cultural deposits. The highest settling rates are found towards Bryggen's north-western border, so investigations have been focused on that area.

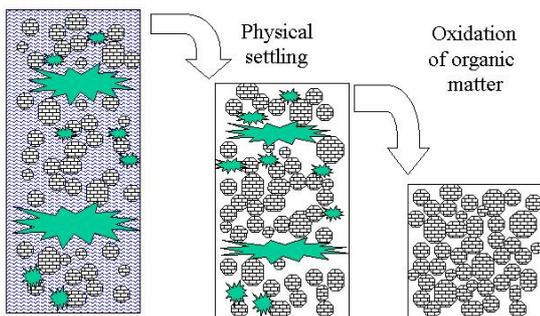
Water Air Organic Inorganic

Drainage may lead to settling through a physical process as well as by the decomposition of organic matter.

The cultural deposits are wet and richly organic. Soil samples typically have a water content exceeding 100% and loss-on-ignition values of 10-70%. Settling of such layers may be caused by for instance drainage, causing both physical settling and decomposition of the organic components. Work is ongoing to model the settling potential of a soil based on its water content and loss on ignition. This can then be compared with archaeological descriptions, to find correlations.

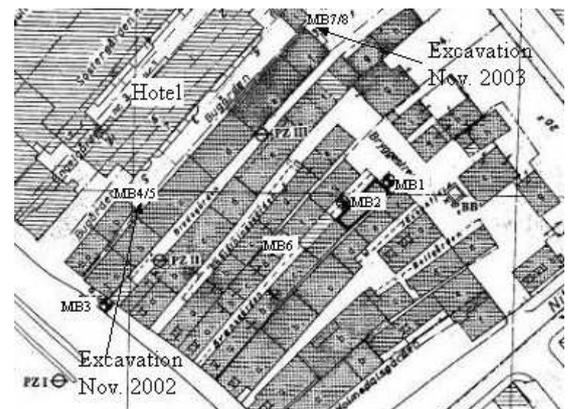
Map of Bryggen showing position of dipwells (MB1-8) and test excavations. The hotel was built in 1980 on the site excavated during the 1950s and -60s.

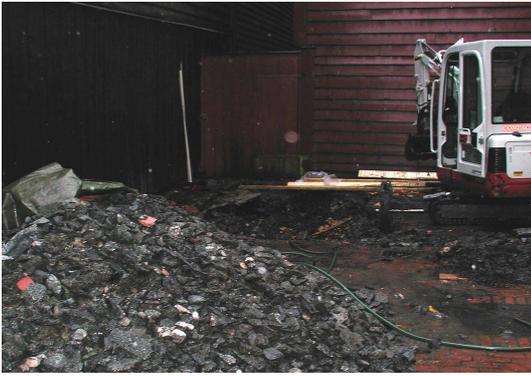
Minor test excavation from November 2002 in the area between the hotel site and the old buildings on Bryggen.

A minor test excavation was carried out in the area between the hotel and the old buildings of Bryggen where high settling rates were found. Even if the excavation pit of 1 m² was not as spectacular as the excavations in the 1950s and -60s, it gave some very useful information. Among other things it revealed that the uppermost deposit next to the sheet piling consisted of fist-sized stones, forming a very efficient draining material that has contributed to a lowered water-table. Soil samples from the excavation pit and from 10-m-long cores were analysed for nutrients, organic matter and salt content. Low salt levels in the upper 2-3 metres of the soil indicated a substantial through-flow of water.

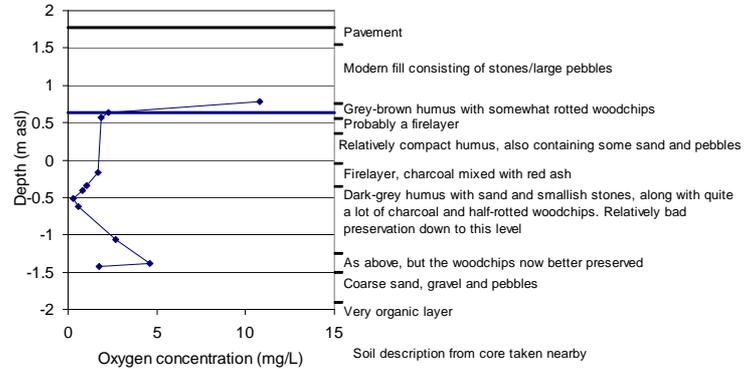
Oxygen profile measured directly in undisturbed soil by Ev Kretschmar, University of Göttingen. Soil surface is at 1.77 m above sea-level (asl) and blue line indicates the groundwater level at time of recording.

The lowered water-table near the sheet piling is worrying, as it increases oxygen supply in the unsaturated zone, thus accelerating decomposition. Furthermore, measurements taken directly in undisturbed soil layers during the test excavation revealed the presence of oxygen at surprisingly deep levels; there were considerable concentrations as far down as 2 m below the water-table. The shape of the oxygen profile was quite irregular, showing both decreasing and increasing concentrations with depth. This suggests that the flow pattern of the groundwater is complex.

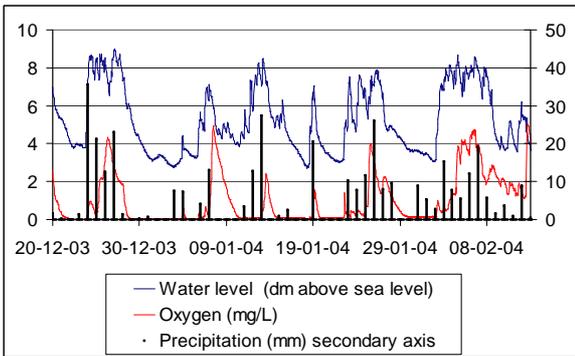
Example of results from dipwell MB4, where porous deposits give instant responses after rainfall, resulting in increased water-level and oxygen content. The logger is situated at -1.3 m asl, or 2 m below the average groundwater level.

Continuous logging in a dipwell installed at the site corroborated the picture of a very dynamic system. Bergen receives as much as 2000 mm precipitation annually, and the water-level and oxygen content clearly reflect the quantity: during rainfall the water-level in the soil at this specific site increases by up to 50 cm and the oxygen content increases temporarily, probably due to fresh rainwater flushing through the deposits. These observations along with other evidence from the site confirmed that the high settling rates measured for the buildings and ground surface may be due to decomposition of organic matter in the underlying strata. The rate will be highest above the water-table, but some decomposition may also take place below the water-table due to the high concentrations of dissolved oxygen.

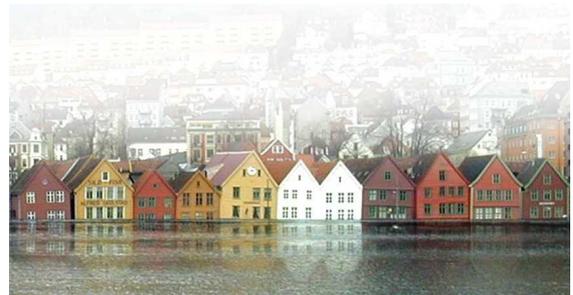
Mitigation strategies may include raising the water-table.... Manipulated photo from Bergens Tidende.

Future studies at Bryggen will include the establishment of a detailed hydrological model for the entire area. This is necessary in order to model the effects of different mitigation strategies and to ensure that such strategies will have no adverse effects on the cultural layers and standing buildings. Mitigation of the settling problem may include the substitution of porous stone fill along the sheet piling with less permeable clay slurry in order to raise the water-table. The future work will also include research into decomposition processes in order better to transfer the results from Bryggen to other sites with similar cultural deposits.
