ARKEOLOGISKE UNDERSØKELSER I  
TRONDHEIM NR. 5

THE CHURCH OF THE BENEDICTINE ABBEY OF  
NIDARHOLM.

REPORT FROM EXCAVATIONS ON THE ISLAND OF  
MUNKHOLMEN, TRONDHEIM 1988-1989.

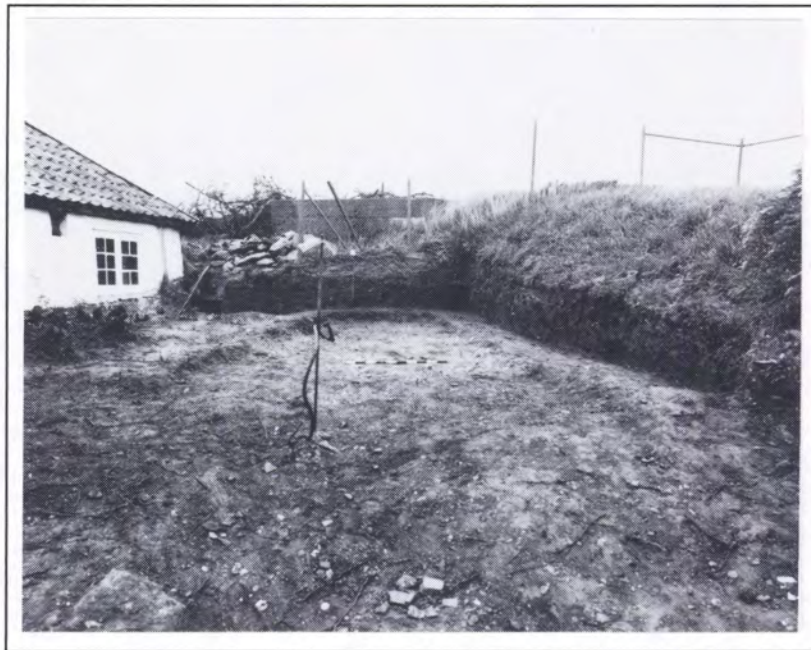
*Fig. 5. Plate showing Excavation Area A, 1989. Looking N. Falkenskjoldsmessen to the left, German WWII gun emplacement in the background, the earthen rampart behind the perimeter walls to the right.*

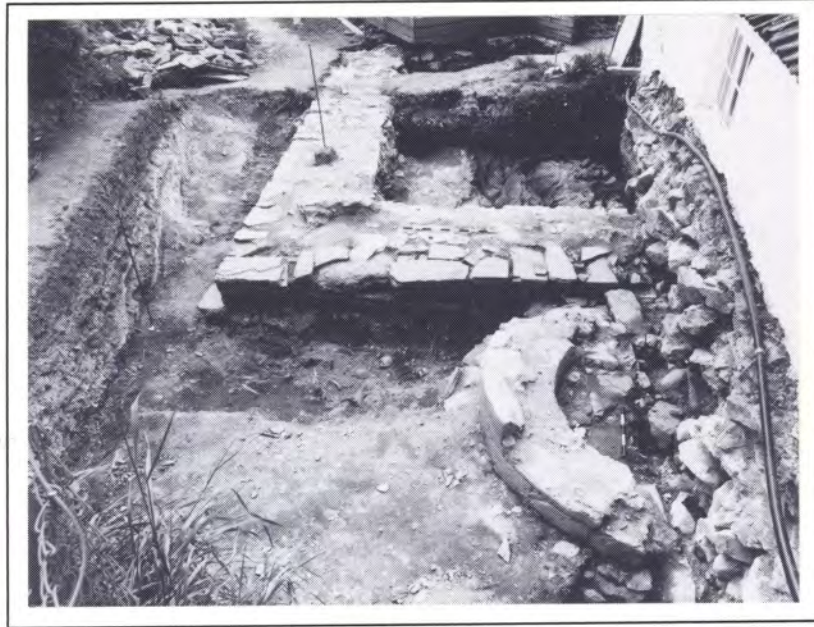
*Fig. 19. PHASE II. Plate showing apse and graveyard in foreground, chancel in background. Falkenskjoldsmessen to right. Looking S.*

As to function: this apse, lying against the northern wall of the church's chancel probably forms the eastern end of a side-building, in all likelihood a small side-chapel: whether it represents a later modification to the eastern end of a pre-existing side-building, or, perhaps more likely, part of a wholly new structure added at some point after the chancel was finished, is not yet verifiable. The apse's interior itself would in all likelihood have housed a side-altar.

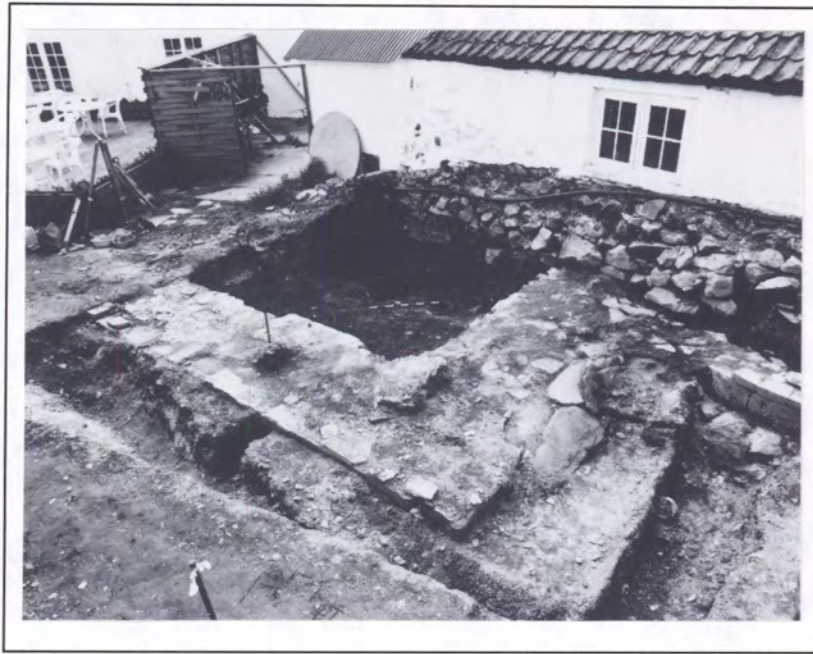
*Fig. 21. PHASE III (Level 1). Plate showing the emptied chancel. Looking SW.*

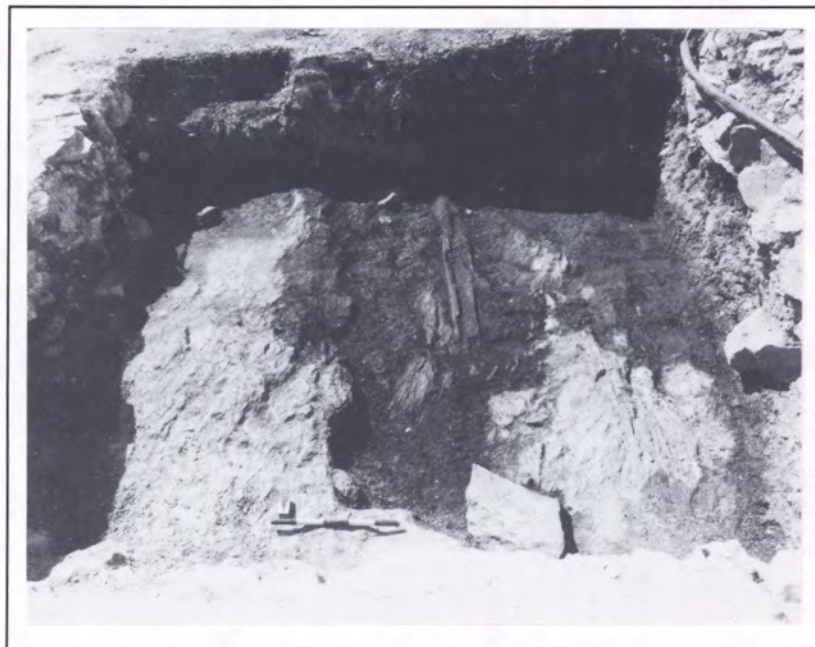
*Fig. 22. PHASE III (Level 1). Plate showing the possible remains of a first floor inserted into the cleared-out chancel, and the cleft in bedrock containing a charcoal deposit, subsequently  $^{14}\text{C}$  dated. Looking S.*

Inside the former chancel, the remains of possibly two levels of timber flooring were found. These sealed deposits within holes and fissures in bedrock, one of which produced a sample of charcoal (see Dating). The lowest floor level (Fig. 20) was very poorly represented: **57** comprised two isolated planks as well as a patchy extent of compressed organic material, possibly additional wooden planking. This lay under **52**, a rather more certain level of flooring. Intervening between these floor-levels was a brown mortar-flecked greasy soil, **50**. Above the upper flooring elements, which were fragmentary, lay a thin discontinuous silty sandy deposit with debris, **48**, itself sealed by a series of banked-up dumps of soil and mortar, **40 - 37a**.

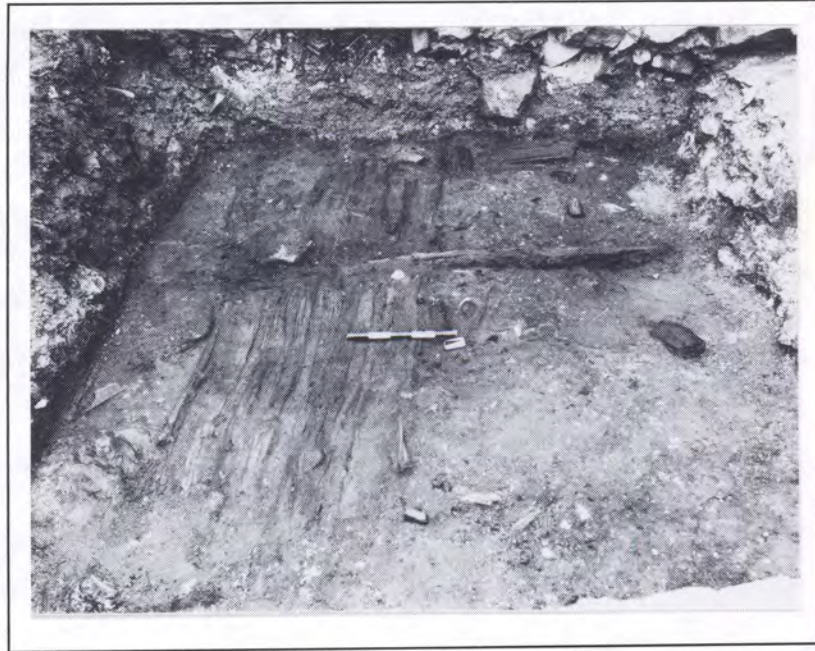
Fig. 24. PHASE III (Level 2). Plate showing the fragmentary planks and joist of the second floor inserted into the cleared-out chancel. Looking W. Note the occasional scattered charred wood fragments (remnant burnt roofing?).

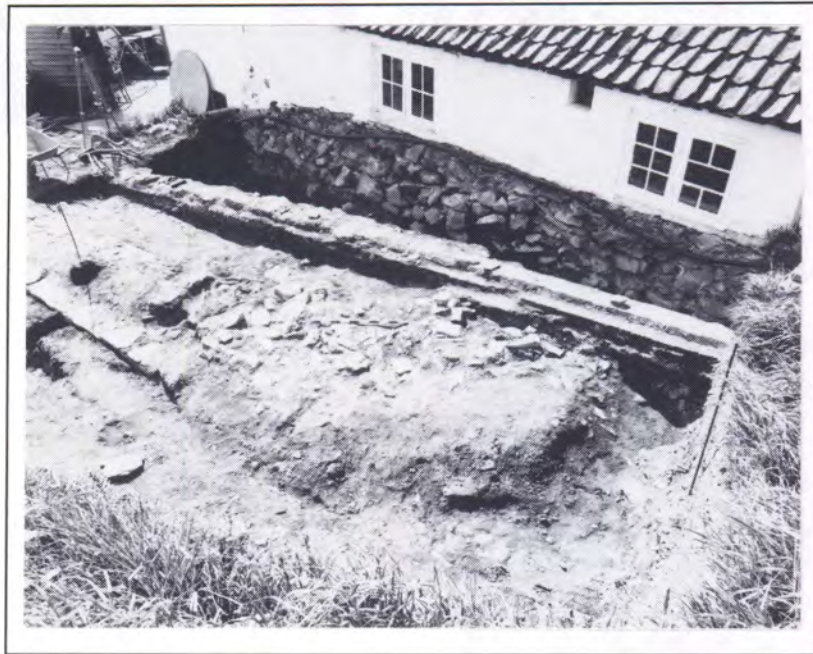
Fig. 27. PHASE IV (Level 1). Plate showing the filled-in line of ditch 41, stone scatter 26, and dumped soils 37a etc. in chancel interior. Looking SW.

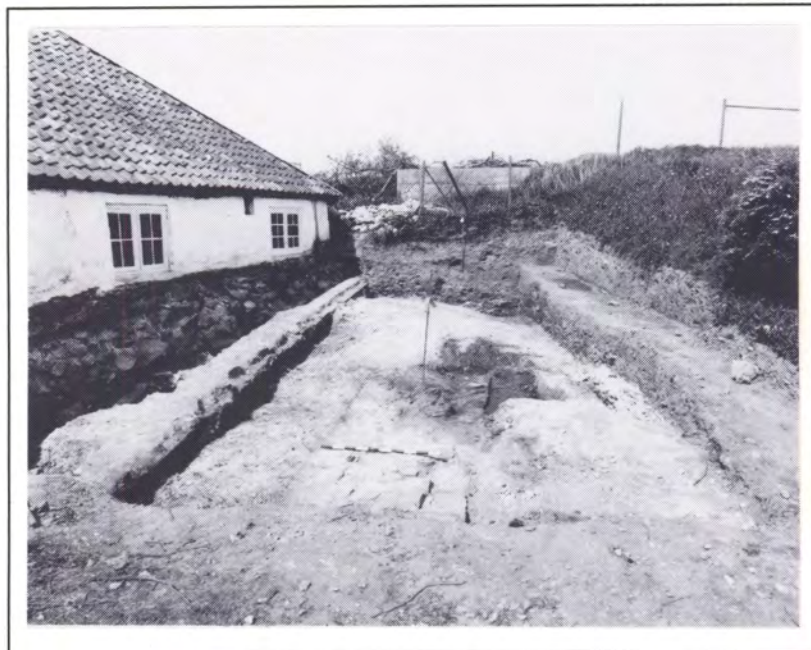
*Fig. 32. PHASE V. Plate showing layers 16, 17, 10, 18, 14, 8, 55. Looking N.*

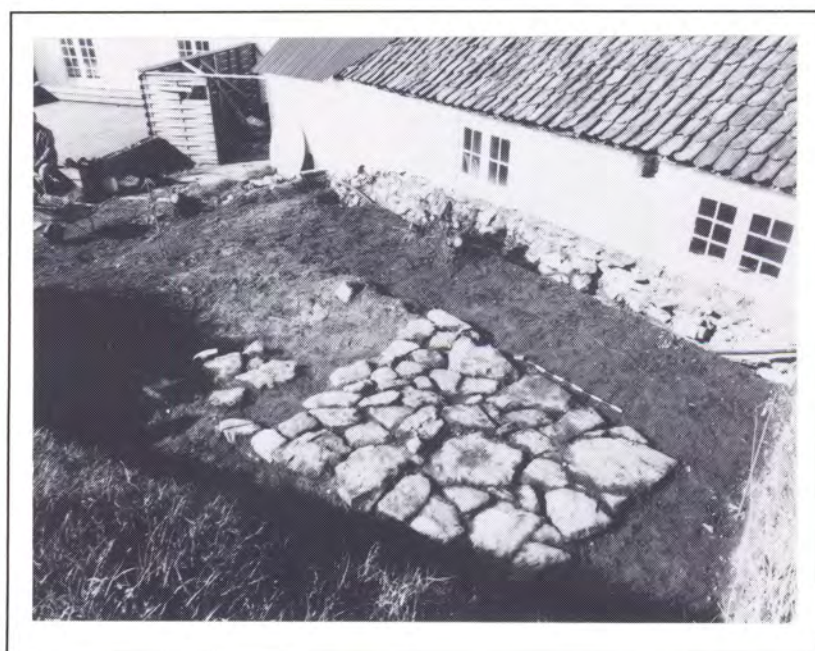
Fig. 34. PHASE VII. Plate showing the stone-paved area 2, and layer 5. Note the 1988 trial trench against the exposed foundation of Falkenskjoldsmessen.

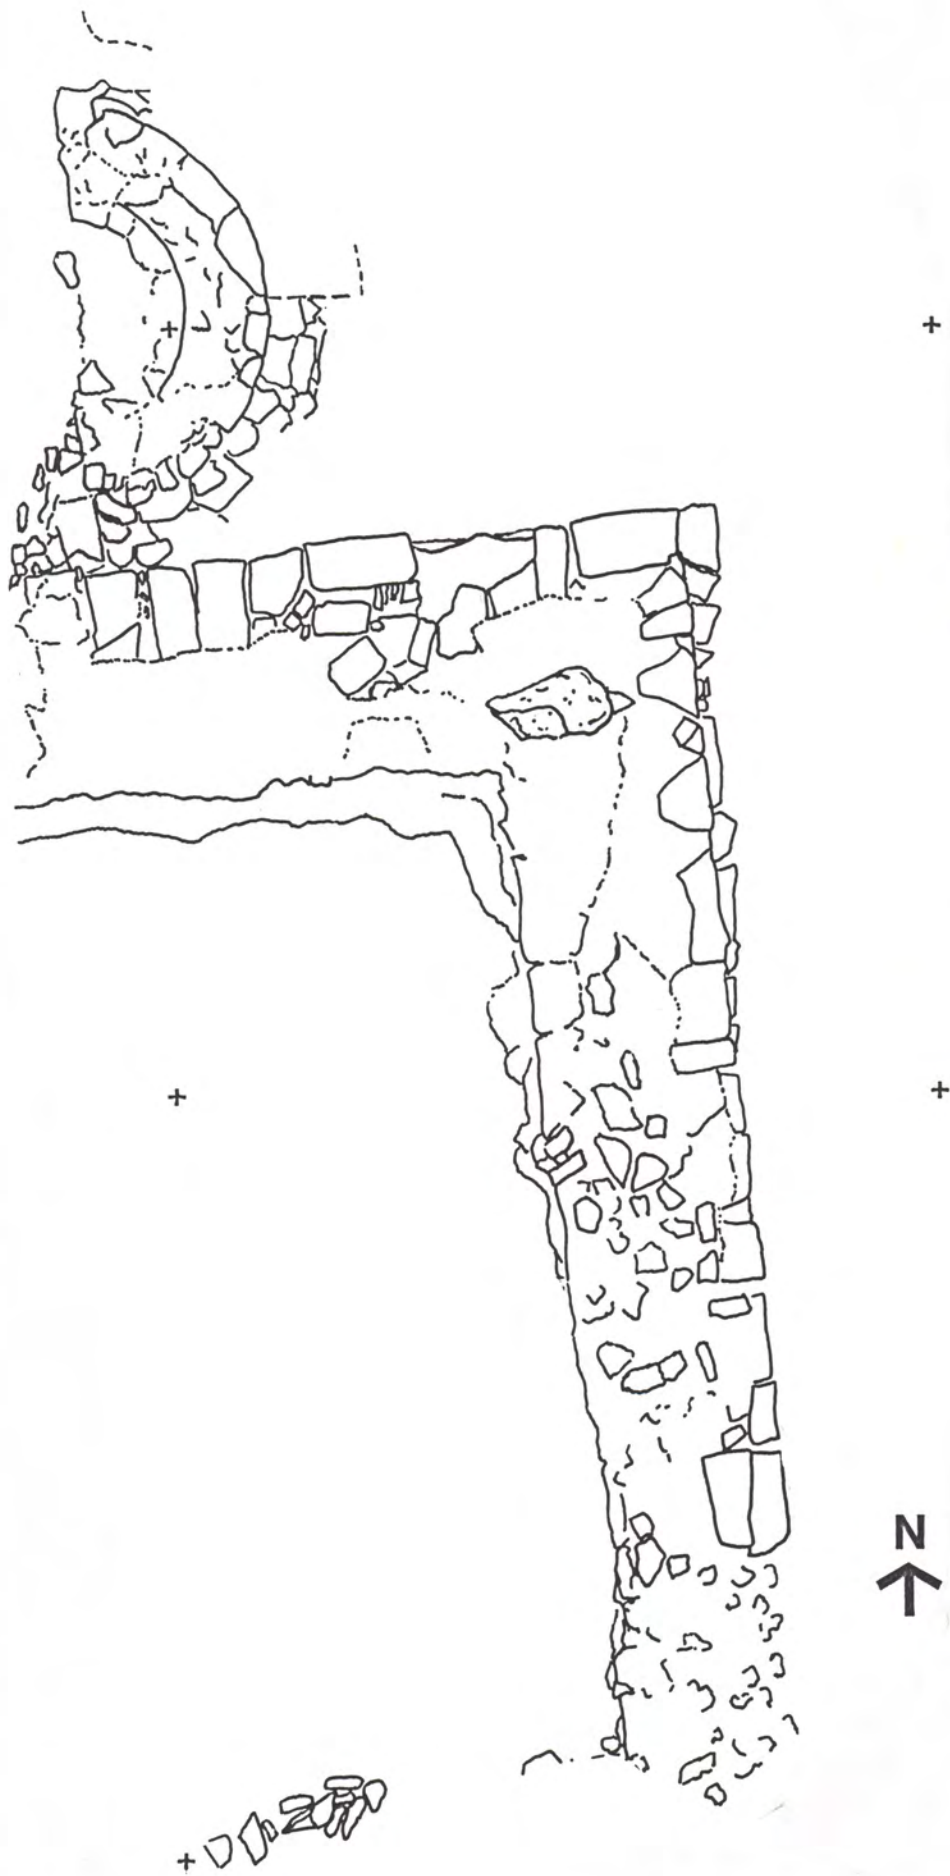
Fig. 35. NIDARHOLM ABBEY CHURCH. Chancel and apse, as excavated. 1:50.

Excavation revealed the partially preserved lower portions of two adjoining stone-built structures (Figs. 35 and 36): the remains of a square-ended building, the eastern end (i.e. the presbytery) of the chancel of the medieval church, and, on its northern flank, a small apsidal structure, part of a probable side-building, in all likelihood a chapel. The two structures differed from each other in specific constructional details; in particular in their respective orientations, methods of foundation and in the type of stone and masonry techniques employed. Stratigraphical evidence indicates that the chancel was built first, the apse being added at a later instance.

The remains of a small half-circular stone structure lay close to the N. wall of the chancel (Figs. 35 and 36). It was preserved to a height of 50cm above its foundation, which was partly exposed in a trial trench as well as in the structure's interior. The curved wall maintained a consistent width of 53cm. The maximum diameter of the whole structure (N-S) was c. 2.6m, while the internal diameter (N-S) was c. 1.5m.

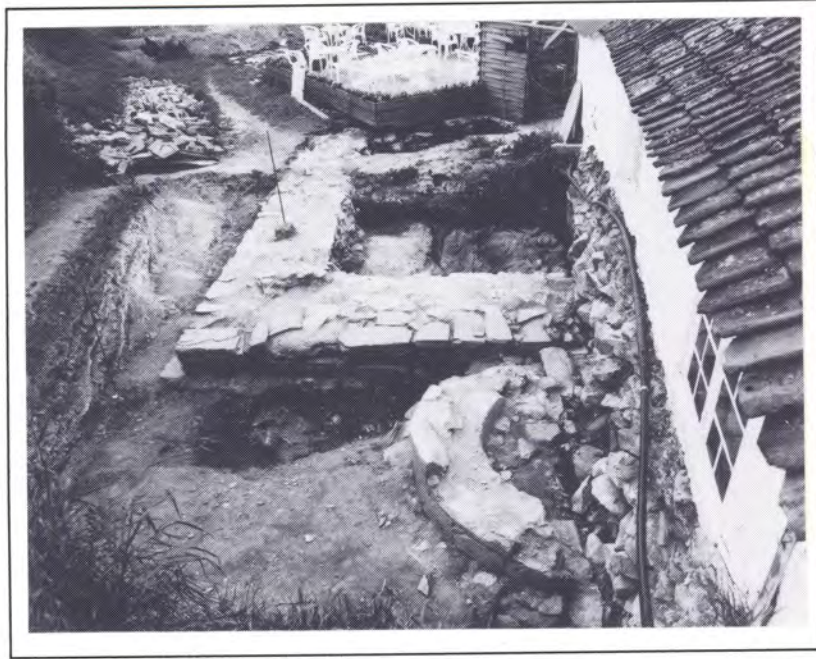
*Fig. 36. NIDARHOLM ABBEY CHURCH. Plate showing the chancel and apse. General view. Looking S.*

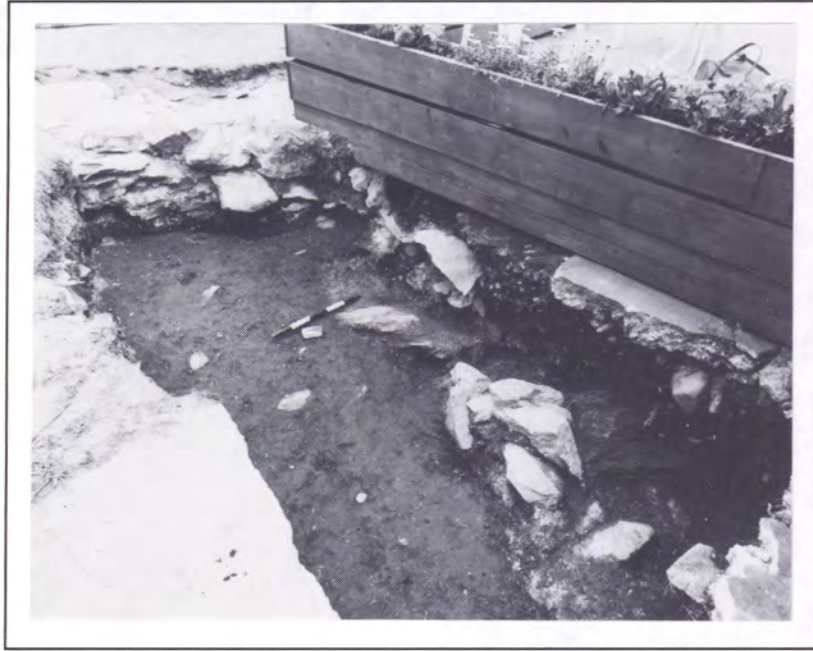
*Fig. 37. NIDARHOLM ABBEY CHURCH. Plate showing the fragmentary remains of the chancel's S. wall, and its junction with the E. wall. Looking E.*

This is represented by the remains of three lengths of walling (20) adjoining each other at right-angles, of which the northern and eastern lengths were the best preserved, the southern wall being represented by only a few mortared stones set on bedrock (Figs. 35 and 37). These low stumps of walling together compose part of a formerly more substantial square or rectangular structure whose surviving dimensions measure c. 9m (N-S) x 4.3m (E-W) externally and 6.4m x 3m internally. The N. and E. walls were preserved to maximum heights of 55cm and 40cm respectively. The N. wall's surviving maximum upper surface width was 1.6m, while that of the E. wall was 1.3m. The N. wall's maximum basal width was 2m, while that of the E. wall was 1.7m. There seems to be a consistent difference in width between these two walls of roughly 30cm.

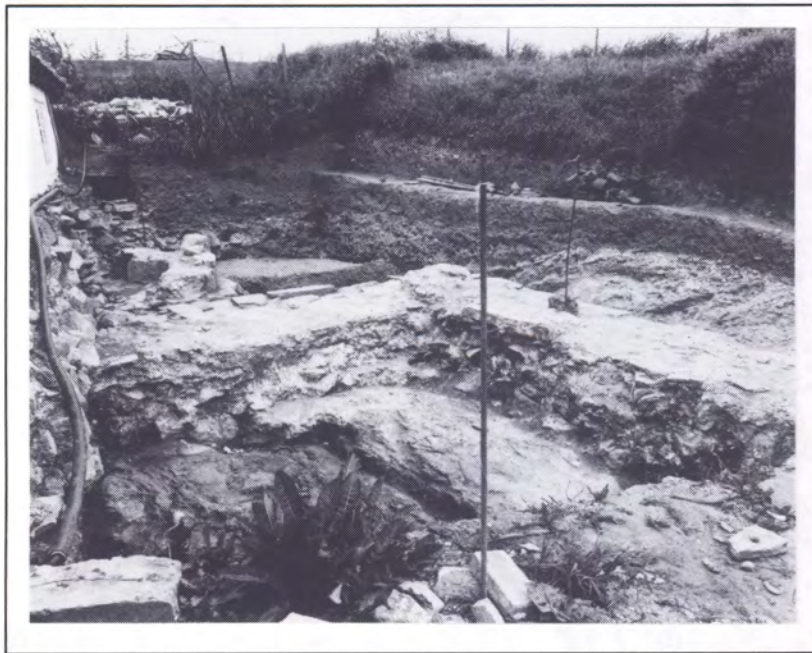
*Fig. 38. NIDARHOLM ABBEY CHURCH. Plate showing the emptied interior of the chancel. Note the ragged exposed core on the inner faces of the walls, the patches of secondary whitewash, and the protruding slab (remnant facing?) on the E. wall's surface. Looking NE.*

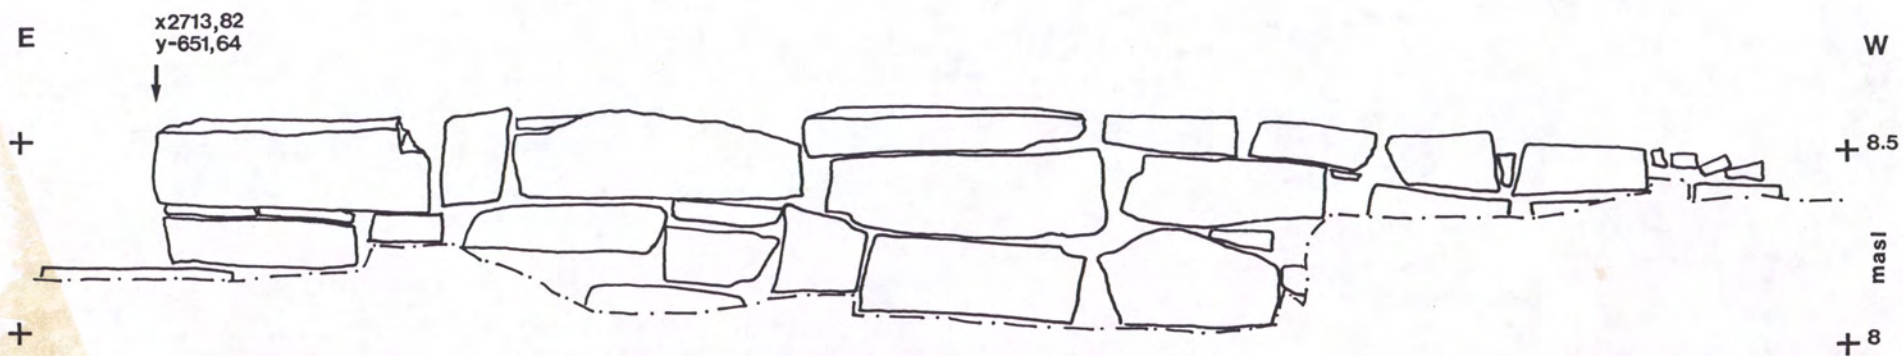
Fig. 39. a. NIDARHOLM ABBEY CHURCH. The chancel's E. wall in elevation. 1:20.

Outside the chancel, the foundation level was partially exposed along the line of the E. wall, while the N. wall's foundation level remained largely unexcavated. The E. wall (Figs. 39a, 40 and 41) appears to have possessed at least two foundation courses of comparatively small stone slabs mortared both to each other and to the surface of bedrock. Above these were two complete courses of larger sub-rectangular stones, with the partial remains of a third course of thinner slabs, all mortar-bound. These upper courses of facing stones were laid on an alignment which deviated partially from that of the two foundation courses, the latter emerging obliquely from a point half-way along the line of the external facing to form an incomplete plinth-like projection. This "plinth" seems to have been confined to the N. half of the E. wall's external length. No trace of a similar projecting arrangement was located in connection with the N. wall (while not fully excavated, it seems probable that the N. wall's lowest facing course did not rest on a foundation, but was rather itself mortared directly onto bedrock).

Above the foundation, the E. wall's two complete courses of quarried rubble facing formed a regular and consistently level arrangement. The lowest of these courses consisted of roughly hewn subrectangular blocks and slabs of about 10cm in thickness. As with most of the chancel walling, there were few if any pinning stones in evidence. The course above this comprised a similarly regular arrangement of larger hewn blocks (c. 20cm thick). The upper surfaces of some of these could be seen partially in the exposed core of the wall; some were set with their greater lengths parallel to the line of the wall, while a few others were bound into the core with their lengths at right-angles to the line of the wall. A few pinning stones set on their edges occasionally intervened in larger gaps between the blocks of this course. A few thinner slabs (c.4cm thick) lay above the second course, possibly forming the remains of a third course. If this is any indication, the E. wall may conceivably have held a series of variably thick courses (and even perhaps placed in a systematic, though irregular, sequence of alternately thick and thin courses?).

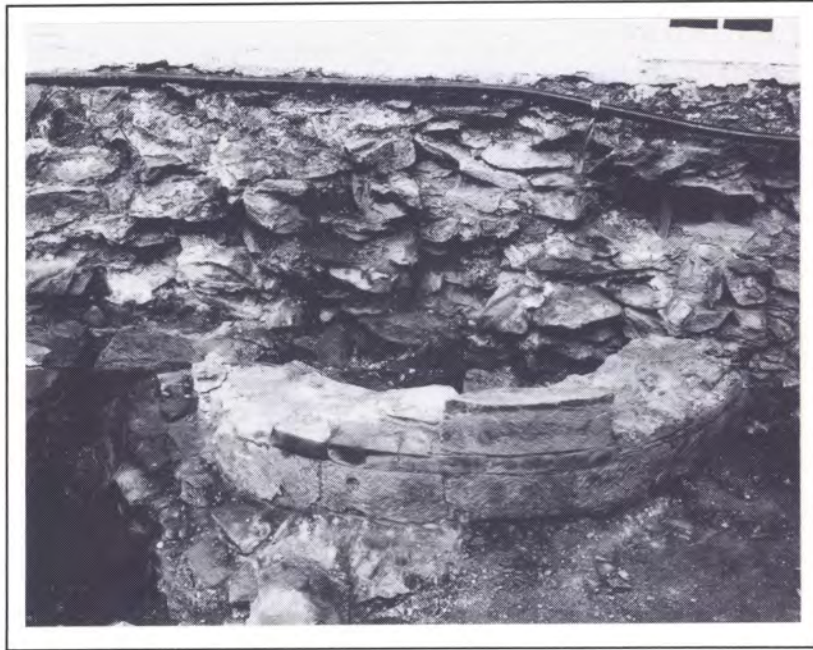
*Fig. 43. NIDARHOLM ABBEY CHURCH. Plate showing the apse as excavated. Looking W.*

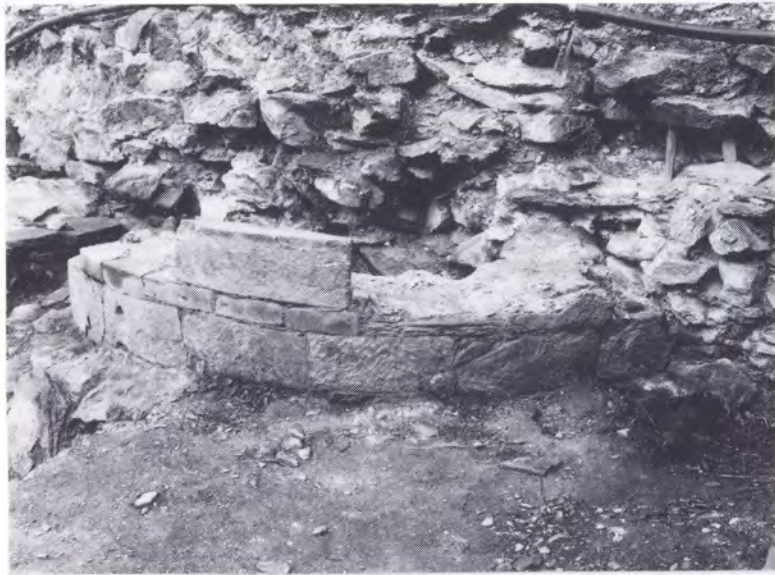
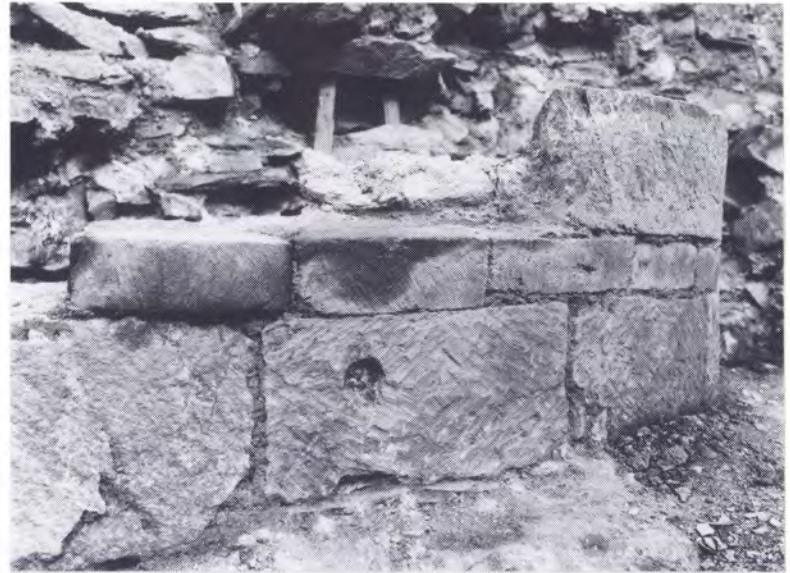
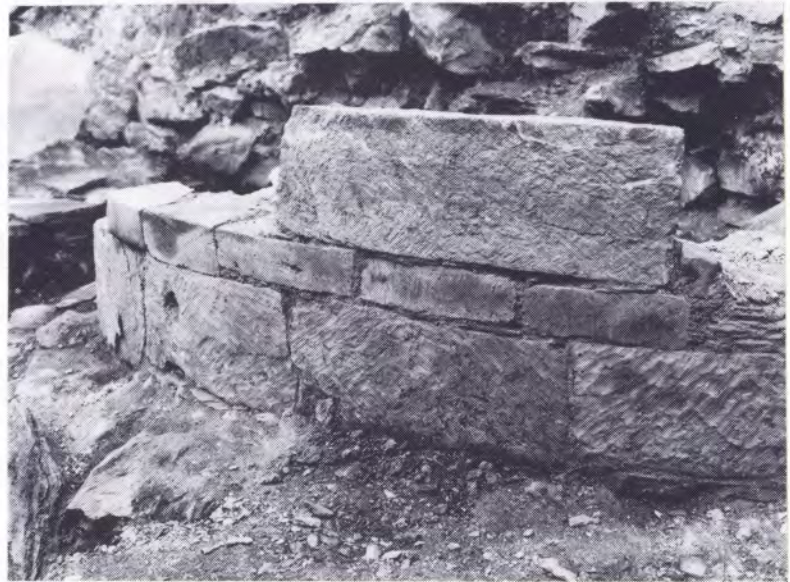
*a. Looking SW.*

*b. N. half, looking NW.*

*d. Looking SW.*

*Fig. 44. NIDARHOLM ABBEY CHURCH. Plates showing the apse in detail.*

As stated, the facing stones were fitted snugly together, each being cut to form a component in a regularly curved structural arrangement. In this the masonry technique appears to be of good quality. However, the character of tooling on these stones' external faces was variable (Fig. 44), being roughly dressed with chisel-marks cut in divergent directions. The surface of one stone in the first course bore both roughly and finely dressed portions (a practice piece?). The stones in the second and third courses were perhaps slightly better finished. One of the stones in the lowest course had a partly mortar-filled 8cm diam. hole bored into its face, as well as a slot some 8cm wide in its base (a re-used stone?). These facing stones appear for the most part to have been placed with their greatest lengths in conformity with the line of the wall.

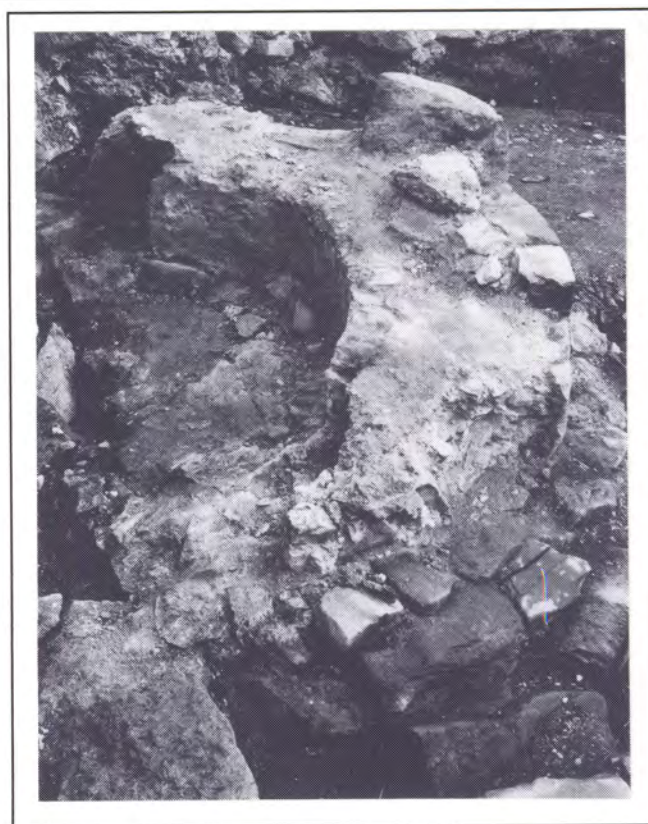
*Fig. 45. NIDARHOLM ABBEY CHURCH. Plate showing the interior and foundation of the apse. Looking N.*

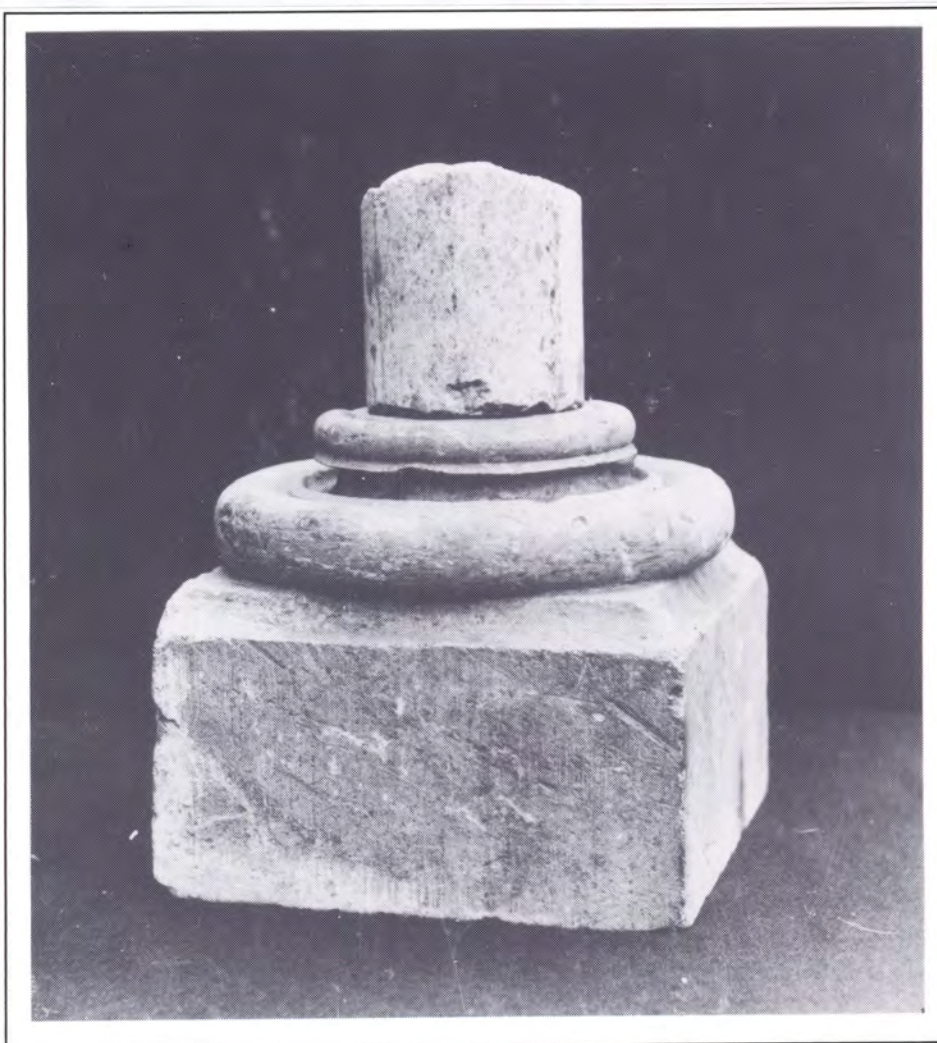
*Fig. 53. Pillar-base found previously on Munkholmen: a so-called "water-holding" moulding. Paralleled in the open porch of Nidaros Cathedral's choir, dated by Fisher to the early 13th century, probably pre-1230 (Fischer 1965, p. 245 "F", p. 248) - A. T. Hommedal pers. comm.*

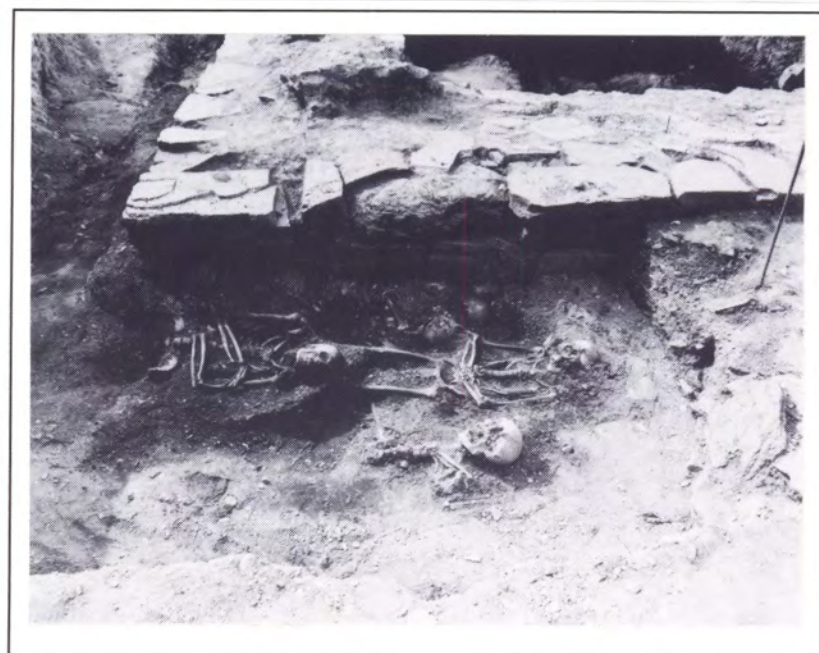
Fig. 54. Plate showing the skeletons 44, 60, and 68 against the N. wall of the chancel. Looking S.

The articulated skeletons uncovered in the trial trench lay grouped closely against the exterior of the chancel's N. wall (Figs. 54 and 55), one in particular (**81**) lying with its head within the narrow space between chancel and apse. This area along the N. wall of the chancel is known to have been considered a special part of the graveyard.
