MONITORING  
MITIGATION  
MANAGEMENT

THE GROUNDWATER PROJECT - SAFEGUARDING THE  
WORLD HERITAGE SITE OF BRYGGEN IN BERGEN

## RIKSANTIKVAREN 2015

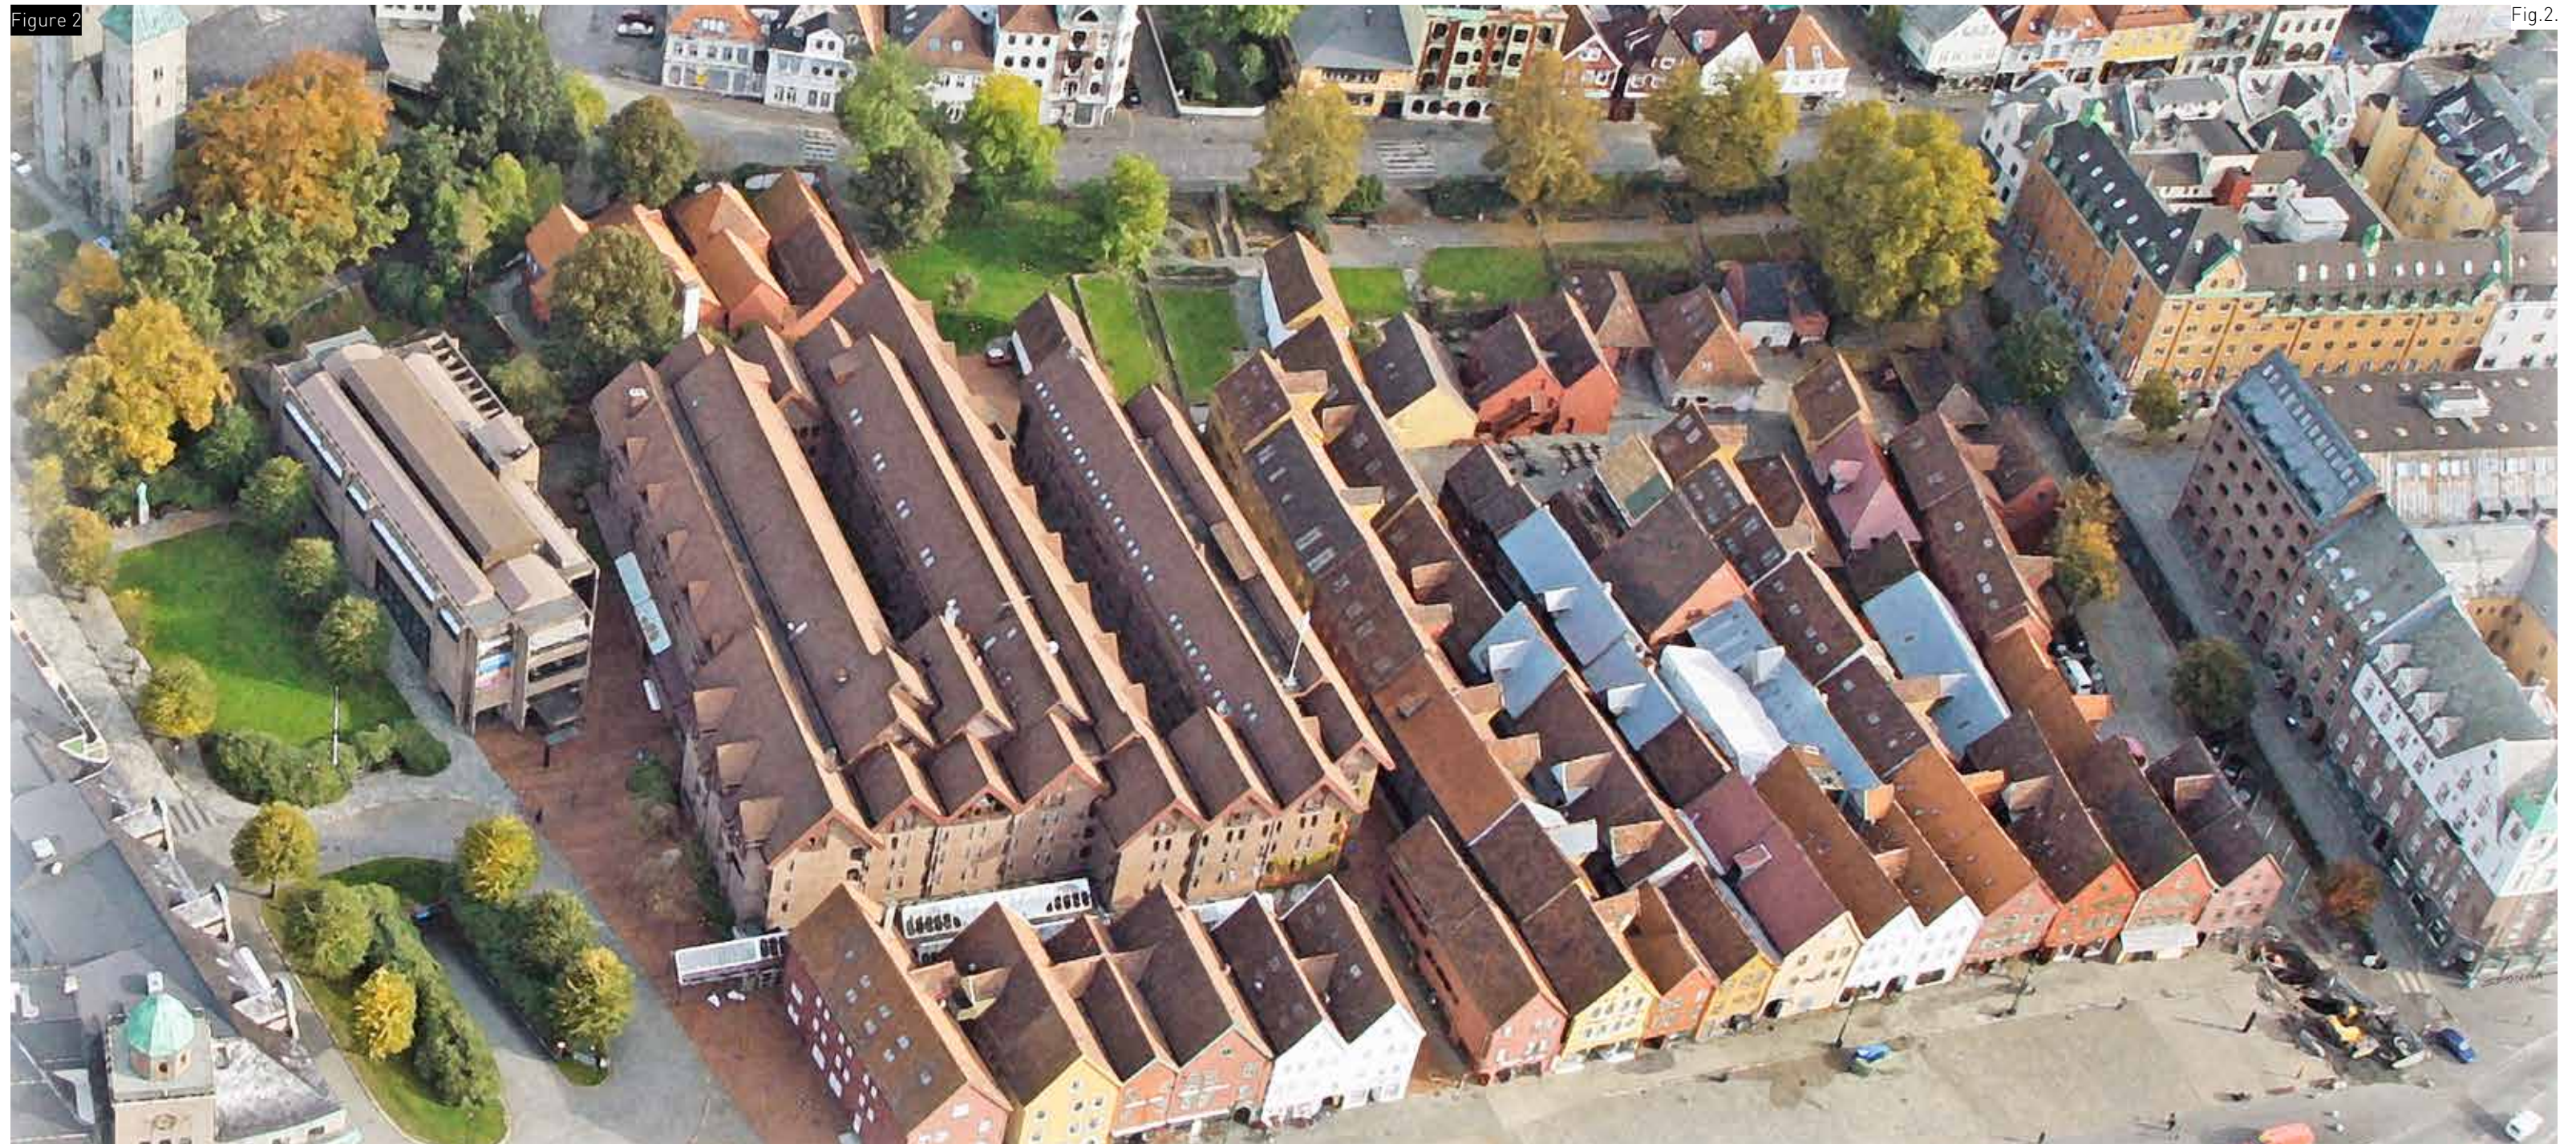
Fig.2.

Figure 2 Overview of Bryggen in Bergen.  
Drawing: T. Sponga, © Riksantikvaren.

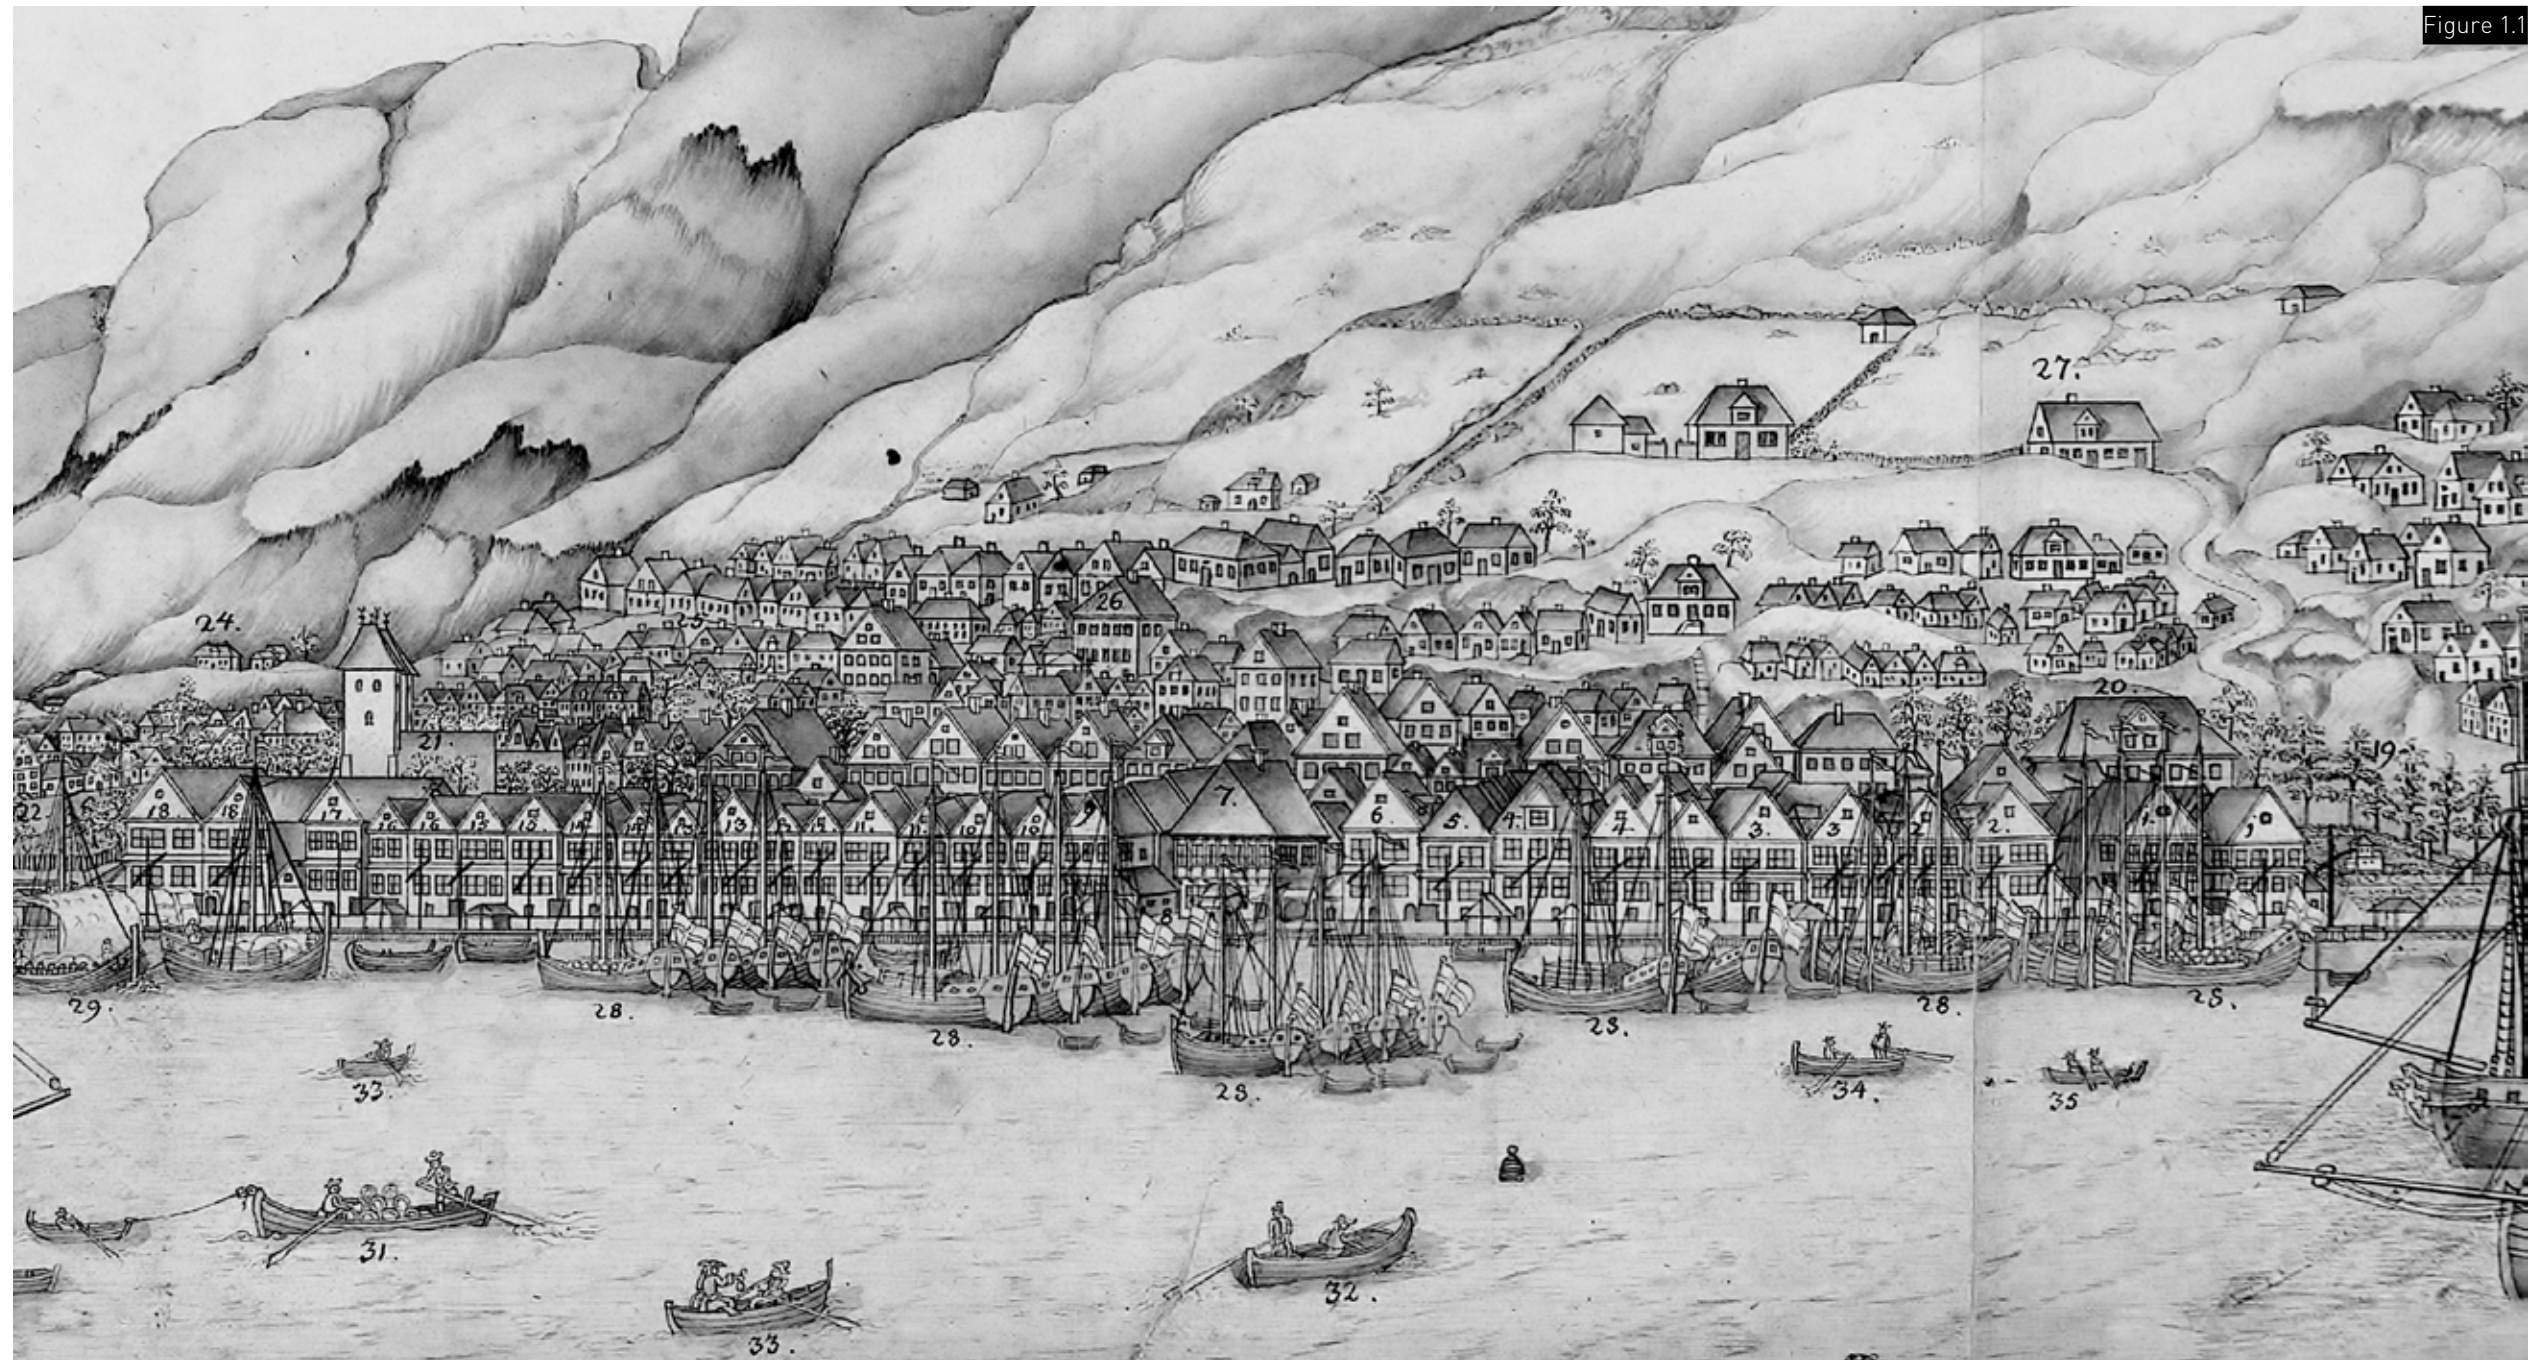
Figure 1.1 Detail from Johan Joachim Reichborn's drawing of 'Handels Contoirtet udi Bergen' in 1768. The Bryggen tenements are numbered 1 – 7 and 9 – 18. 1. Finnegården, 2. Dramshusen, 3. Bratten, 4. Leppen, 5. Revelsgården, 6. Sologården, 7. Kjøpmannsstuen, 9. Kappen, 10. Holmdalen, 11. Jakopsfjorden, 12. Svensgården, 13. Enhjørningen, 14. Bredsgården, 15. Bugården, 16. Engalgården, 17. Søstergården, 18. Gullskoen. Compare to figure 5. (The original drawing is kept at Bergen Byarkiv).

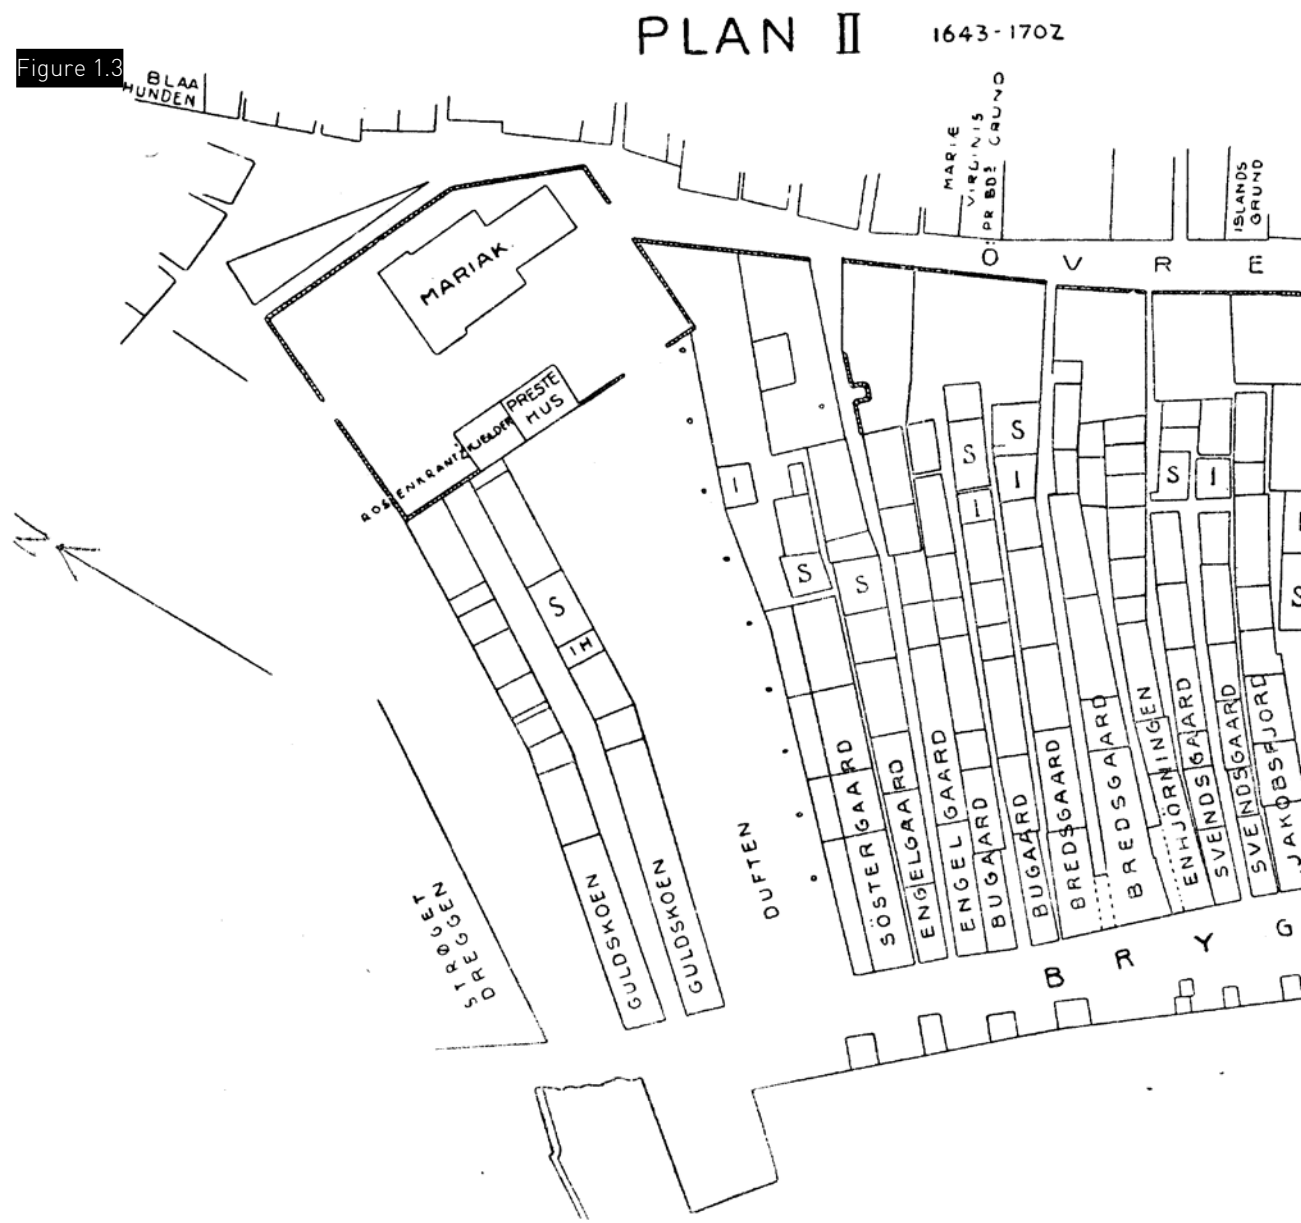
Figure 1.3 This map is Koren Wiberg's interpretation of Bryggen's topographical outline after Rothmansgarden to the south of Vetrliden had been demolished in 1643. In broad strokes, it gives a valuable impression of Bryggen before it was devastated by fire in 1702. The open spaces among the tenements, called Duften, represent the sites of the desolate plots agreed upon after the fire in 1476. However, accounts of The Kontor from the late 17th century show that by this time the Duften had been densely occupied by small storehouses. (Koren Wiberg 1908, 16-17).

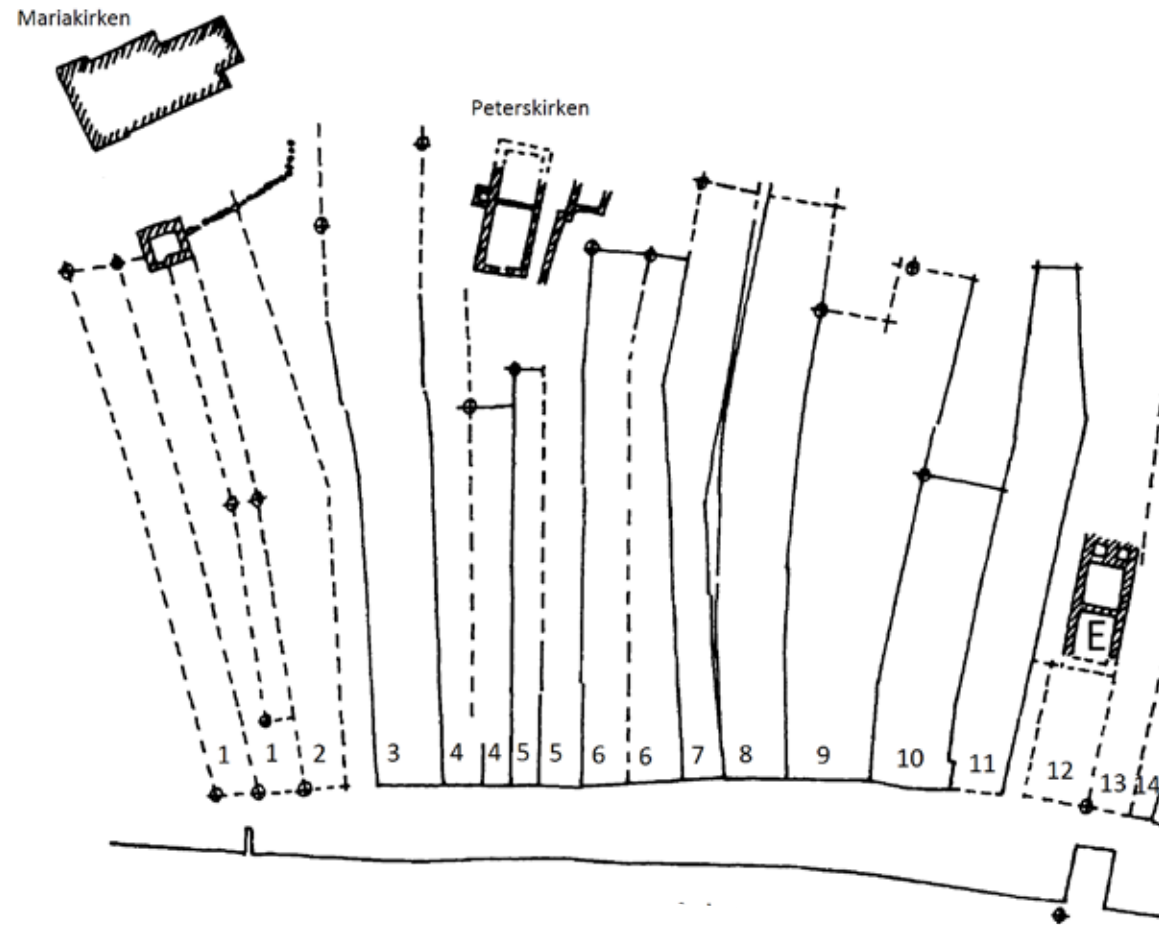
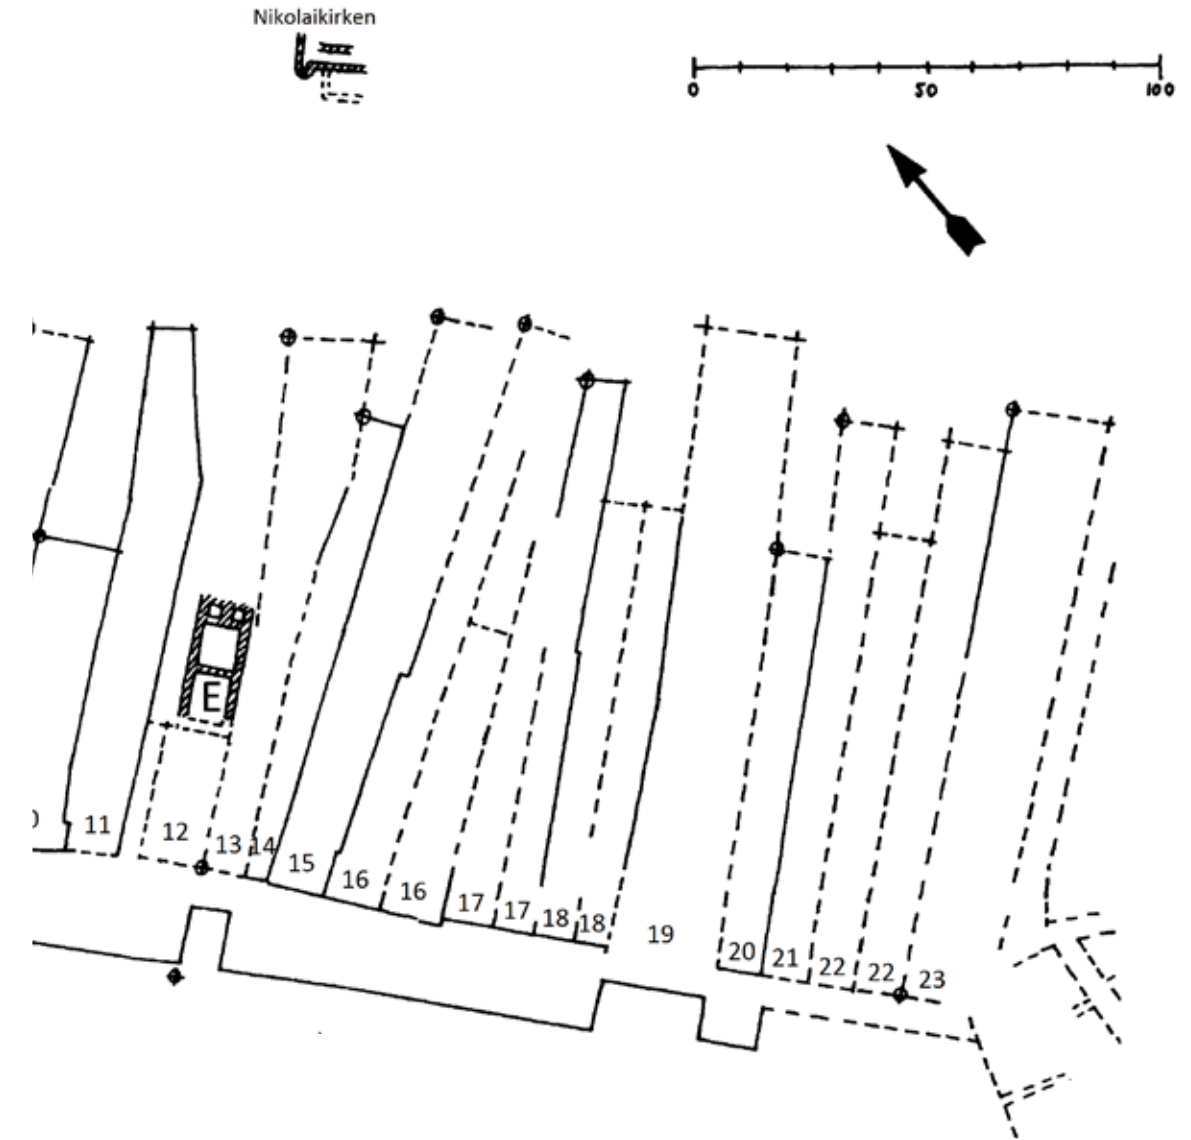
Figure 1.5

- 1. Gullskoen. 2. Atlegården (ødegrunn). 3. Søstergården.
- 4. Engalgården. 5. Bugården. 6. Bredsgården. 7. Enhjørningen. 8. Svensgården.
- 9. Jakobsfjorden. 10. Holmedalen. 11. Kappen. 12. Kjøpmannsstuen. 13. Michelgården (ødegrunn).
- 14. Solegården. 15. Revelsgården. 16. Leppen. 17. Bratten. 18. Dramshusen. 19. Schaften, Buchlergrunn og Ridstaden (ødegrunner).
- 20. Finnegården. 21. Brødregården. 22. Vetrliiden. 23. Rotmangården. E. Vinkjelleren

Figure 1.5. The annual plot rents for the plots at Bryggen, found in deeds from the 1560s and a ledger from 1686, can be used to calculate the length of each tenement plot at Bryggen in the 1560s. At that time the plots were measured from the quayfront. Numbers 2, 13 and 19 were left desolate (ødegrunn). The outline of each plot has been projected onto a detailed map from 1879/80, except for nos. 1 and 20-23, where minor changes to the plot structure had taken place following the rebuilding of the tenements after the major fire in 1702.

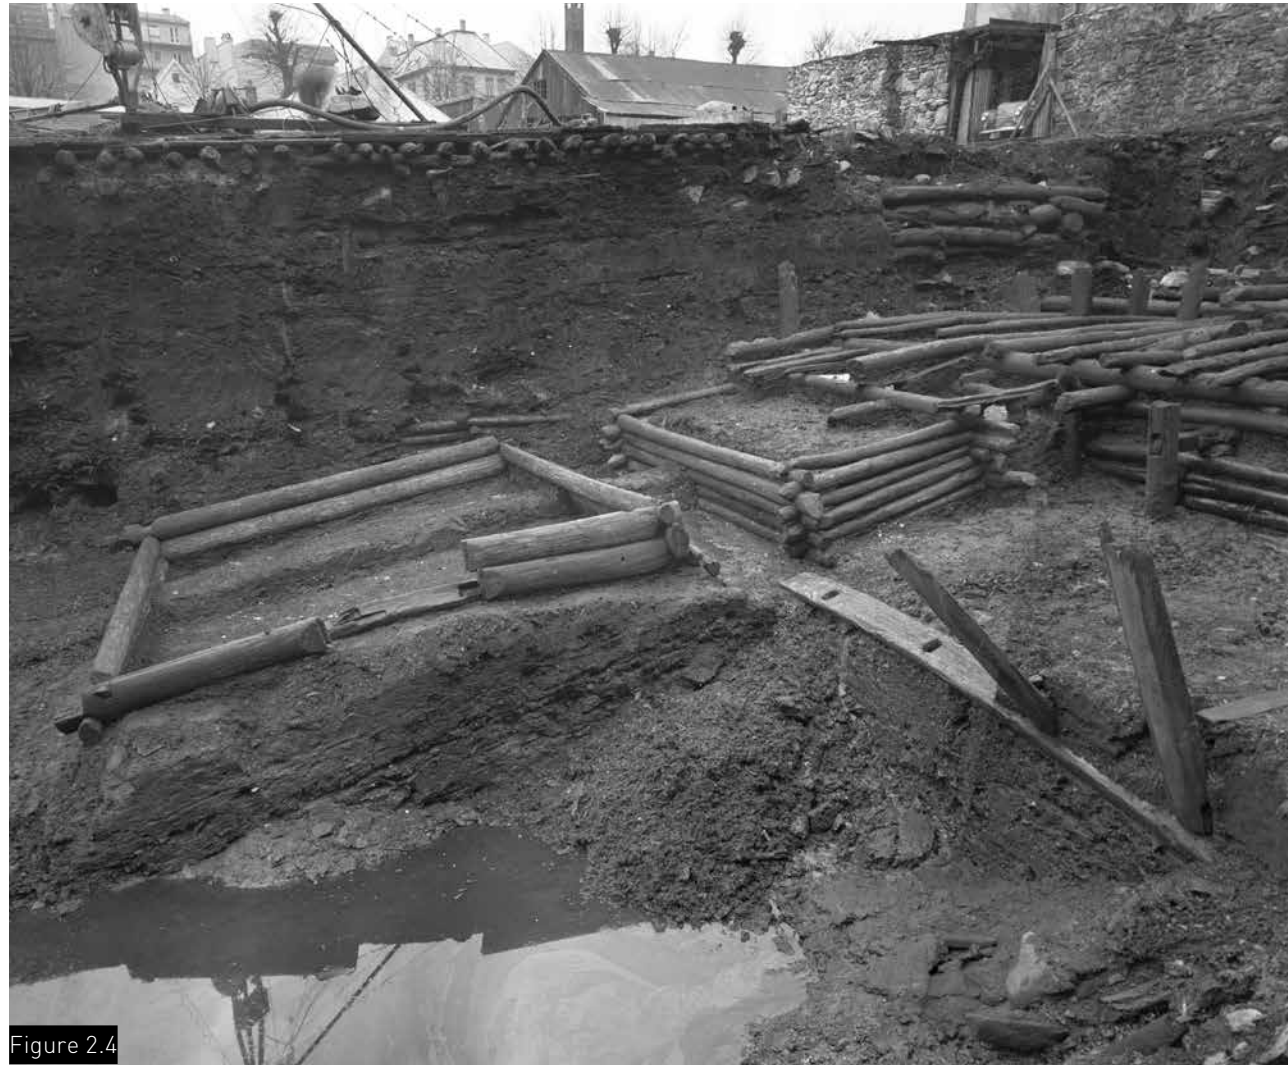
Figure 2.4

Figure 2.4. Quay structures of wood.  
Photo: Bryggens Museum.

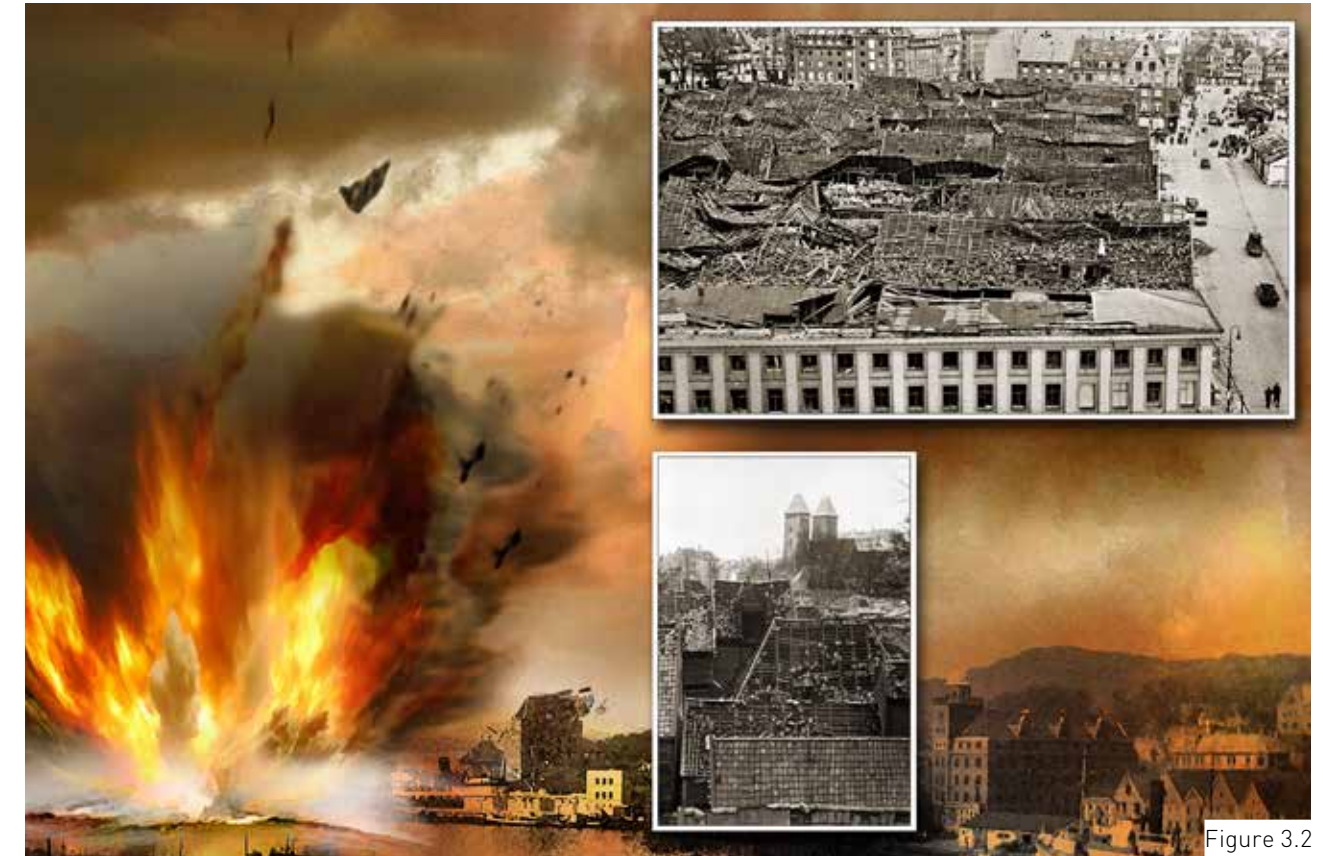
Figure 3.2 Bryggen - artist's impression of the Voorbode explosion on April 20th 1944. The photo inserts show the damage done to the historic buildings' roofs.  
Drawing: T. Sponga, © Riksantikvaren.  
Photo: Unknown. In BT's photo archive.

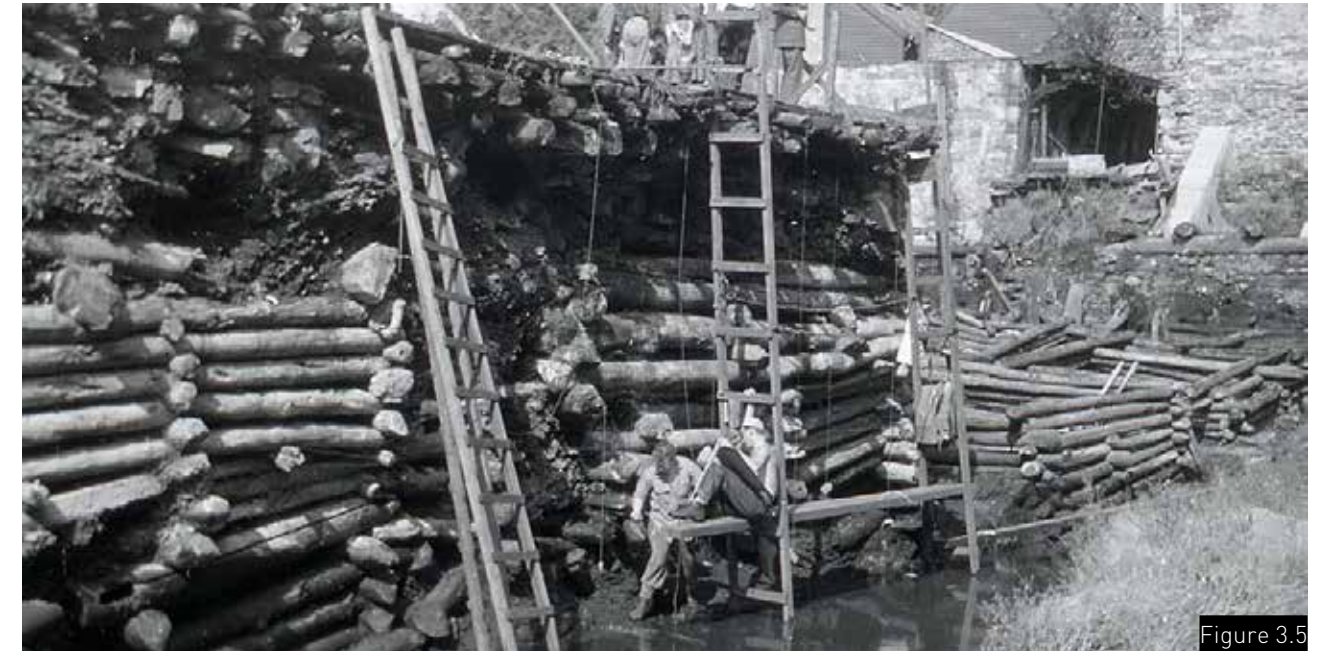
Figure 3.5 Documentation of archaeological deposits and constructions in a section at Bryggen. Photo: Universitetsmuseet i Bergen, UiB.

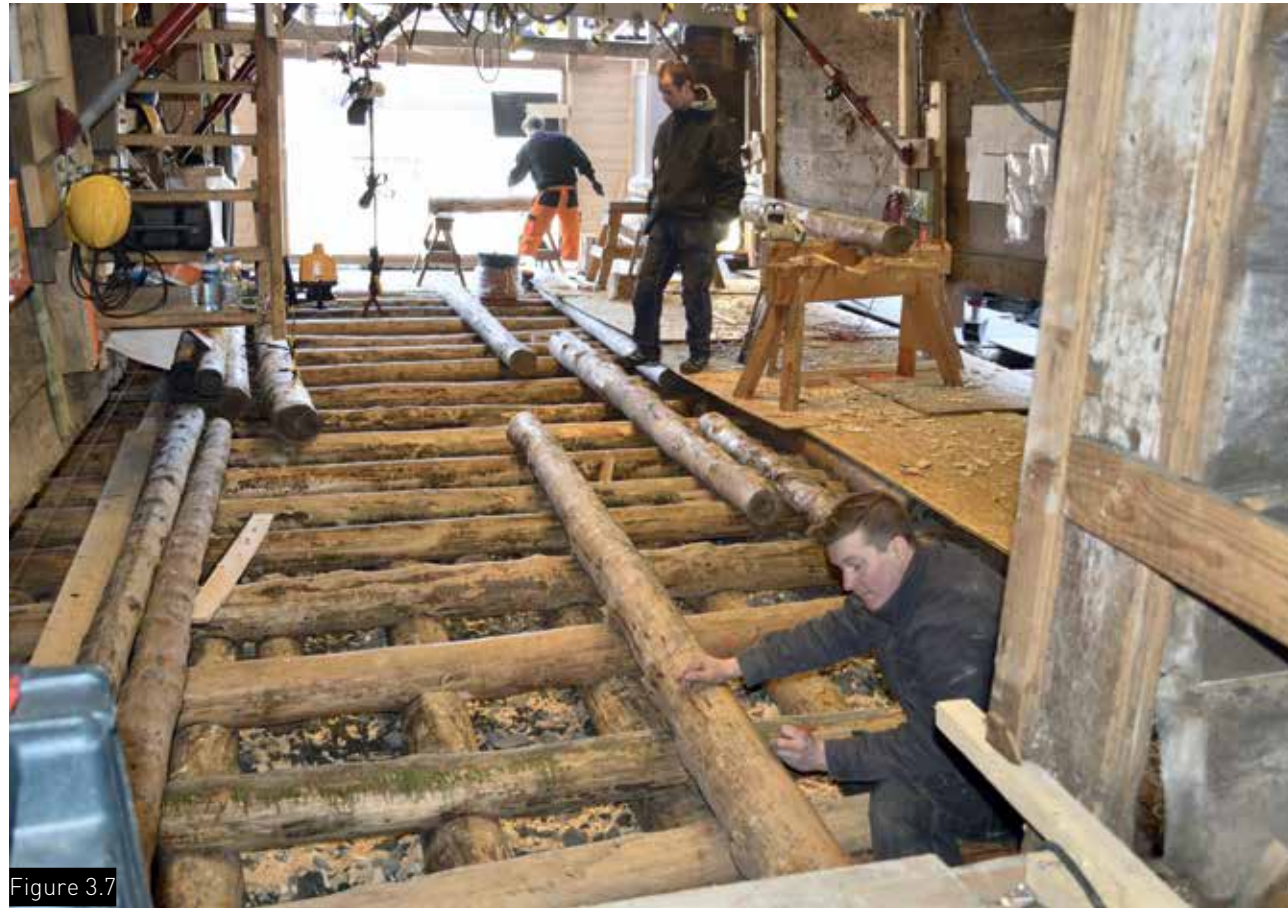
Figure 3.7 Building renovation works at Bryggen. Marius Røbech (foreground) and Sondre Andersen from the Bryggen Foundation are constructing a new timber foundation for a building using traditional methods. Photo: E. Jensen, Stiftelsen Bryggen.

In the middle of the 1990s there was a shift in restoration principles away from the use of modern materials in foundations. A method of restoration was introduced whereby traditional methods and materials were used as far as possible. In this way both the techniques and access to materials are retained. This also meant that the method used for the new foundations of newly-restored buildings moved away from pile and concrete footings and went back to using traditional, cross-laid rafts of horizontal timbers to replace the rotten timbers. These rafts were to contain at least three courses of logs, and nowadays work is going on where necessary to replace

the timber foundations all the way down to the firelayer deriving from the 1702 fire, where deposits of ash, charcoal, broken bricks/tiles, gravel and stones make up an excellent impermeable layer. In those places where the firelayer is missing, attempts are being made to recreate the stratigraphic conditions.

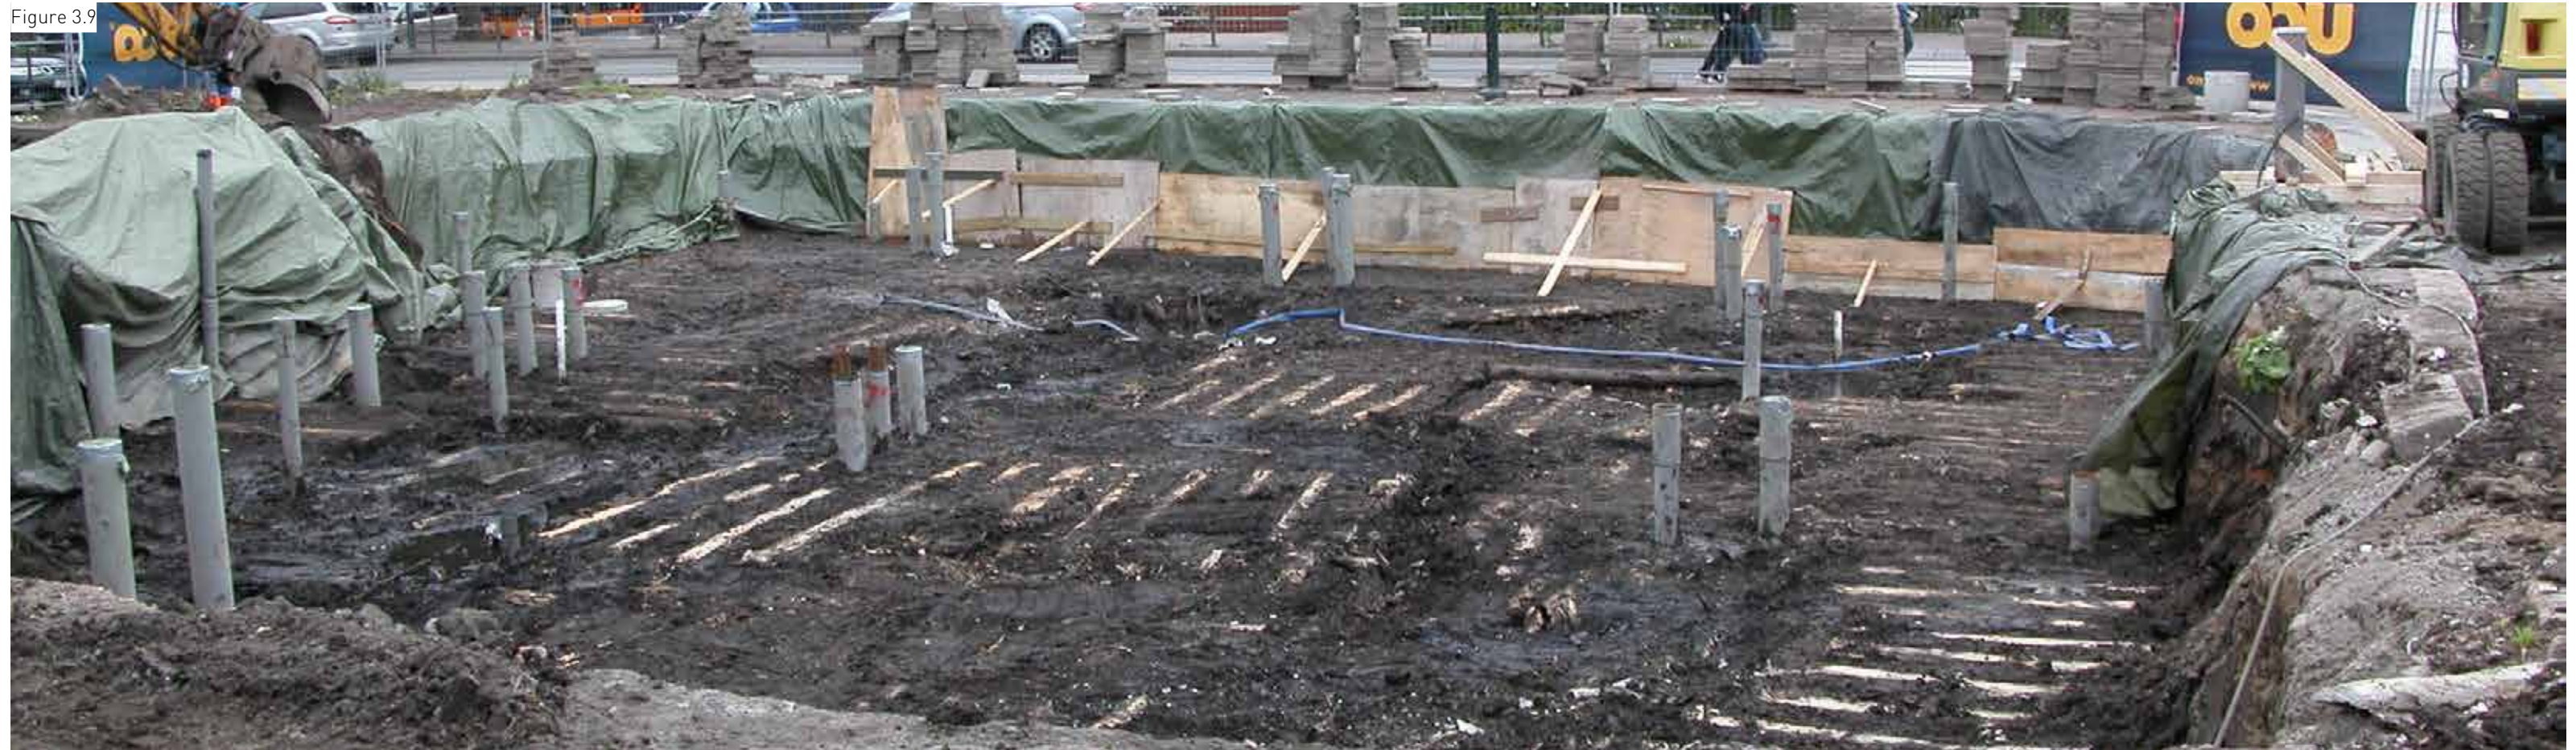
Figure 3.9 Piles drilled through archaeological deposits in Tønsberg. Photo: J. Rytter, Riksantikvaren.

Briefly the project involved collecting documentation about the state and conditions in archaeological deposits close to the piles. The investigations showed no sign of damage close to the drilled piles. Following this project a measure was introduced with conditions whereby permission must be obtained for piling in certain types of building projects. Piling is not suitable for Bryggen. In the period 2005-2014 environmental monitoring was introduced in the majority of mediaeval towns and cities in Norway and also for other categories of cultural heritage. In addition a Norwegian standard for environmental monitoring of cultural deposits has been drawn up in NS 9451:2009 (also available in English)<sup>89</sup> and guidelines in SINTEF Byggforskserien 721.305 Bygging på kulturlag i middelalderbyene (Building on cultural deposits in medieval towns and cities).<sup>90</sup>

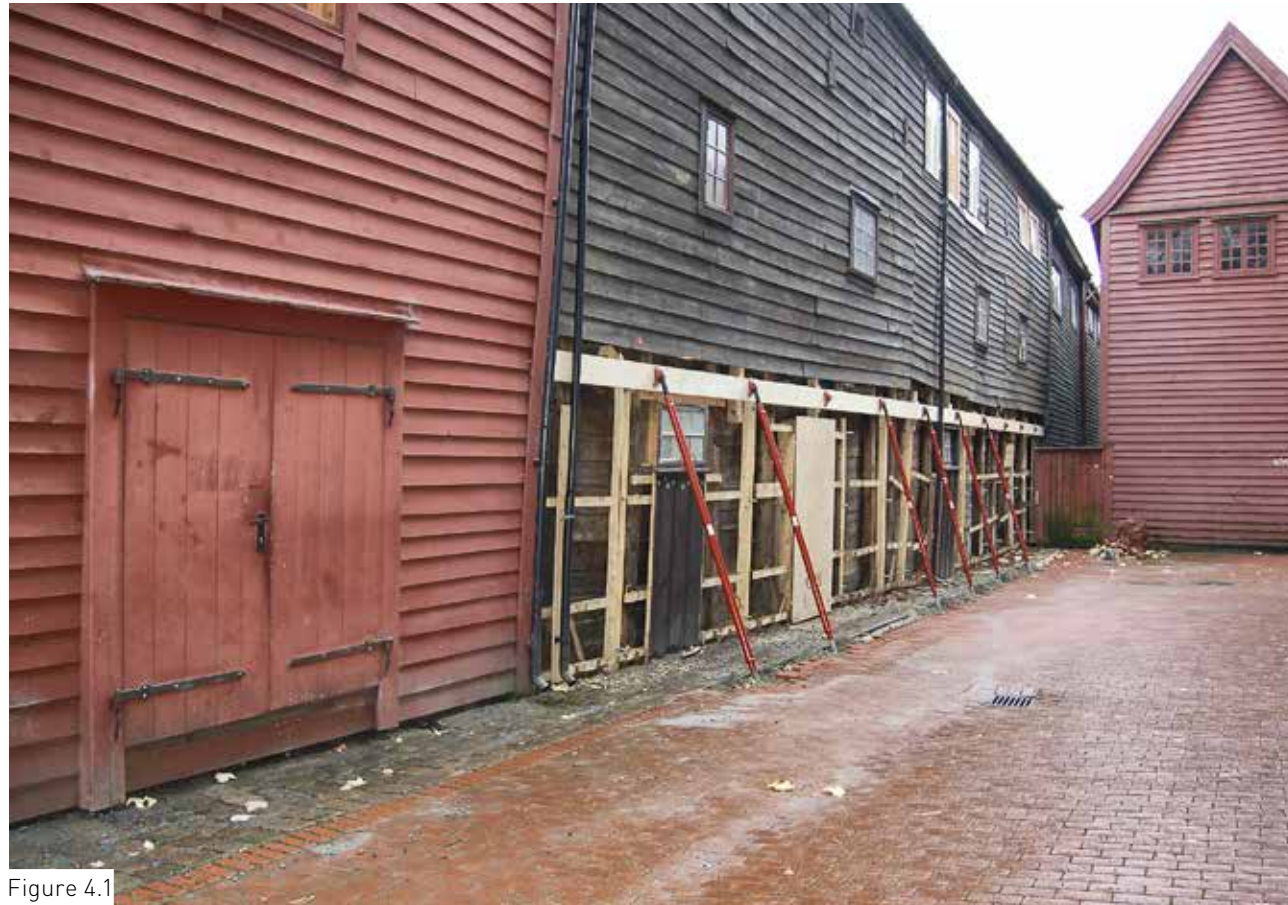
Figure 4.1 Bredsgården tenement: shoring up buildings damaged by subsidence.  
Photo: E. Jensen, Stiftelsen Bryggen.

During the 1990s the owners of buildings within the World Heritage site noticed signs of damage to their buildings, damage that was linked to subsidence. Measurements were taken that showed that in some areas the annual rate of subsidence was 5-7 millimetres. Initially, vibration from vehicular traffic along the front of Bryggen was suspected to be the culprit, but it very soon became clear that the principal cause was lower than anticipated groundwater levels in the most badly affected areas.

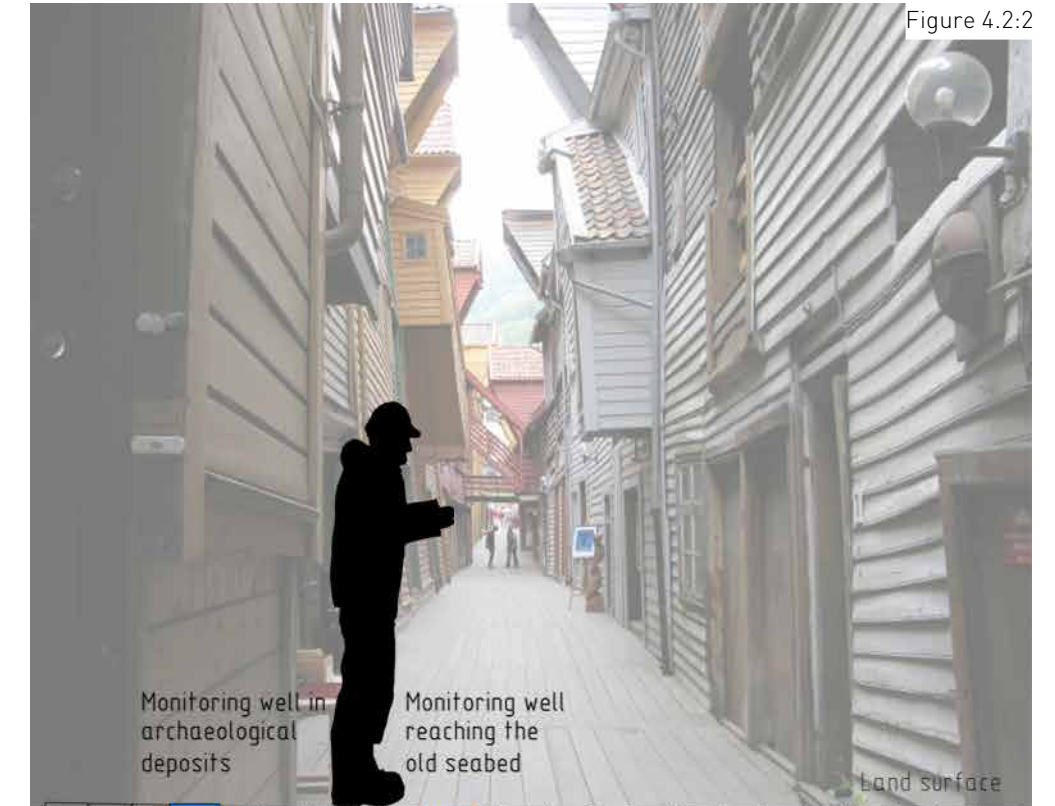
Figure 4.2:2

Figure 4.2:1-2 Monitoring and surveying methods.  
Drawings: Multiconsult AS/  
O. M Hansen, Alkymi Design.

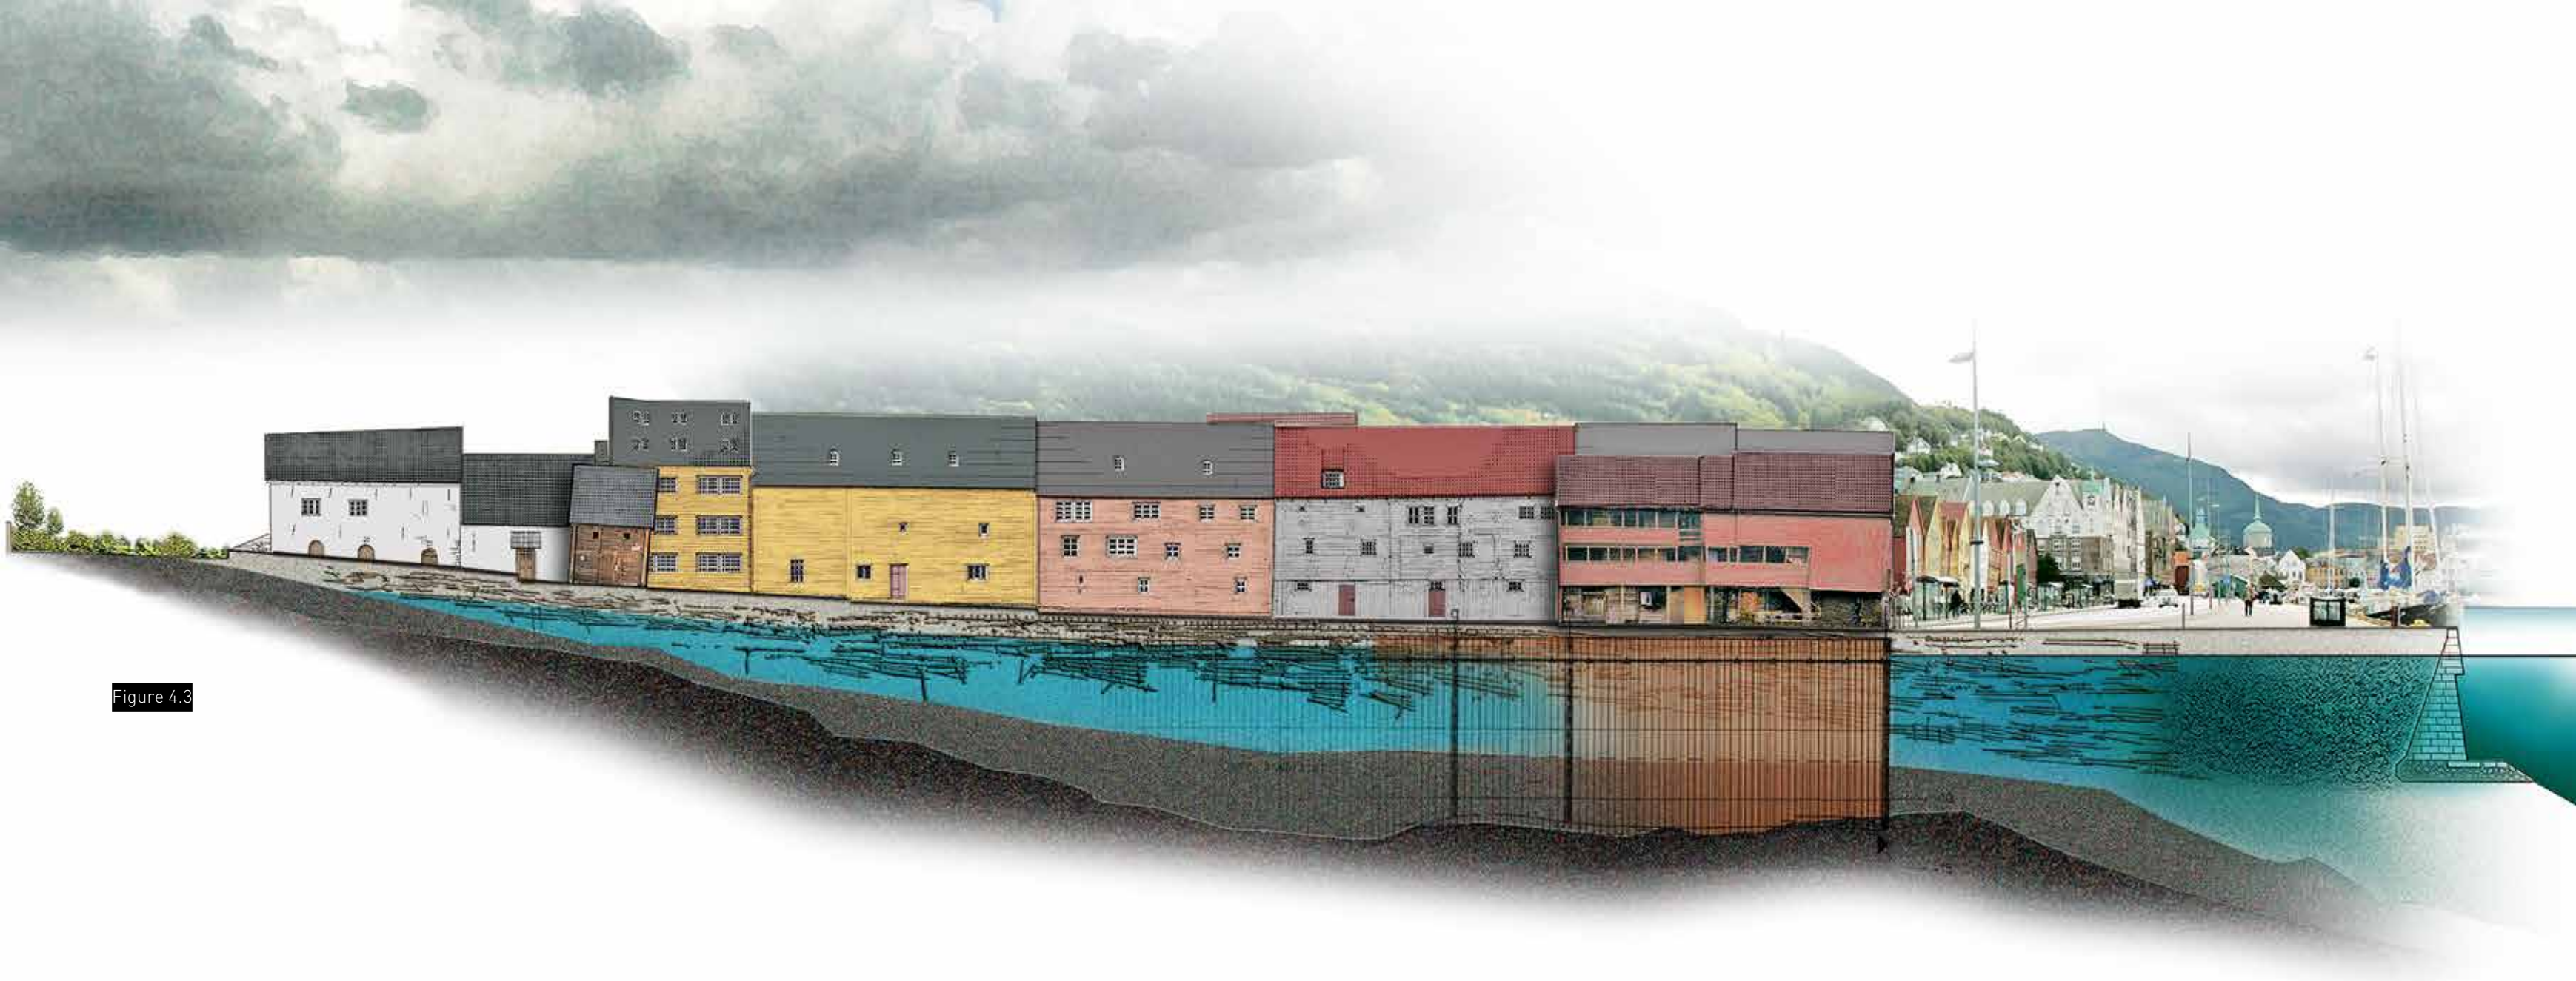
Figure 4.3 Bryggen - sections showing buildings, archaeological deposits and groundwater.  
Drawing: T. Sponga, © Riksantikvaren.

A comprehensive monitoring programme was designed to follow the groundwater situation, and by 2010 some 35 monitoring wells had been installed, along with a test-pit with various sensors placed at different depths in one of the soil walls.
