MONITORING  
MITIGATION  
MANAGEMENT

THE GROUNDWATER PROJECT - SAFEGUARDING THE  
WORLD HERITAGE SITE OF BRYGGEN IN BERGEN

## RIKSANTIKVAREN 2015

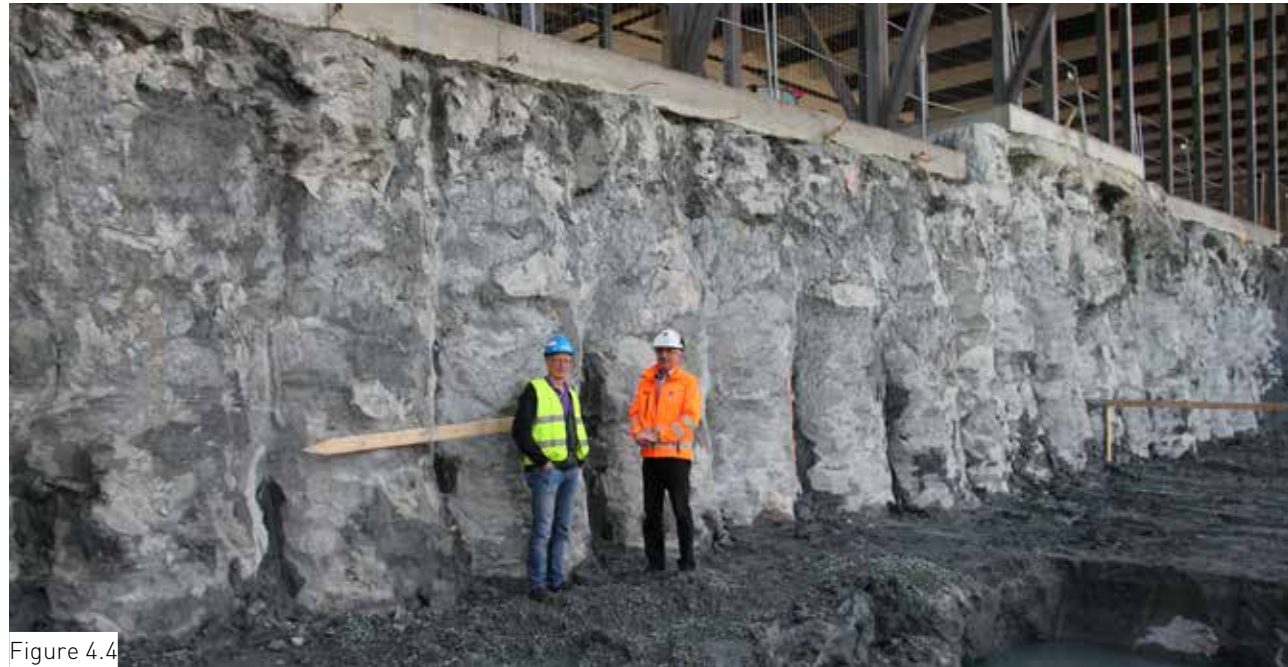
Figure 4.4 Column piling at the City Lade project, Trondheim, 2012. Photo: Jetgrunn AS.

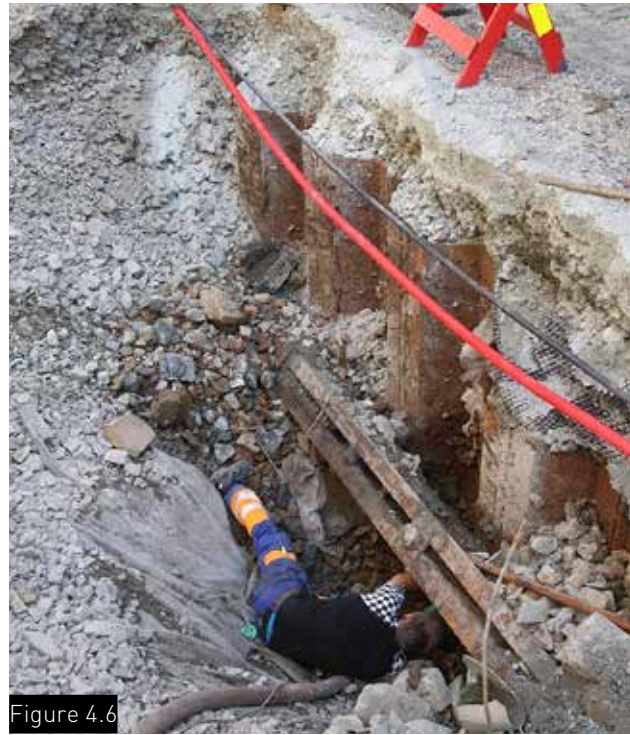
Figure 4.6 Sealing of hole for one of the sheet piling's anchor stays. Photo: A. R. Dunlop, NIKU.

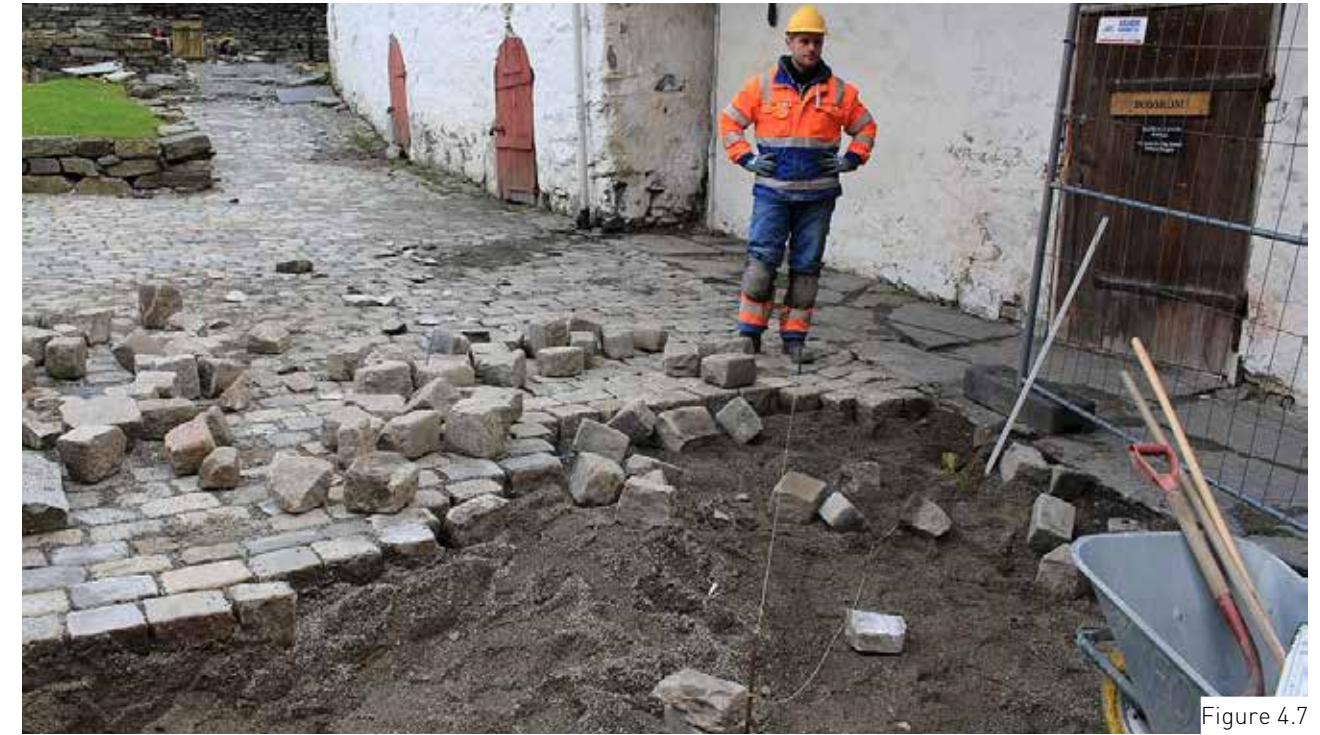
Figure 4.7 Construction of permeable pavement behind Bredsgården. Photo: A. R. Dunlop, NIKU.

on channelling surface-/rainwater. Downpipes were sunk into the ground rather than being so connected to the drainage systems that remove water from the area, and the cobblestone surface in parts of Bryggen was converted into permeable pavement, whereby the fine-grained fill between the stones was replaced with coarser fill to facilitate infiltration. And a couple of the grassy areas behind the Bredsgården tenement that had previously had a convex or flat surface were reshaped as shallow depressions, known as swales, where rainwater could collect and percolate slowly into the ground.

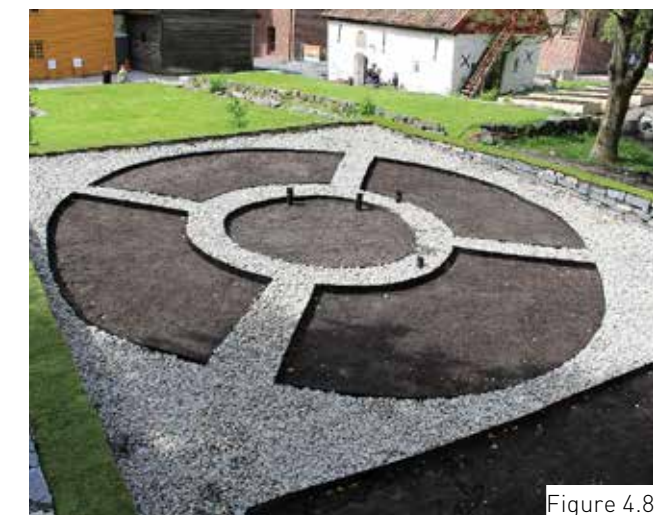
Figure 4.8 Rainwater garden under construction. Photo: A. R. Dunlop, NIKU.

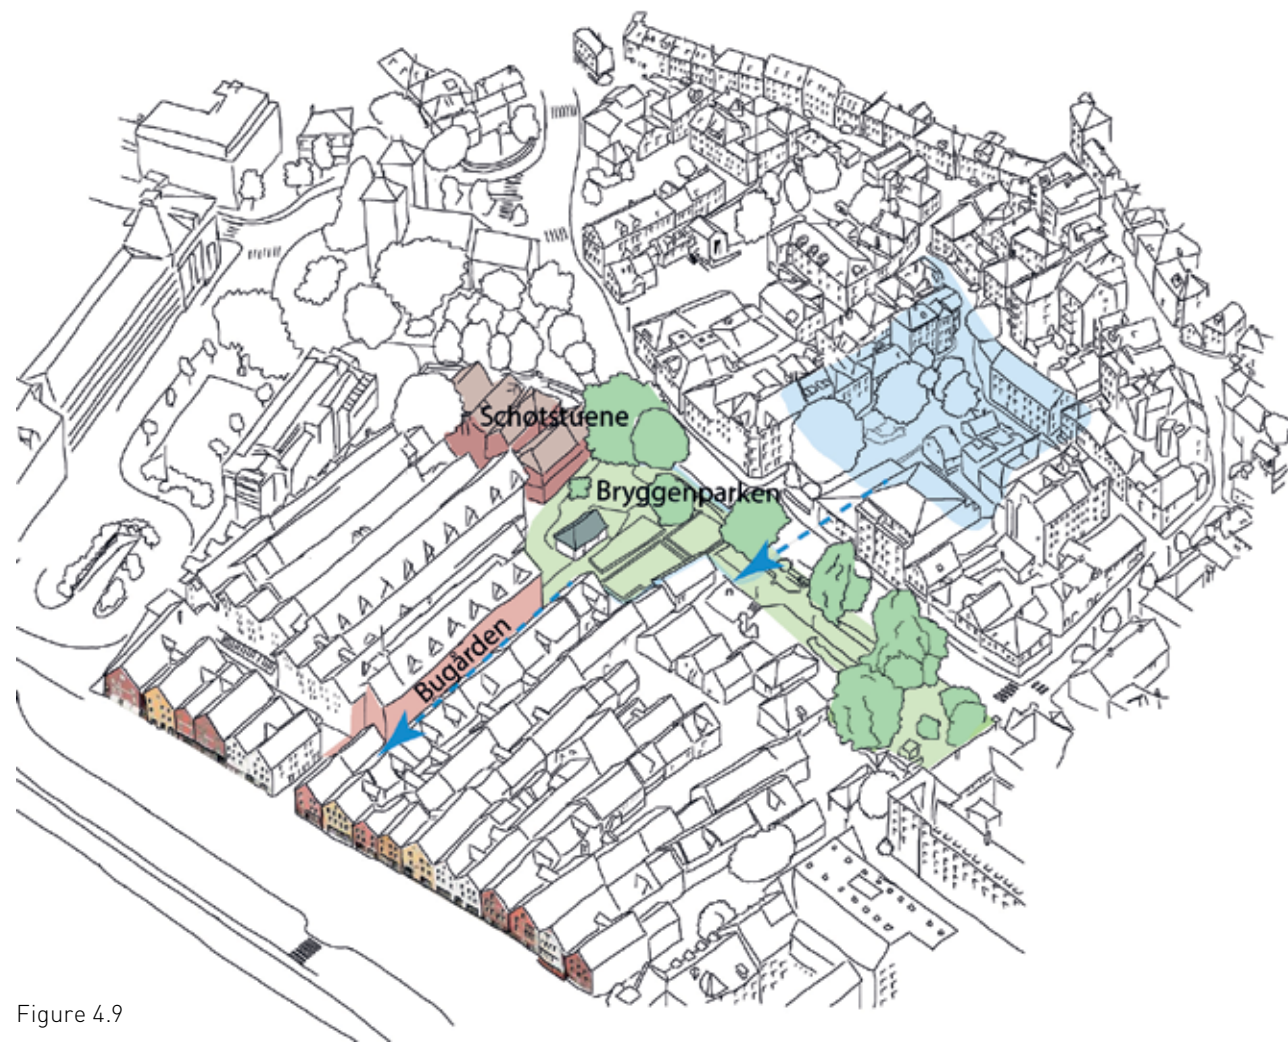
Figure 4.9 Bryggen's catchment area; arrows mark the various water flowpaths. Drawing: Multiconsult AS.

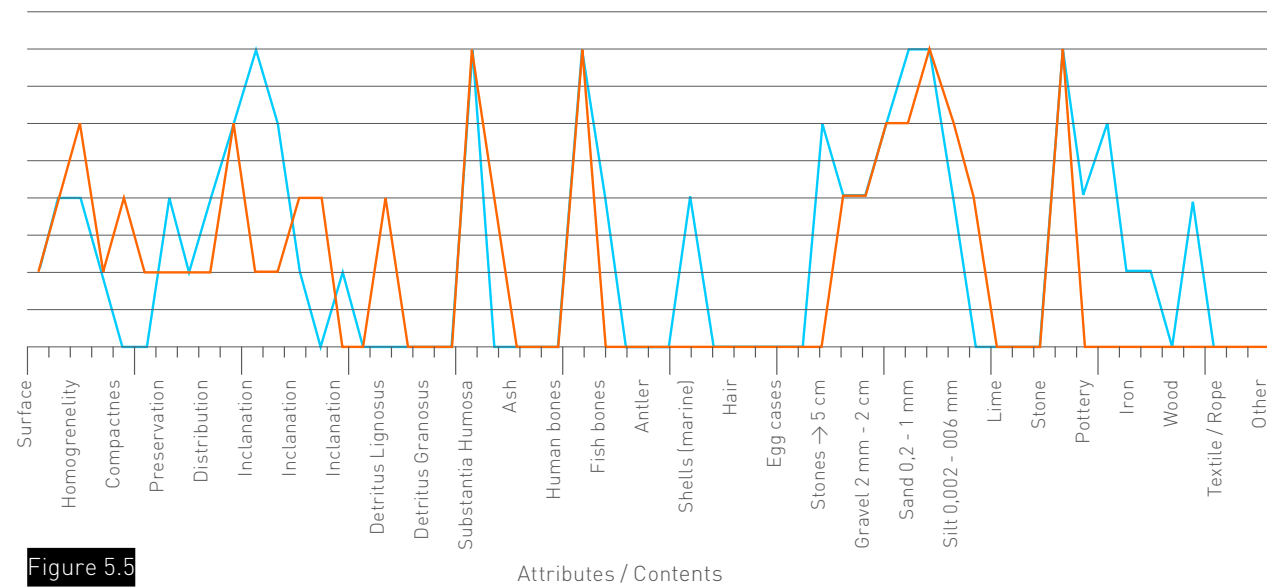
These values can then be plotted in Microsoft Excel and presented in the form of a graph - which provides, in effect, a 'signature' of the layer (see example diagram Fig. 5.5 above page). This enables comparison of two or more contexts found on an excavation site: to determine, for instance, whether or not they really form part of the same deposit.

Figure 5.5 Comparison of layer 'signatures'. Illustration: A. R. Dunlop, NIKU.

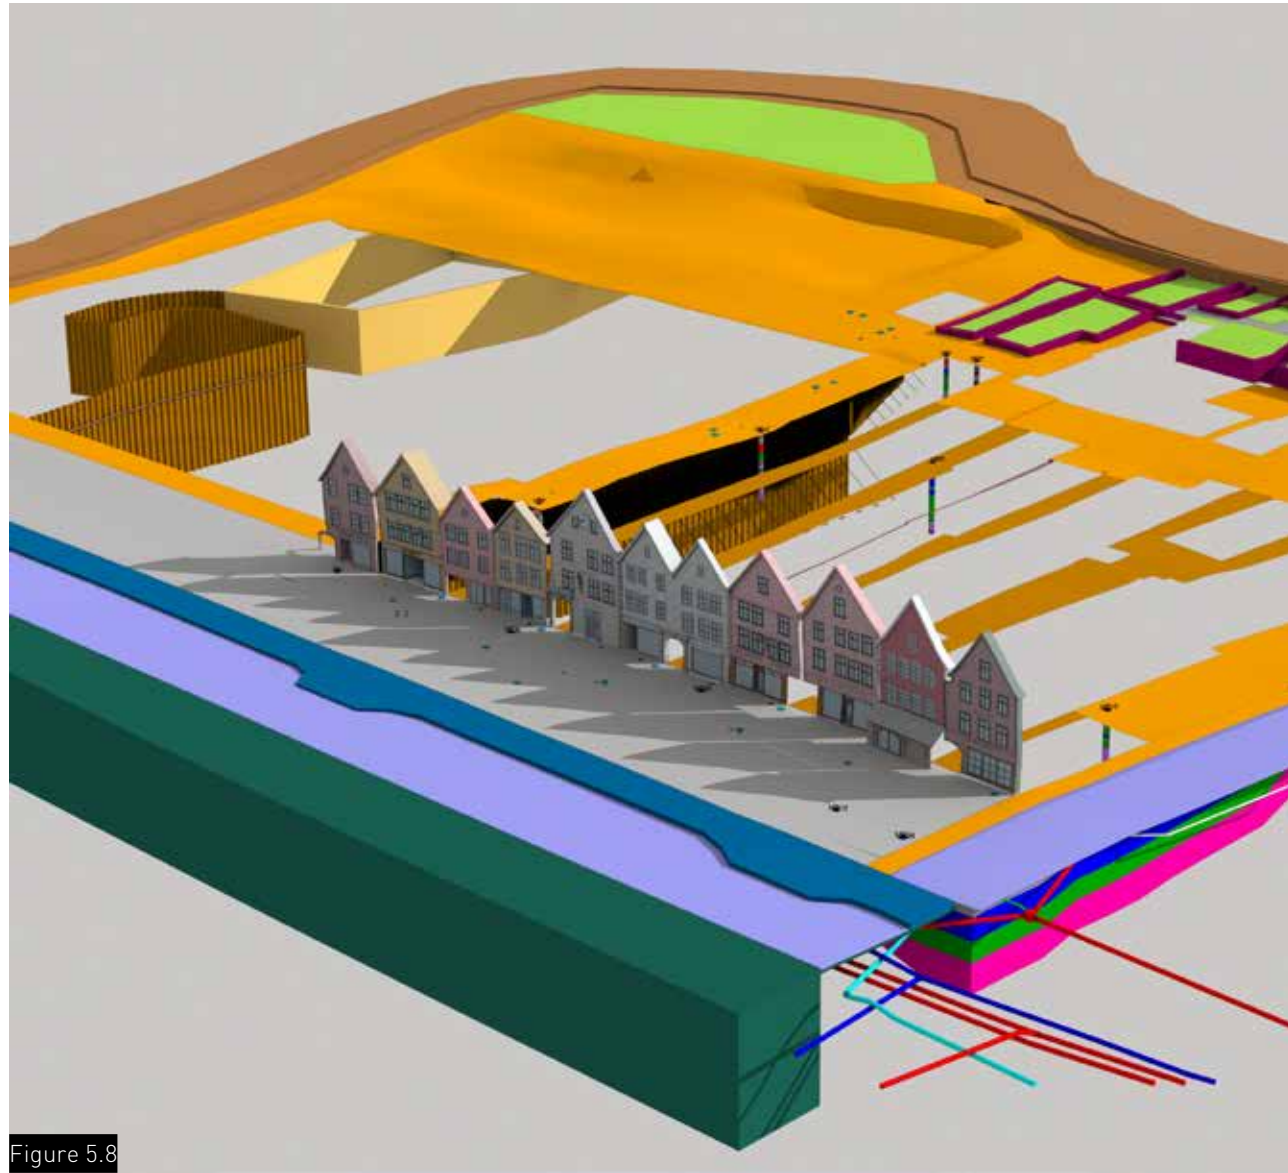
It will not be possible to go into detail here, but there are a number of 2D and 3D models, produced by Gładki and by de Beer, that show the situation admirably, as exemplified by Fig. 5.8.

Figure 5.8 Model of state of preservation of archaeological deposits under Bryggen. Drawing: M. Gładki, PAST S.C.

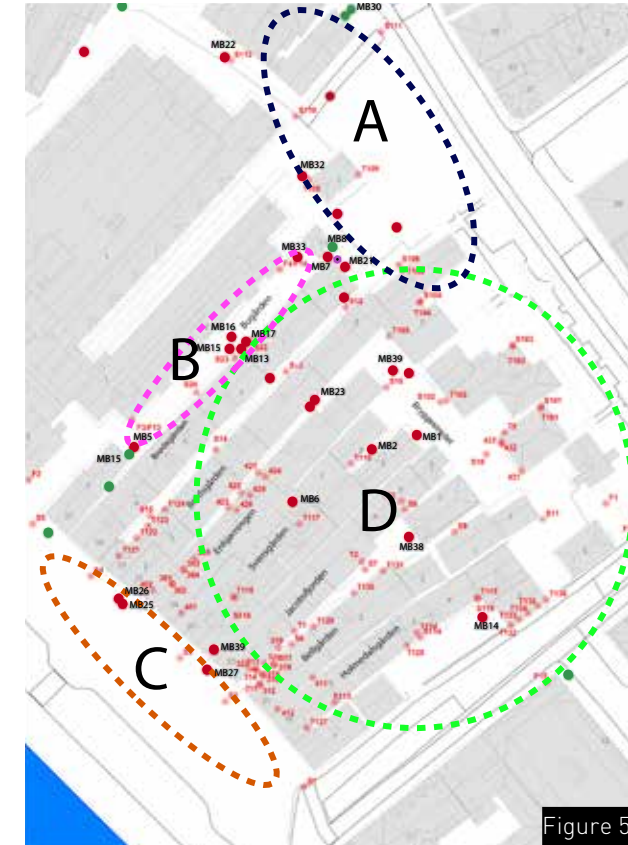
Figure 5.9

Matthiesen has drawn up a map (Fig. 5.9) where Bryggen is divided into four zones based on a) mechanisms governing preservation conditions<sup>106</sup>, and b) to some extent observed preservation conditions. Based on the available information - mostly from the 40+ drillings carried out within the Bryggen area - there appears to be quite good correspondence with the overall state-of-preservation picture.

Figure. 5.9 Matthiesen's map showing Bryggen divided into four zones characterized by differing preservation conditions.

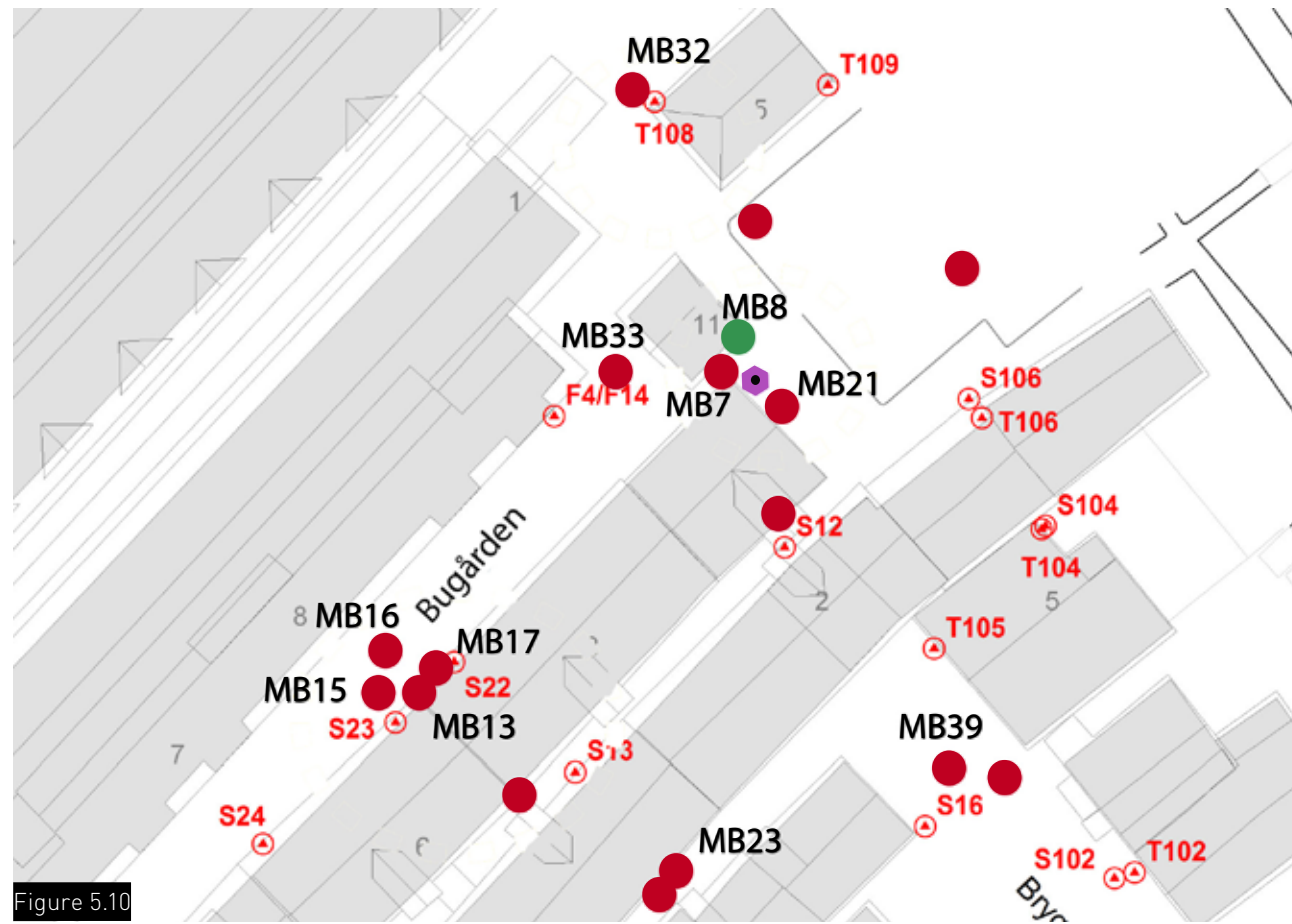
So far, there has been only one documented case - within the time frame of the Bryggen monitoring project at least - of deterioration in the state of preservation of an archaeological deposit lying at great depth. This occurred when monitoring well MB15 was installed close to monitoring well MB13 (Fig. 5.10) in what was formerly part of the eavesdrop between the northern Bredsgården tenement and the southern Bugården tenement, MB13 having been drilled in 2005, MB15 four years later.

Figure 5.10 The approximate positions of monitoring wells MB13 and MB15. Map: A. Seither, NGU.

The measurements near the sheet piling took place at depths down to five metres below the surface. Probes were placed at two distances from the sheet piling, allowing the interpretation of the effects of this barrier. This location was near three dipwells, with MB13 being the reference monitoring well (Fig. 5.10), and directly beside the I/T-system Introduction (Fig. 5.10) that was installed in 2013. This location is known to be under threat, but not as seriously threatened or damaged as the area at the back of the Bredsgården tenement.

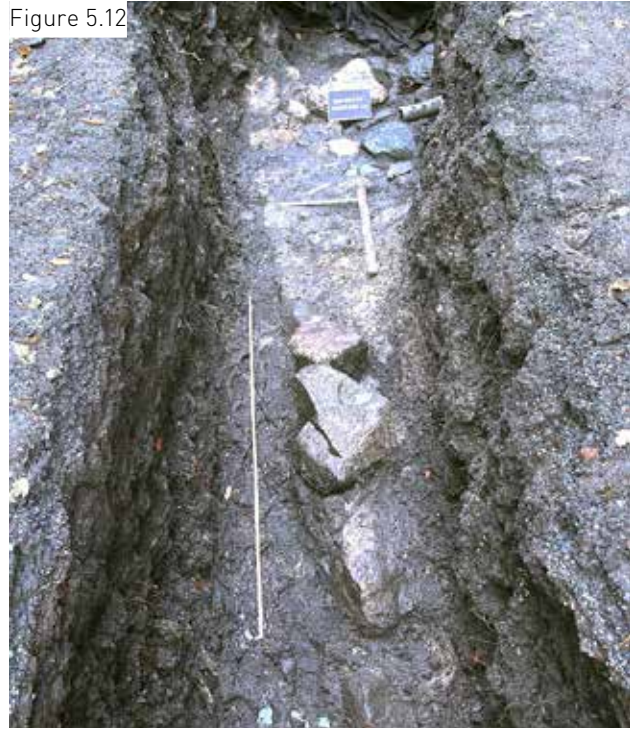
In early 2014, excavation work in connection with construction of the water management system around the suite of historic buildings called Schøtstuene - which is part of the Bryggen WHS - brought to light a section of stone foundation (Fig. 5.12) running along the northeastern side of the suite's northwesternmost building. (This was designated context 48 in the archaeological report<sup>112</sup>). Context 48 was aligned from northwest to southeast and could be followed for about eight metres. At its southeastern end there was a probable corner, where the foundation turned at right-angles to the southwest.

Figure 5.12 Context 48.  
Photo: A. R. Dunlop, NIKU.

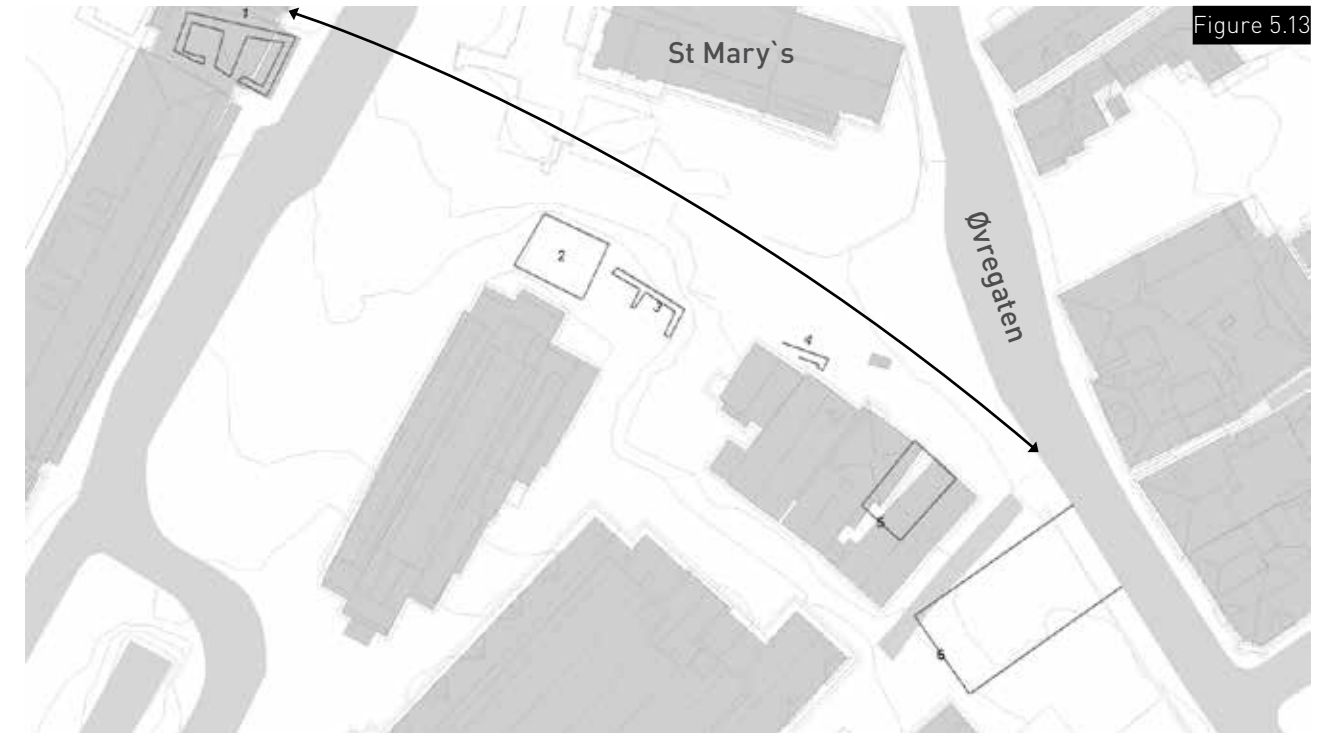
With this discovery, we now seemed to have an entire chain of stone buildings running north-west to south-east along the back of the Dreggen area and of Bryggen's northern part; this is shown on Fig. 5.13 opposite page. Starting from the northwest, the chain comprises the following buildings:

Figure 5.13 The chain of ruined stone buildings at the rear of Dreggen and of Bryggen's northern end.  
Map: NIKU, Modified by O.M. Hansen, Alkymi Design.

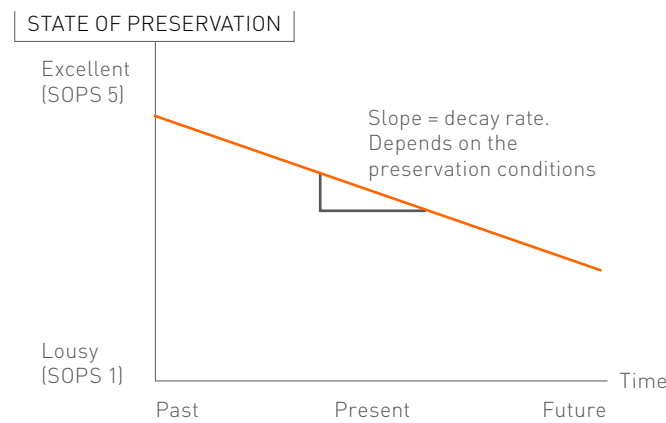
The terms 'state of preservation' and 'preservation conditions' on archaeological sites are sometimes used synonymously. However, as stated in the Norwegian monitoring standard<sup>113</sup>, it is necessary to distinguish between the two terms (Fig. 6.1). The state of preservation is the current state of the archaeological deposits including artefacts, ecofacts, structures and soil stratigraphy, as described by Dunlop in chapter 5. The state of preservation depends on both current and historical decay, and the 'decay rate' indicates how fast the state of preservation decreases over time. The preservation conditions are the physical, chemical, and microbiological conditions in the ground - in short, the set of environmental parameters - which determine the current decay rate of the archaeological deposits, as discussed in this chapter.

Figure 6.1 Illustration of "state of preservation" vs. "preservation conditions" and "decay rate". Time scale (x-axis) is artificial. The "state of preservation scale" (y-axis), where each archaeological layer or sample is ascribed a value from 1 to 5, is described by Dunlop in chapter 5. From Matthiesen 2014a.

All these parameters are indicators of the preservation conditions that may be used to estimate the ongoing decay rate (Fig. 6.1). In order to validate this, renewed drillings in selected areas will be carried out at intervals. This will allow a renewed assessment of the state of preservation of the archaeological deposits that can be compared directly to previous assessments, as described in chapter 5.

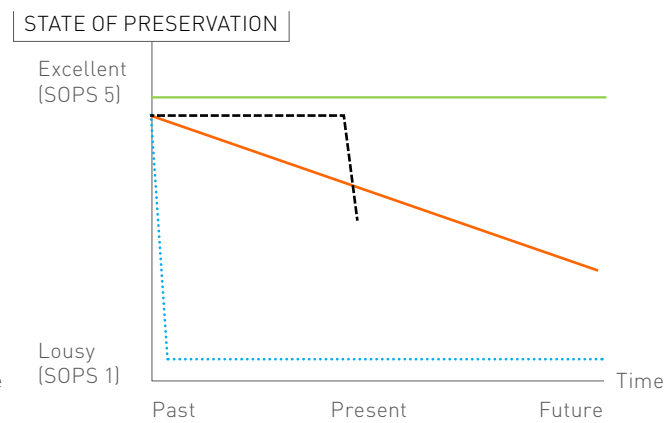
Decay may follow different patterns over time<sup>114</sup>: In Fig. 6.2 the blue line represents a site, an area, or an archaeological material that decayed significantly immediately after deposition, after which it became more stable. The red line represents a site where the decay is gradual and more or less constant over time. The green line represents a site where the decay is extremely slow and the state of preservation is excellent even after centuries or millennia. Finally, the black line represents a site that enjoyed an excellent state of preservation until recently, but then the conditions changed and the decay rate increased significantly. This means that the 'state of preservation' and the 'preservation conditions' are not always identical - it is possible to have a good state of preservation and poor preservation conditions, or vice versa. In order to ensure continued preservation and prioritize mitigation measures, it is necessary to be able to distinguish between these different scenarios, between past and ongoing decay, and between relatively stable sites and sites under rapid decay. In terms of mitigation work the highest priority should be given to the 'black line scenario', i.e. where a site, area or material is still in a good state of preservation, but is undergoing rapid decay.

Figure 6.2 The change in "state of preservation" over time may follow different paths, due to different site-formation processes and preservation conditions. From Matthiesen 2014a.

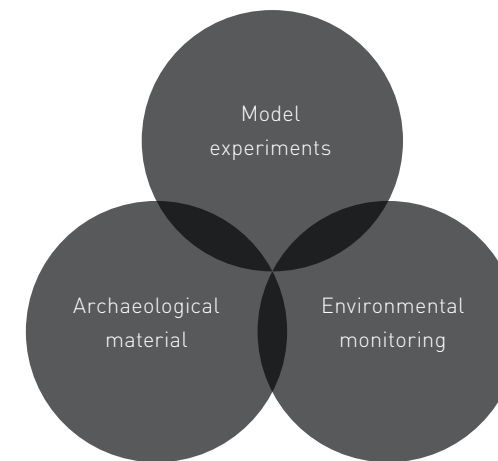
Figure 6.3 Several approaches may be used to study decay at an archaeological site. A combination of different approaches is often necessary to evaluate and quantify ongoing decay. Modified from Matthiesen 2014a.

1. Investigate and quantify the state of preservation of the deposits at regular intervals
2. Monitor environmental parameters and use an interpretation scheme to estimate decay rates
3. Make model experiments of decay processes in the field and in the laboratory

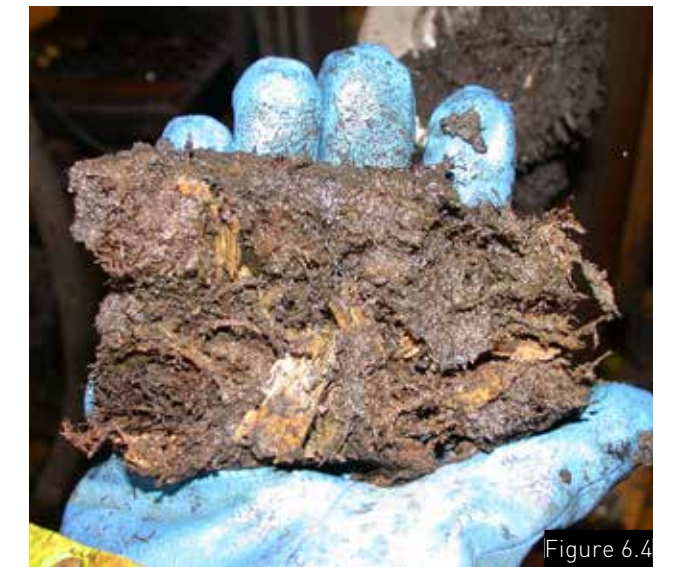
Figure 6.4 The archaeological deposits at Bryggen have a very high organic content and contain different types of organic matter. Sample from monitoring well MB22 at Schøtstuene. Photo: A. R. Dunlop, NIKU.

The archaeological deposits at Bryggen are highly organic, and some layers consist of up to 70 % organic material (measured as the weight loss when a dried soil sample is ignited at 550°C). The organic material consists of both spectacular artefacts and structures (chapter 2) and of a less spectacular, but highly informative, organic soil matrix. It contains a wide range of components such as wood, bark, twigs, straw, hazelnut shells, moss, bones, insect remains and dung. A few studies have been made specifically on deterioration of wood in the Bryggen deposits,<sup>116</sup> but in most contexts the organic material

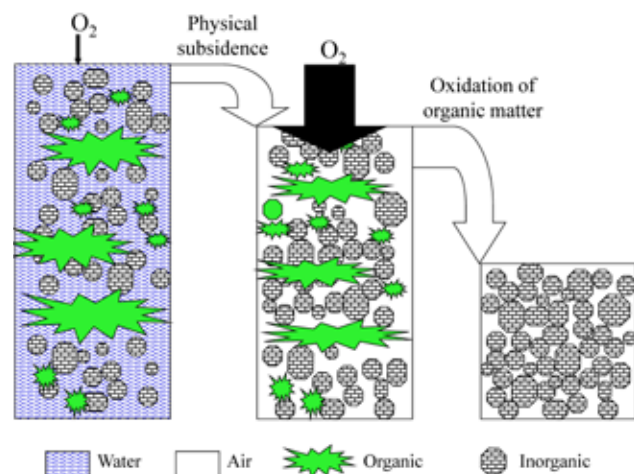
Figure 6.5 Drainage of water-saturated organic soil may lead to loss of organic material and subsidence of the soil surface. From Matthiesen 2014a.

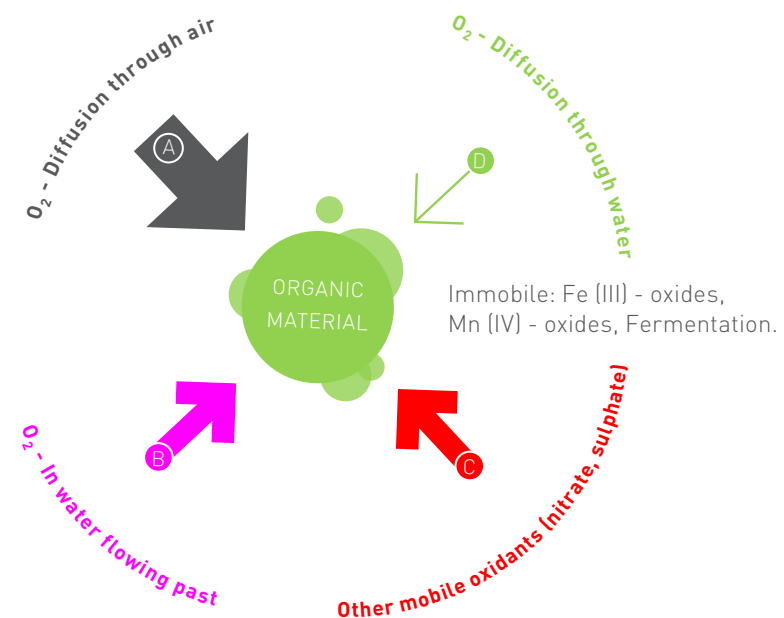
Figure 6.6 The oxidation of organic material present in archaeological deposits is strongly influenced by the supply of different oxidants. Oxygen is the most reactive oxidant and is supplied through air or dissolved in water. Nitrate and sulphate are both soluble and may be supplied through water. Iron and manganese oxides are solid and immobile, and will only oxidize organic material in their immediate surroundings. Finally, in fermentation the organic material is decomposed without the use of external oxidants. Modified from Matthiesen et al 2008.

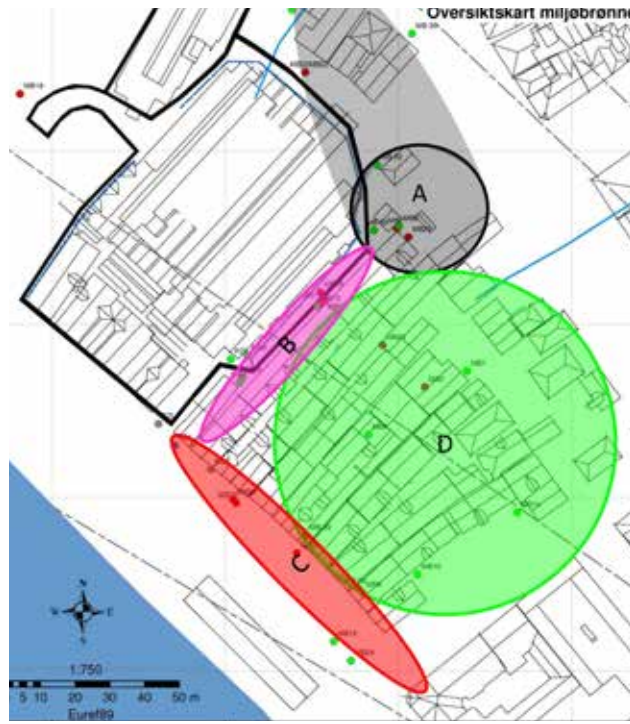
Figure 6.8 Overview of the Bryggen area, where different colours show areas with different preservation conditions and threats to preservation. Modified from Matthiesen et al. 2008.

The first years of monitoring at Bryggen allowed us to divide the site into four separate areas with different preservation conditions and threats/challenges<sup>117</sup> (Fig. 6.8). These areas are used in the remainder of this chapter to illustrate the effects of different oxidants and supply channels. Area A was characterized by a lowered groundwater level, which may illustrate the effects of oxygen supply through soil air (arrow A in Fig. 6.6). Area B was characterized by an increased water flow through the deposits, where focus was on the supply of dissolved oxygen (arrow B in Fig. 6.6) and other dissolved oxidants (arrow C). Area C was characterized by occasional flooding with seawater, where focus was on supply of dissolved sulphate (arrow C in Fig. 6.6). Finally area D was characterized by a limited groundwater flow, where

In areas B, C and D (Fig. 6.8) the focus has been on the groundwater quality and how the chemical composition of the water may influence the decay of archaeological material. In order to estimate this it is necessary to have detailed information about the supply of water, the concentration of different species dissolved in it, and the reactivity of these species. This has required the coupling of the chemical analyses of the water with a hydrological model and laboratory studies of decay under water-saturated conditions.

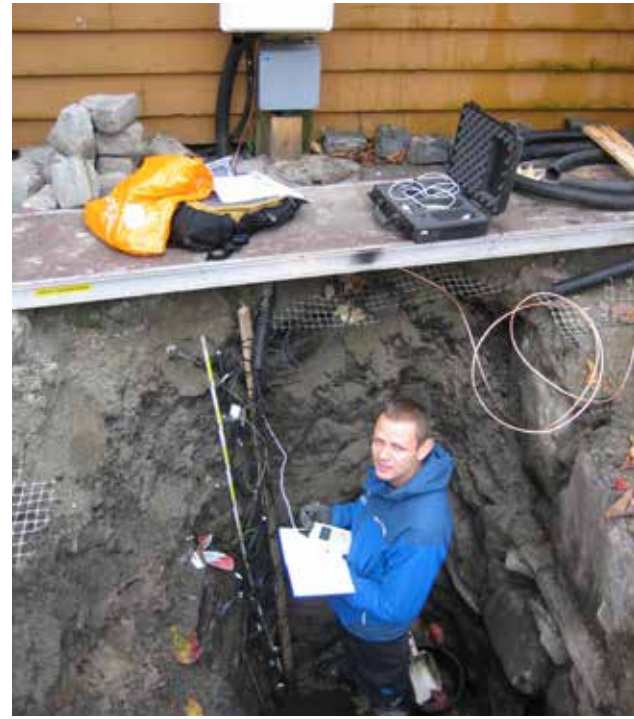
Figure 6.9

Figure. 6.9 Jørgen Hollesen installing sensors for measurement of oxygen, soil moisture and temperature in the upper soil layers behind the Bredsgården tenement. Photo: H. Matthiesen, Nationalmuseet.

A small test-pit was excavated just to the rear of the northern Bredsgården tenement in 2006 and reopened in the autumn of 2010 in order to install monitoring equipment in the area with severe subsidence problems (Fig. 6.9). The excavations and description of the different soil layers were carried out by archaeologist Rory Dunlop (chapter 5). The archaeological description distinguished between 14 different layers and phases in the test-pit, but based on the soil characteristics this was condensed into five main layers (Fig. 6.10).

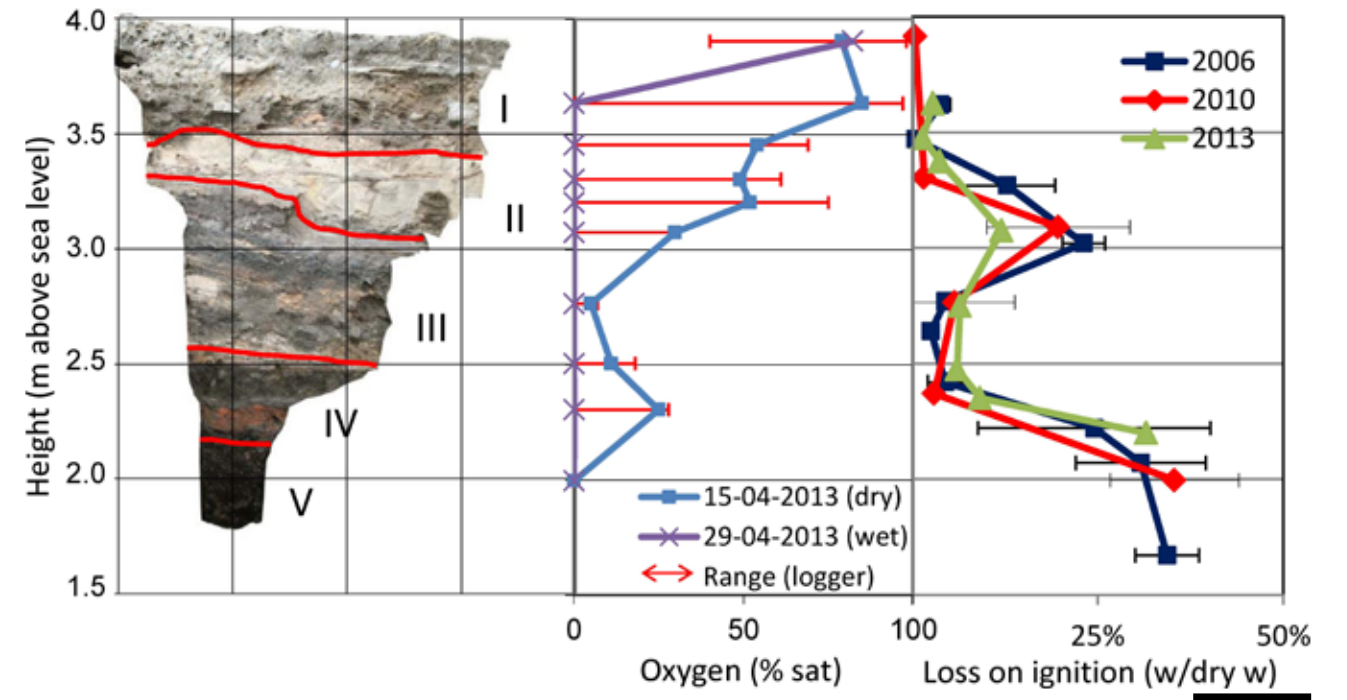
Figure 6.10 Photo from the test-pit with approximate layer boundaries; soil surface is at 4.14 m above sea level (left). Examples of oxygen measurements during dry and wet periods, along with the range measured at different depths over the whole monitoring period (middle). Loss on ignition values measured in samples from excavations in 2006 and 2010, and from a drilling in 2013 (right). Error bars on the loss on ignition data show the standard deviation between duplicate samples from the same layer. Photo: M. Gładki, PAST S.C. Modified from Matthiesen et al. 2014b.

The conditions in the unsaturated zone turned out to be very dynamic, with oxygen concentrations and water contents varying considerably from day to day in close correlation with the precipitation.<sup>122</sup> Some general trends in the oxygen distribution and variation are presented in Fig. 6.10 (middle). During the monitoring period oxygen was permanently or at least very frequently present in the upper 1 m of the test-pit (layer I and II), it was seldom present and only at very low concentrations in layer III, it was occasionally present at low concentrations in layer IV, and it was never present in layer V. Correspondingly, the wood samples that were installed in the soil layers in the period 2006-2010 showed decay by oxygen-demanding fungi in the soil layers with permanent or occasional presence of oxygen, but only bacterial decay in other layers. Over time, the presence of oxygen can also lead to a decrease in the organic content and loss-on-ignition values of the soil. Fig. 6.10 (right) indicates that the loss on ignition measured at the bottom of layer II decreased

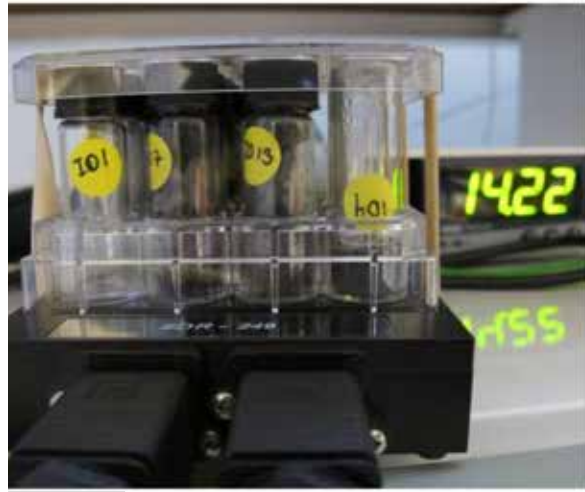
Figure 6.11 Measurements of oxygen consumption in soil samples from Bryggen under controlled conditions in the laboratory. The samples are placed in airtight containers where the oxygen concentration is followed over time (left). The results show that all samples have increasing reactivity at increasing temperatures, and also that samples from deeper layers in the test-pit (layer V) are significantly more reactive than samples from higher in the test-pit (right). Error bars show standard deviation for triplicate samples.

The reactivity of the archaeological material taken from the test-pit was measured under controlled conditions in the laboratory.<sup>119</sup> Samples were placed in closed vials and their oxygen consumption was quantified at varying water contents (from 30 % vol to saturated) and varying temperatures (5, 10, 15 and 20°C). After this, the vials were filled with water and the consumption of different dissolved oxidants (oxygen, nitrate and sulphate) was quantified.<sup>120</sup> The oxidants may be consumed by different processes in the soil, but it was assumed that most of it was used by microorganisms for oxidizing organic material, making it possible to calculate a theoretical loss of organic material from the consumption of oxidants.

Laboratory studies of soil samples from the test-pit showed that the soil temperature had a significant effect on the decay, and that a 10°C temperature rise increased the decay rate of the analysed samples by 100-180 % (Fig. 6.11).

When the in-situ measurements of oxygen, water content and temperature were combined with the laboratory studies of decay, (Fig. 6.11) it was possible to estimate a theoretical decay rate in the different soil layers.<sup>123</sup> This indicated that most decay took place in layer II and occasionally in deeper layers, where there was a combination of frequent oxic conditions and relatively reactive soil. Furthermore, it indicated that the decay took place all year round. The study estimated that prior to mitigation work the annual loss of organic material in the upper 2 m of the test-pit could be up to 1-2 % of the total amount, depending on the model used to interpret the monitoring data.<sup>124</sup>

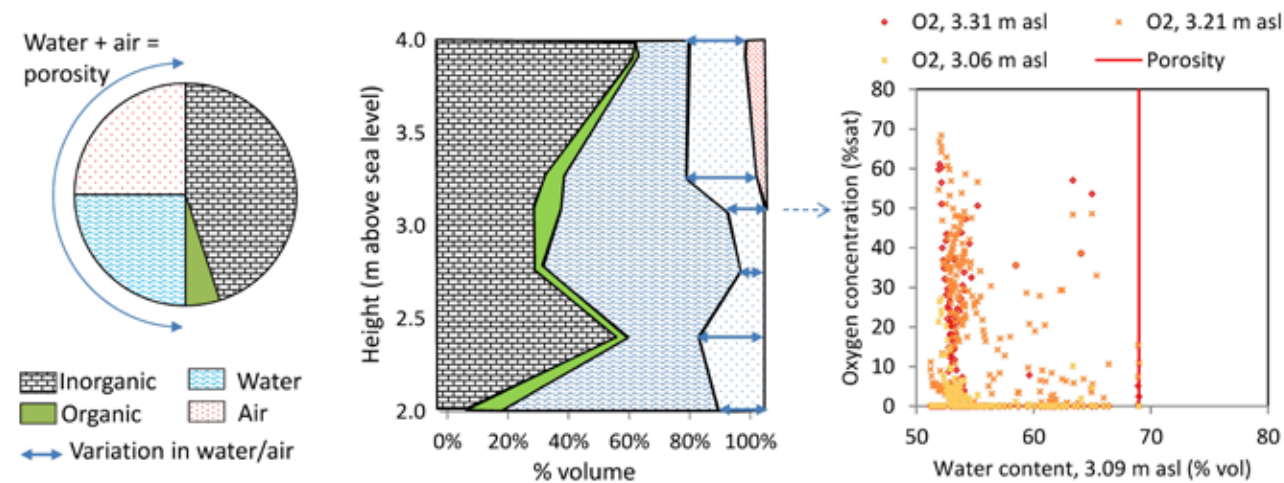
Figure 6.12 The pore space between the soil particles is called the soil porosity, and these spaces are filled with air and/or water (left). Different types of layers in the test-pit have different porosities, and the ratio between water and air may vary considerably over time and space (middle) - the air content cannot be measured directly but is calculated as porosity minus water content. Comparison between oxygen and water content measurements in layer II shows that oxygen concentrations typically increase when the water content drops below a certain level (right).

The soil porosity is a measure of the pore space in the soil, which is filled with either air or water (Fig. 6.12 left). The porosity of soil samples from the test-pit varied between 40 and 80 % volume, which means that some soil layers were water saturated when they contained 40 % vol water, while others needed 80 % vol water to become water saturated. The water content (and thereby also the air content) of the different layers varied during the monitoring period as indicated by blue arrows in Fig. 6.12 (middle). There was a strong correlation between water content and oxygen content, and it was found that as a general rule oxygen occurred in a given soil layer in the test-pit when the air content exceeded 10-15 % vol.<sup>125</sup> As an example Fig. 6.12 (right) shows results from layer II where the porosity is 69 % vol and where oxygen mainly occurred when the water content dropped to 55 % vol, corresponding to an air content of 14 % vol. The actual oxygen concentration measured will be influenced

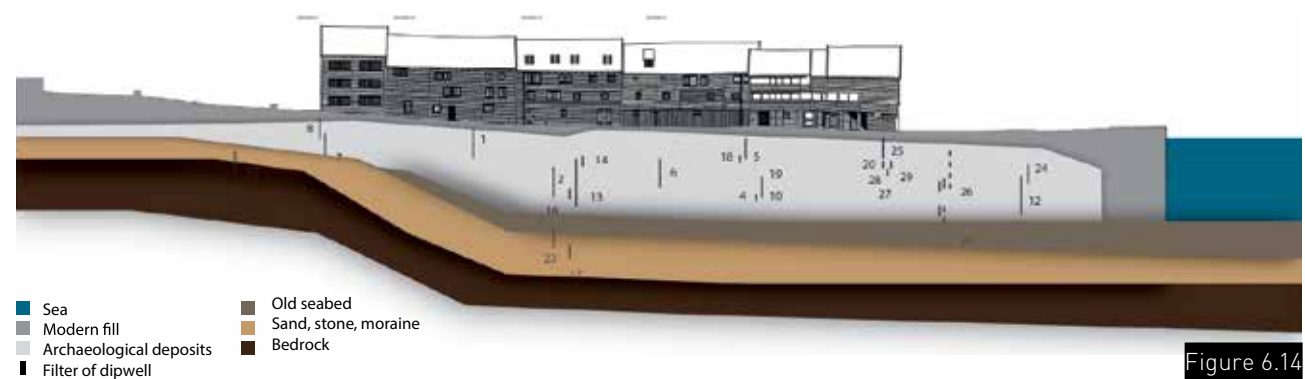
Figure 6.14 Monitoring wells were installed all over the Bryggen area, with their water intakes (filter) at different depths and in different soil strata, in order to monitor the level and chemical composition of the groundwater. Modified from Matthiesen 2008. Modified by O.M. Hansen, Alkymi Design.

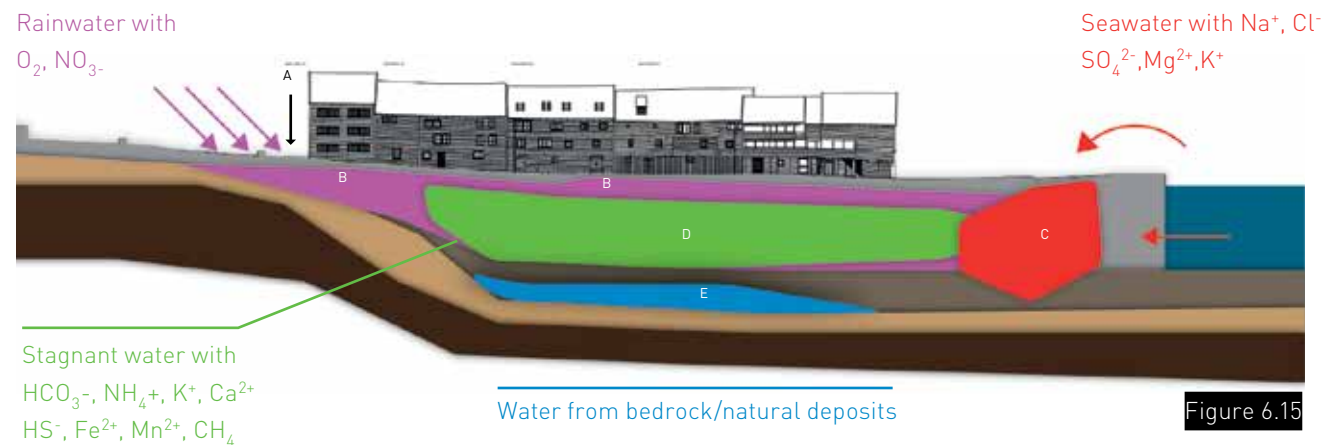
Figure 6.15 Conceptual model of hydrogeology and groundwater chemistry. The detailed analysis of groundwater from 40+ monitoring wells showed some general trends in the water chemistry that allowed us to distinguish between different sources of water and between good and poor preservation conditions. A: localized area with lowered groundwater level at the rear of Bryggen (not shown in this cross-section); B: contribution from rainwater; C: contribution from seawater; D: the contribution from old stagnant water. Modified from Matthiesen et al. 2008.

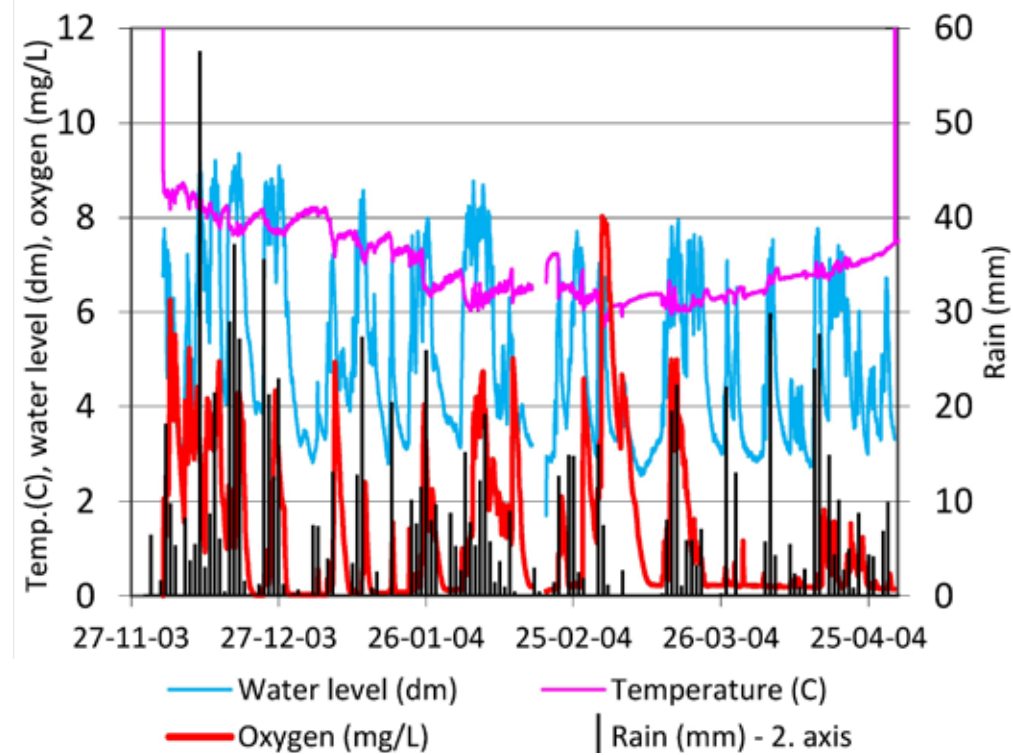
Figure 6.17:1

The area alongside the sheet piling was investigated in terms of horizontal and vertical water flow and its consequences for the preservation conditions. The horizontal water flow in the upper deposits was significant in the area, causing very dynamic conditions and flow of oxygen-rich water through the deposits (pink arrow in Fig. 6.6). As an example Fig. 6.17 shows measurements of oxygen, water level and temperature in one of the monitoring wells (MB5) in the area. The oxygen logger was placed within the well's filter length at -1.4 m asl, where oxygen measurements carried out directly in the soil had previously shown increased oxygen content. The measurements from 2003-04 (Fig. 6.17:1) revealed an extremely dynamic environment, where the water level and oxygen concentration increased abruptly every time it rained, and decreased quickly after the rainfall stopped. This showed that oxygen-rich rainwater could actually reach considerable depths in the deposits in this area close to the sheet piling, probably because the sheet piling served as a barrier that diverted the groundwater flow. The solubility of oxygen in water is relatively low

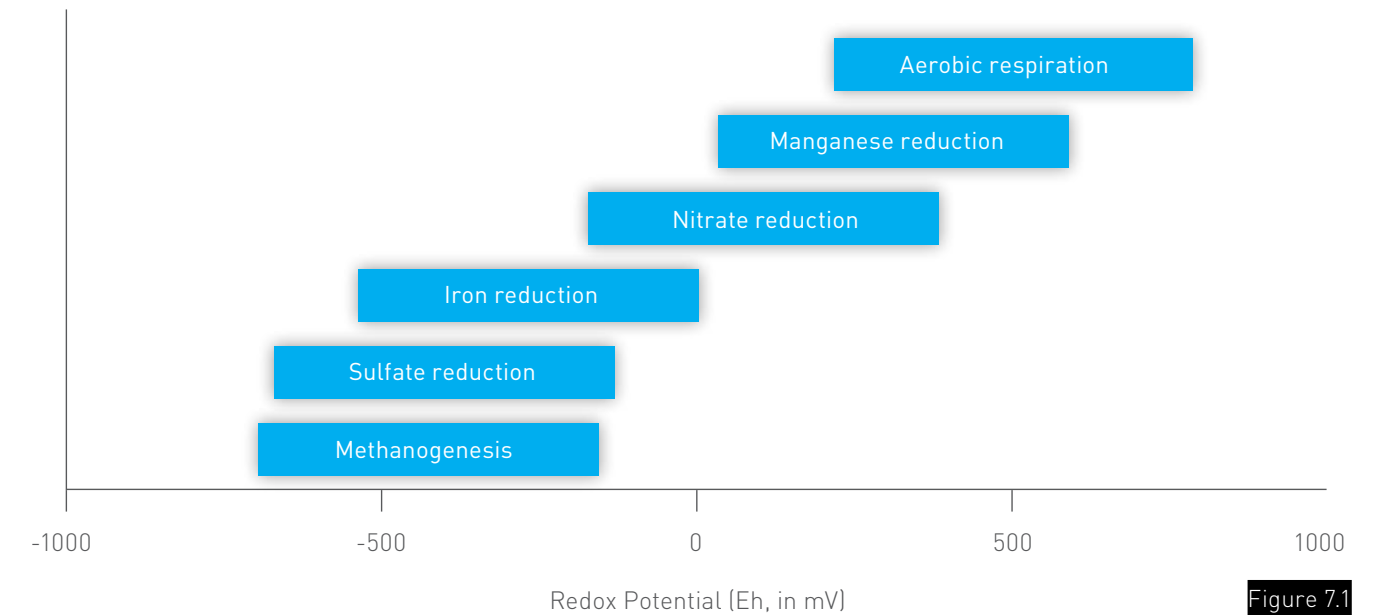
Figure 7.1

The measurements of oxygen, as described in chapter 6, have shown that the organic deposits at Bryggen are sometimes oxic, and aerobic decay can occur. The aim of the recent mitigation works at Bryggen is largely to reduce the presence of oxygen in the soil by raising the water table. This will result in very low to zero oxygen levels, levels that cannot be measured. Measurement of the redox potential can provide information on the decay potential in the soils once oxygen is depleted. A high redox potential, mainly with values higher than +400mV, shows an oxic environment, with oxygen present.<sup>144</sup> Low redox potentials, below 0mV, show anoxic conditions.<sup>145</sup> Redox potential values between 0 and 400mV are usually referred to as sub-oxic.<sup>146</sup> Fig 7.1 shows the relationship between the redox potential and the electron receptors that play a role at that redox value. It also shows there is considerable overlap for possible processes in the reduced (<0mV) region of the redox potential scale.
