MONITORING  
MITIGATION  
MANAGEMENT

THE GROUNDWATER PROJECT - SAFEGUARDING THE  
WORLD HERITAGE SITE OF BRYGGEN IN BERGEN

## RIKSANTIKVAREN 2015

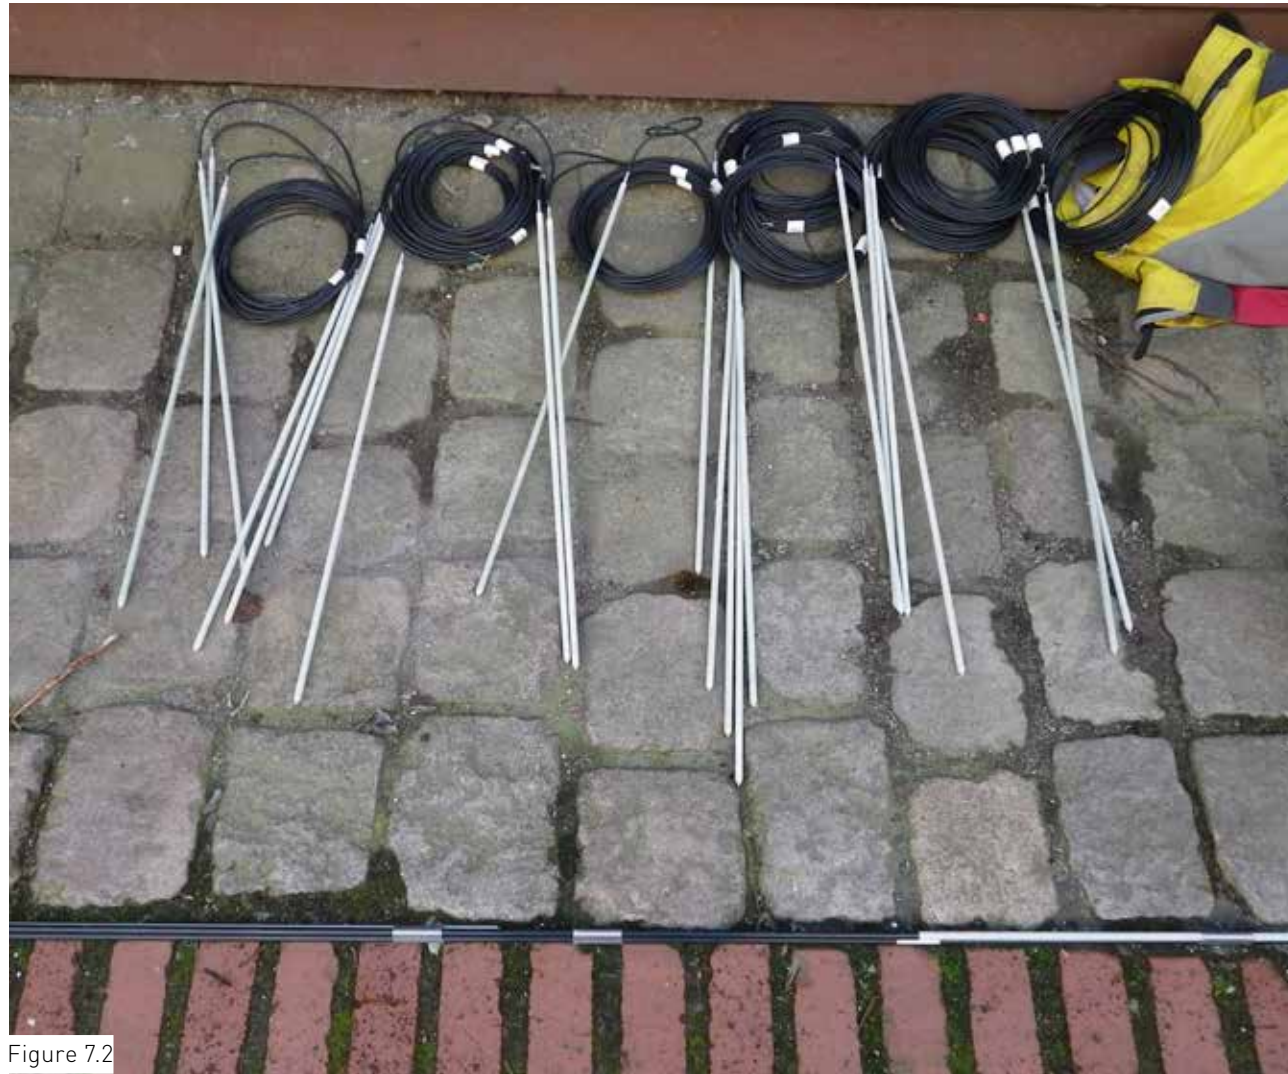
Figure 7.2 Bundles of the redox potential and temperature probes, as installed at Bryggen.  
Photo: M. Vorenhout, MVH Consult.

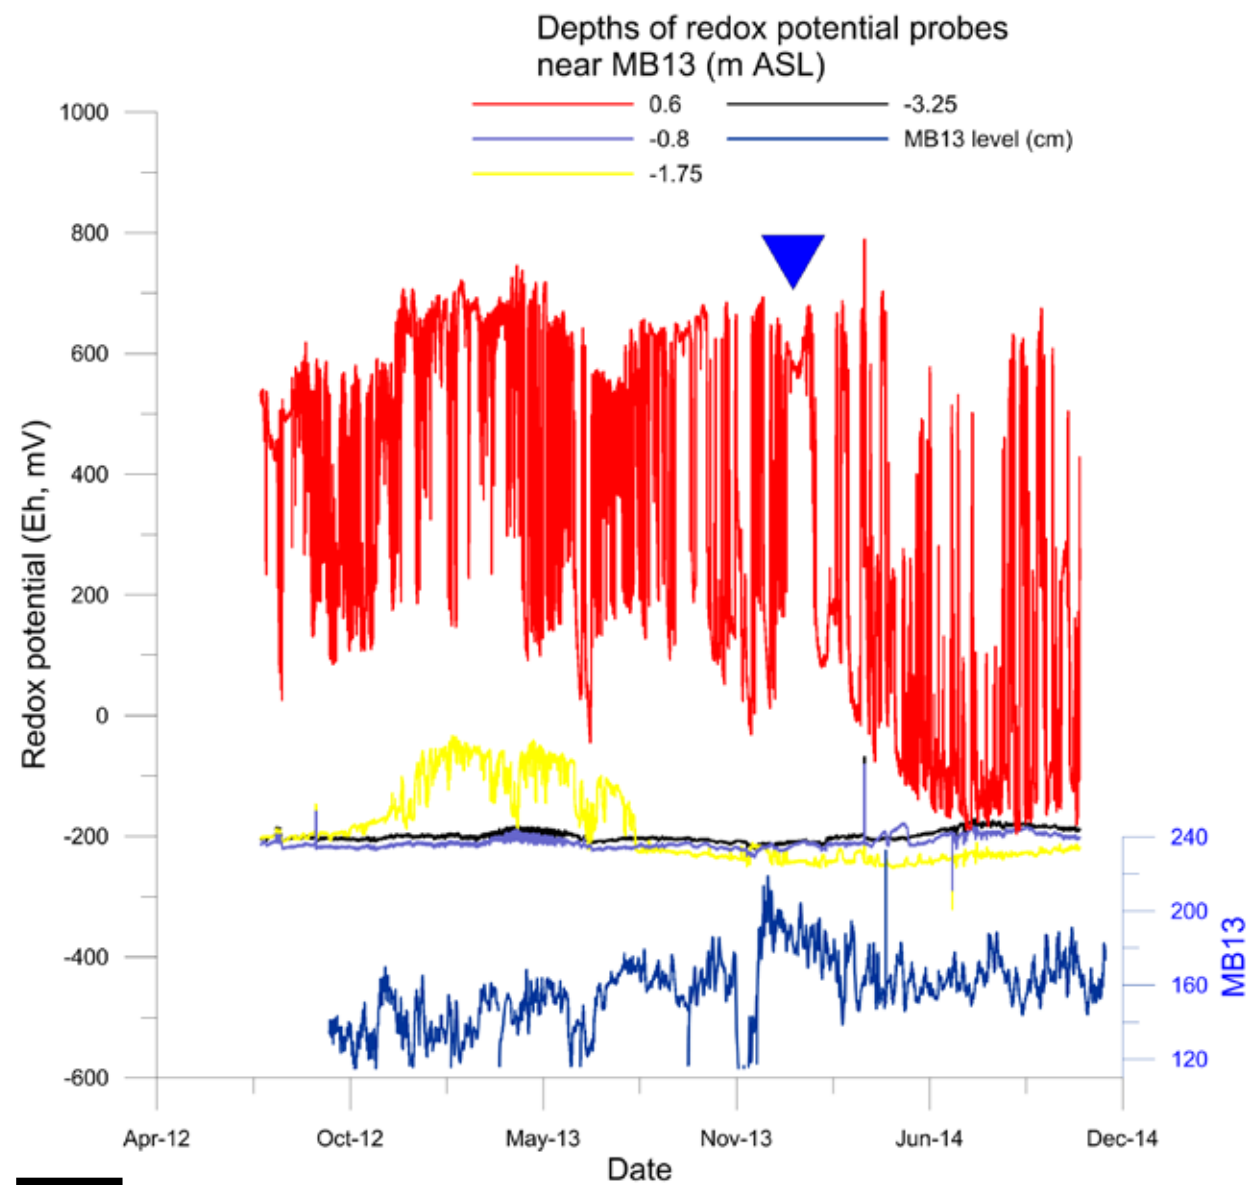
Figure 7.4 A selection of measured redox potentials near monitoring well MB13. Note that the modern surface here is at 2.0 m asl.  
Illustration: M. Vorenhout, MVH Consult.

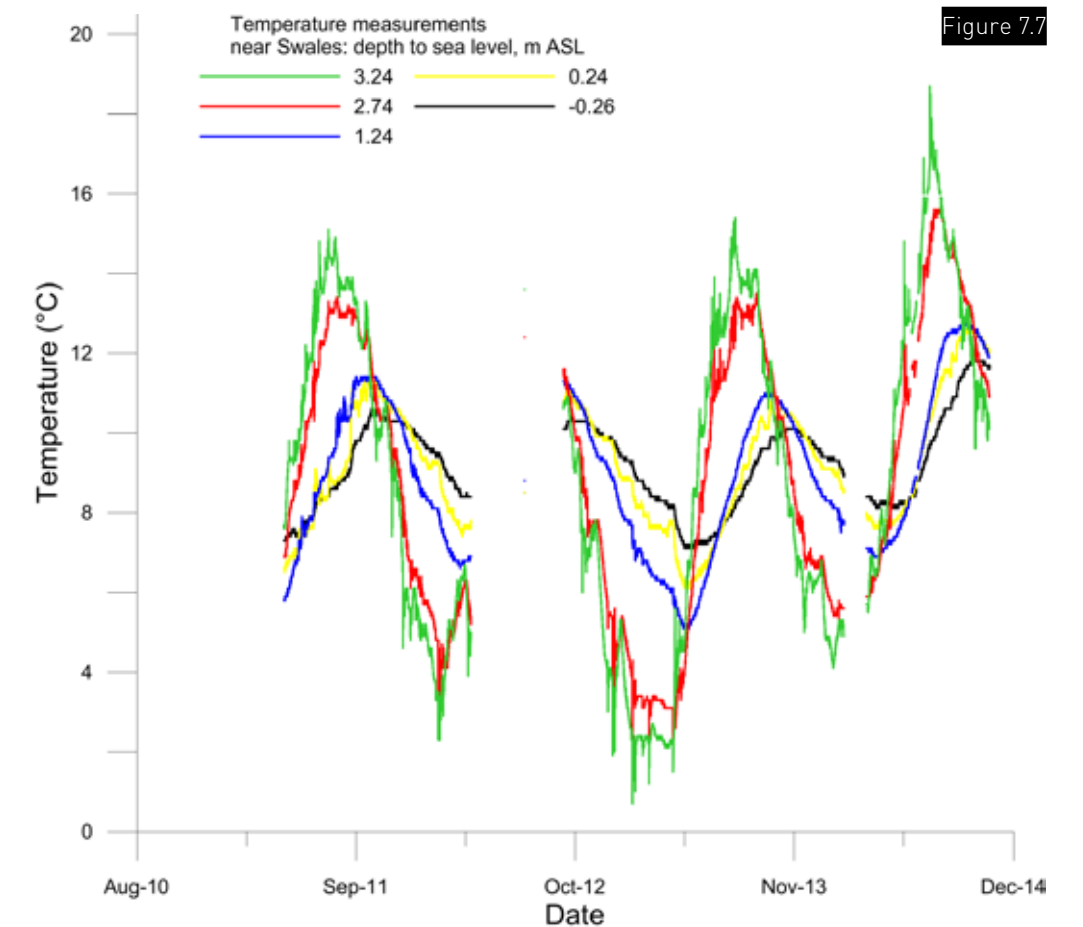
Figure 7.7 A selection of temperatures as measured at the back of the Bredsgården tenement. Note that the modern surface here is at 4.14 m asl.  
Illustration: M. Vorenhout, MVH Consult.

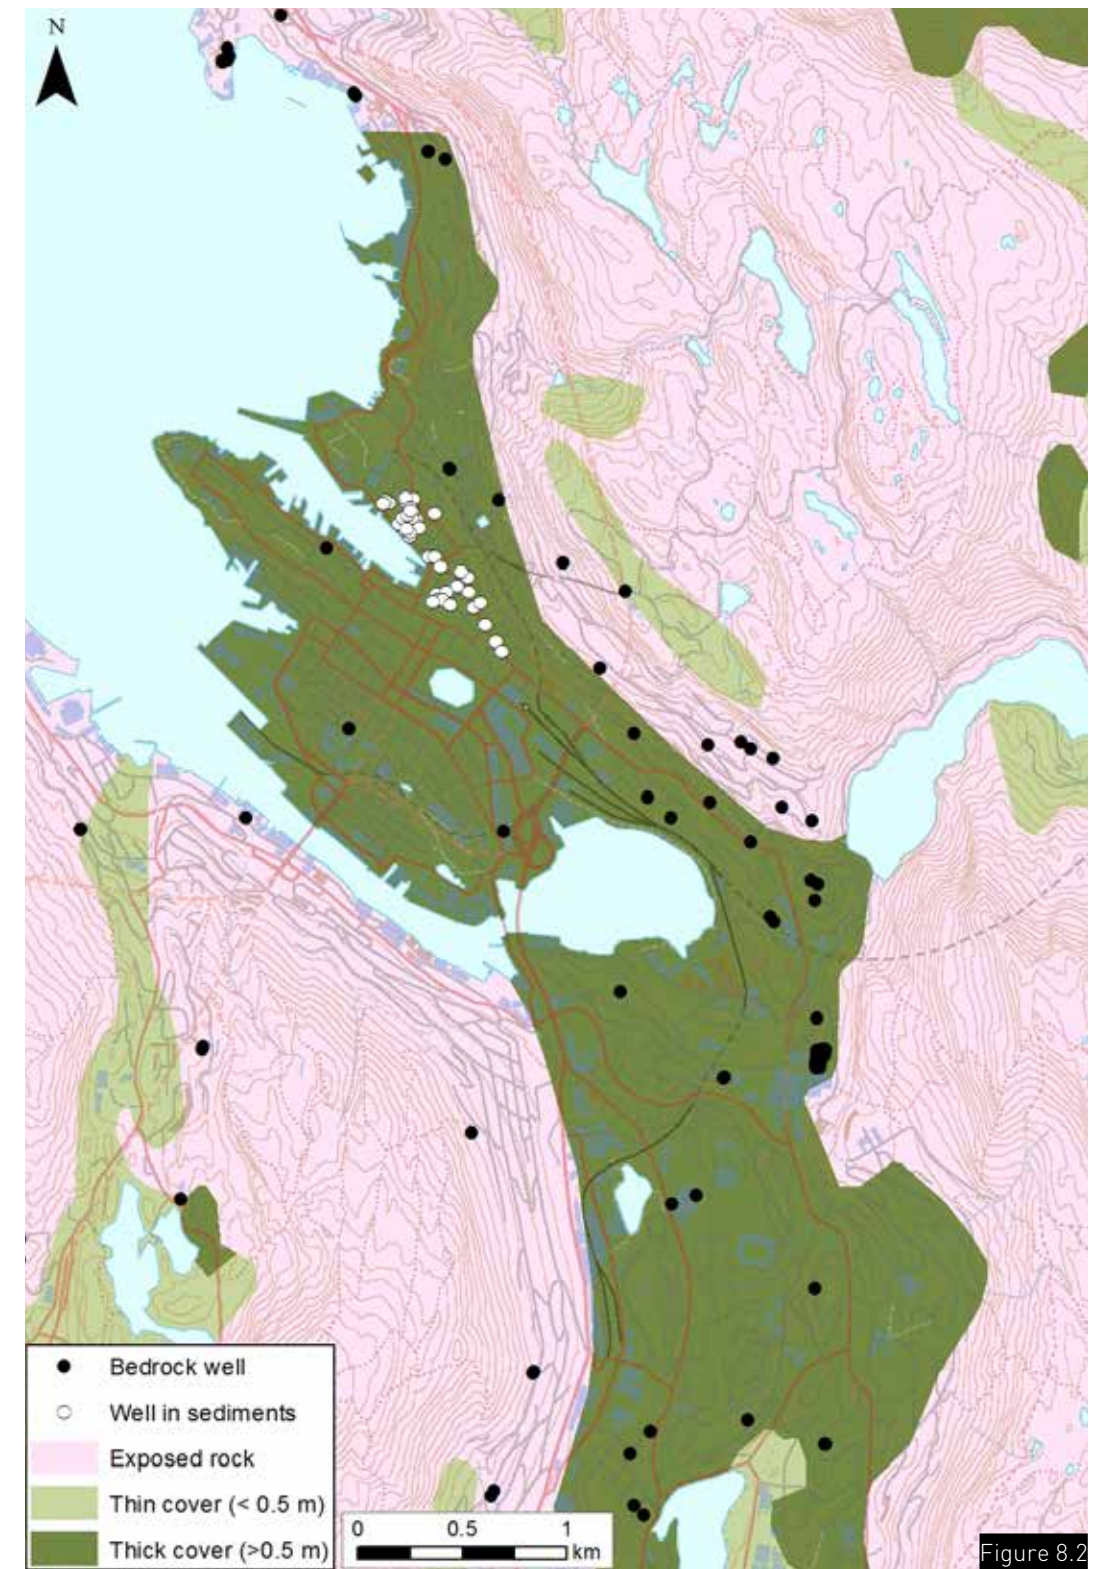
Figure 8.1 Physical geography of the Bergen area. Map: A. Seither, NGU.

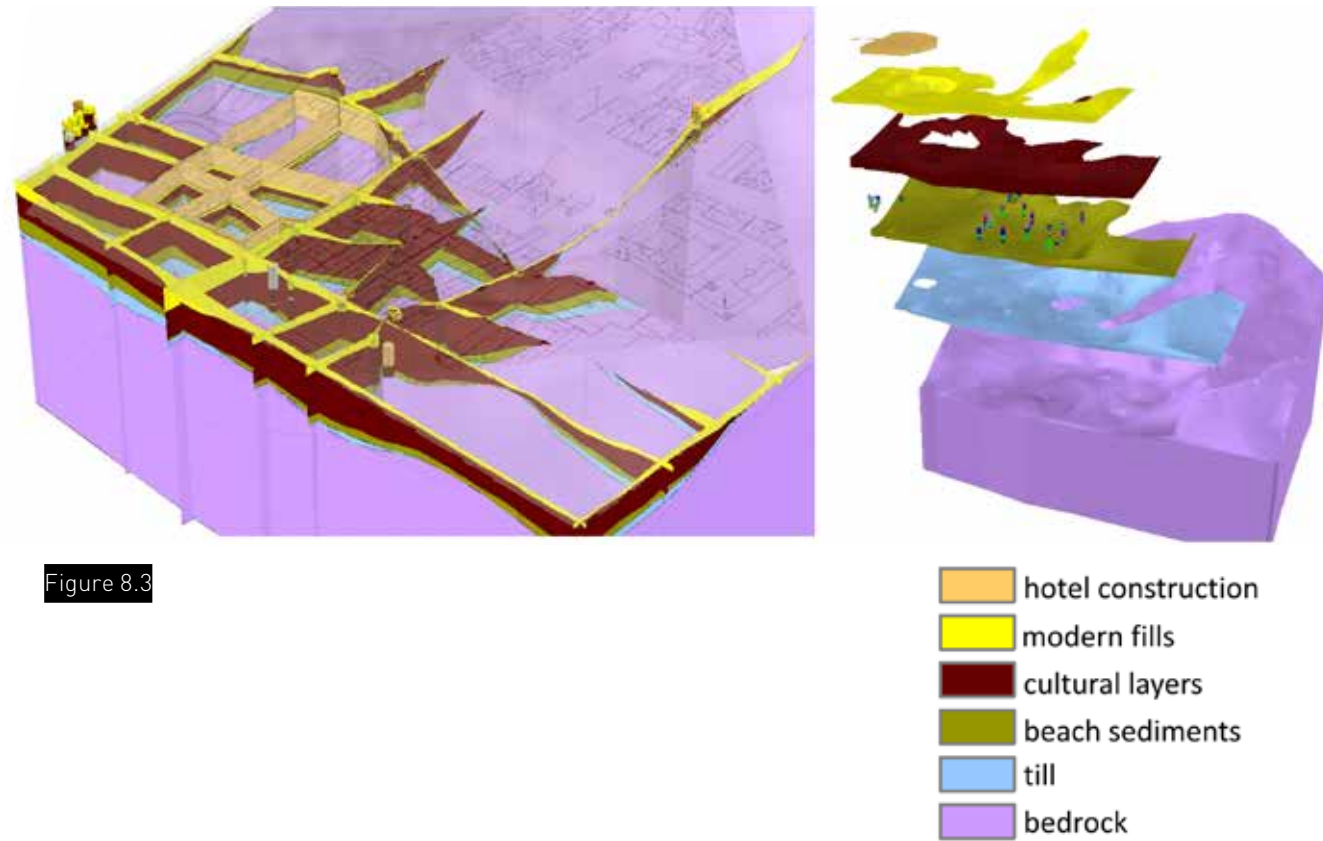
Figure 8.3 3D visualization (GSI3D) of the deposit sequence underneath Bryggen's timber buildings, extrapolated between neighbouring monitoring well-borehole columns. An exploded view of the 3D sub-surface model is shown above. J. De Beer et al., 2012.

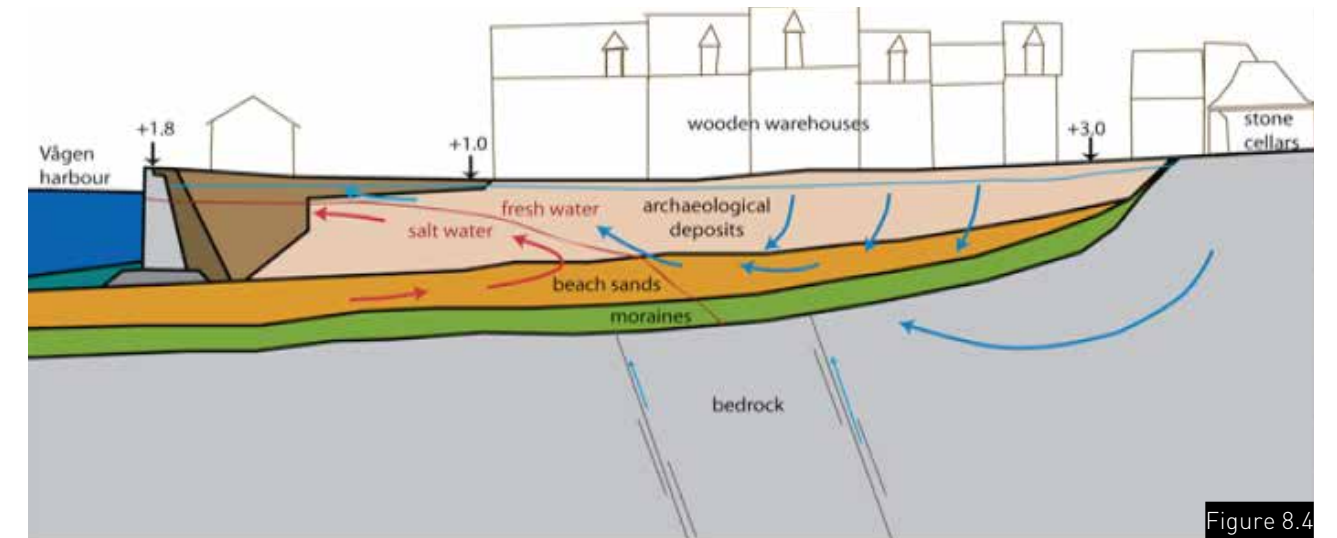
Figure 8.4 Cross-section from the harbour to the rear of Bryggen, giving a simplified picture of the sub-surface sequence of principal deposit types and the local water flows (modified and extended by J. de Beer after E. Mørk, Stiftelsen Bryggen).

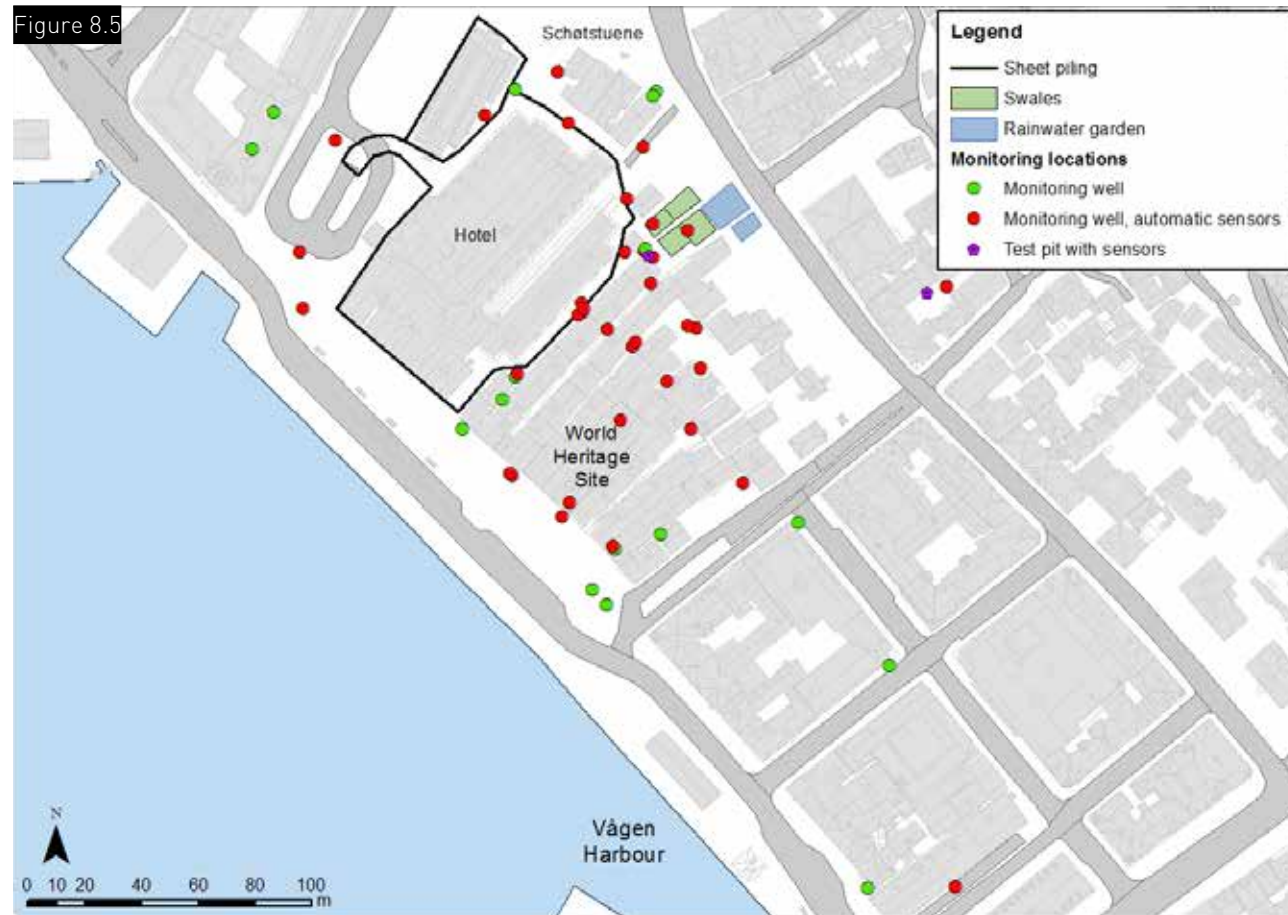
Figure 8.5 Overview map of groundwater monitoring wells (dipwells).  
Map: A. Seither, NGU.

Over a period of 14 years, 47 groundwater monitoring wells have been installed in the area. In addition to these monitoring wells, a rainwater gauge has been installed on the roof of Bryggens Museum, adjacent to the Bryggen site. The rainwater gauge also includes an air pressure sensor that is used to calibrate the measured groundwater pressures for temporary changes in barometric pressure. An overview over the locations of these wells is given in Fig. 8.5. 33 of these wells have been equipped with

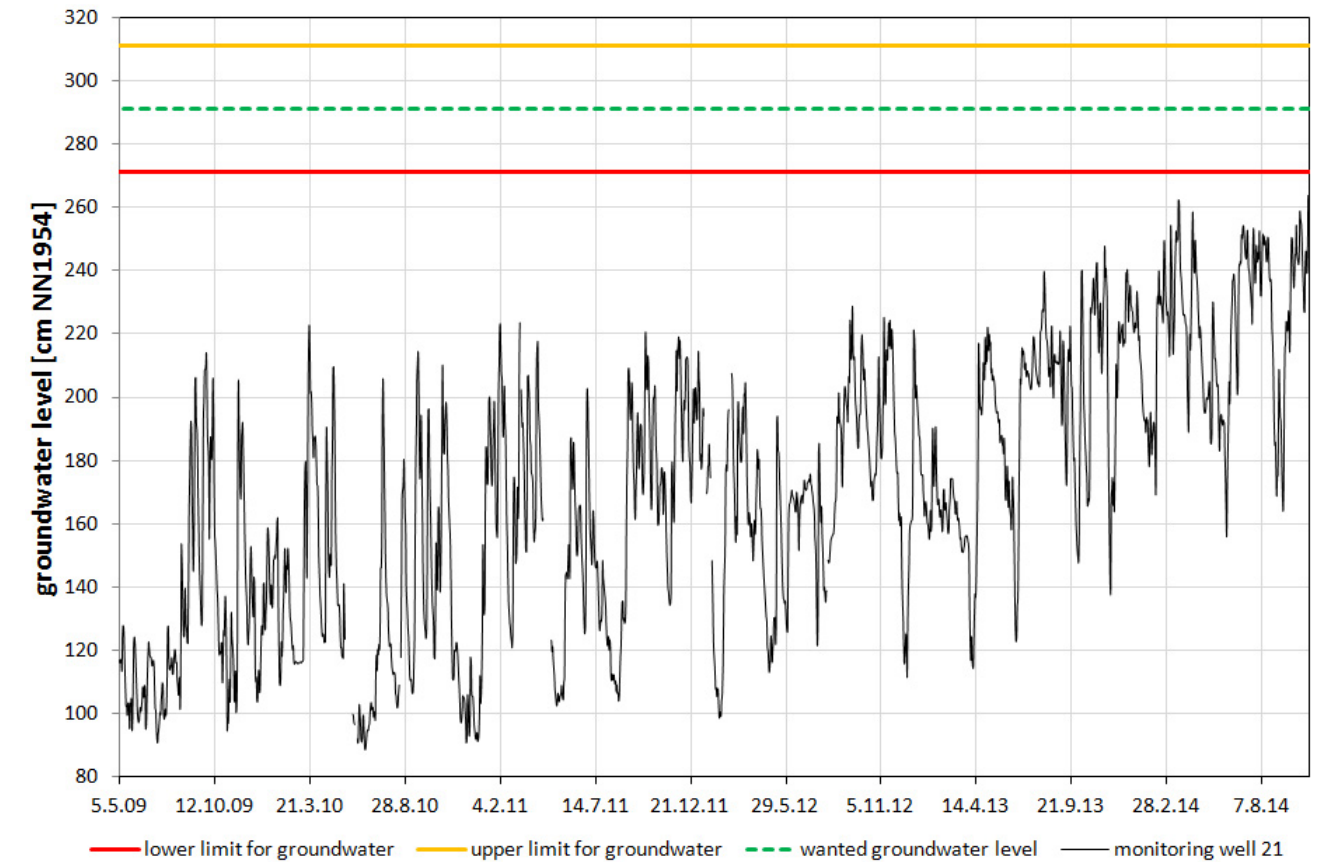
Figure 8.6 Groundwater level in monitoring well MB21.  
Drawing: J de Beer, NGU.

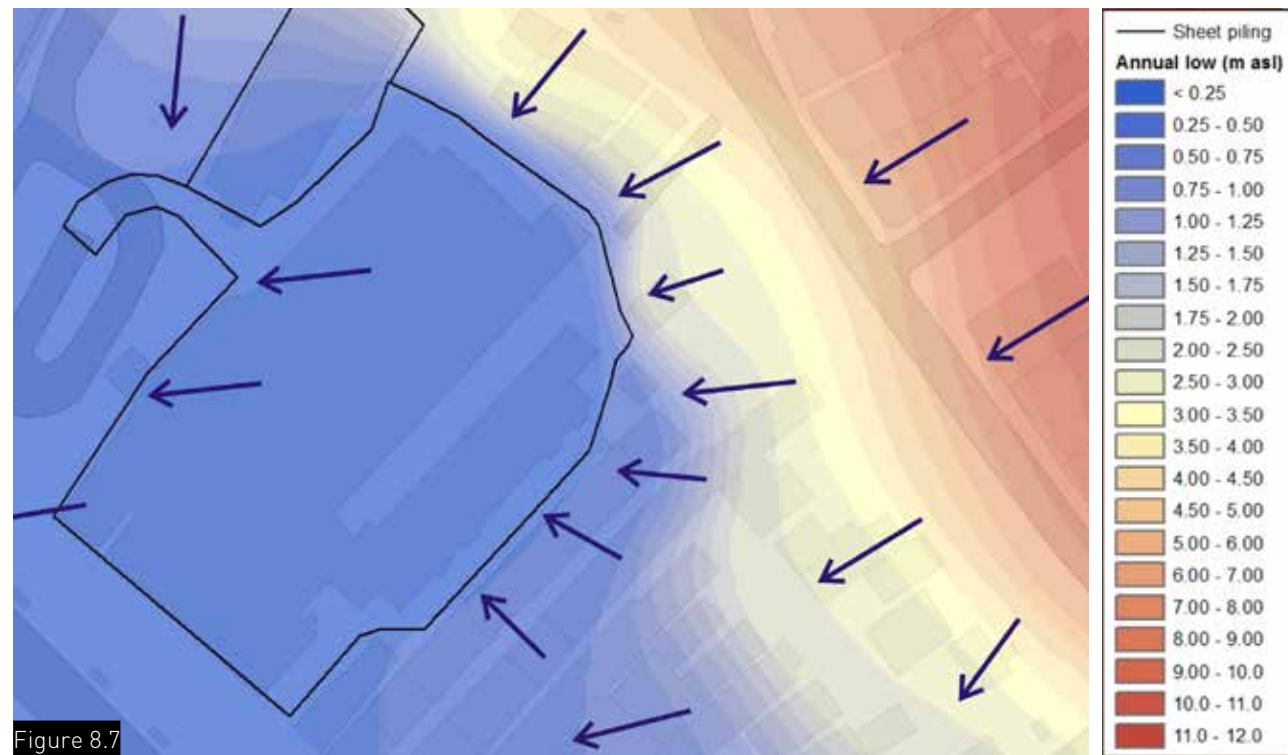
Figure 8.7 Simulated groundwater level and direction of flow at Bryggen. The dashed line indicates the hotel area. J de Beer, 2008.

Since increased subsidence and low groundwater levels began to be observed in 2001,<sup>158</sup> the neighbouring hotel area was suspected of playing a role. The increased monitoring efforts since 2005, combined with groundwater-flow modelling, strengthened this suspicion (Fig. 8.7).

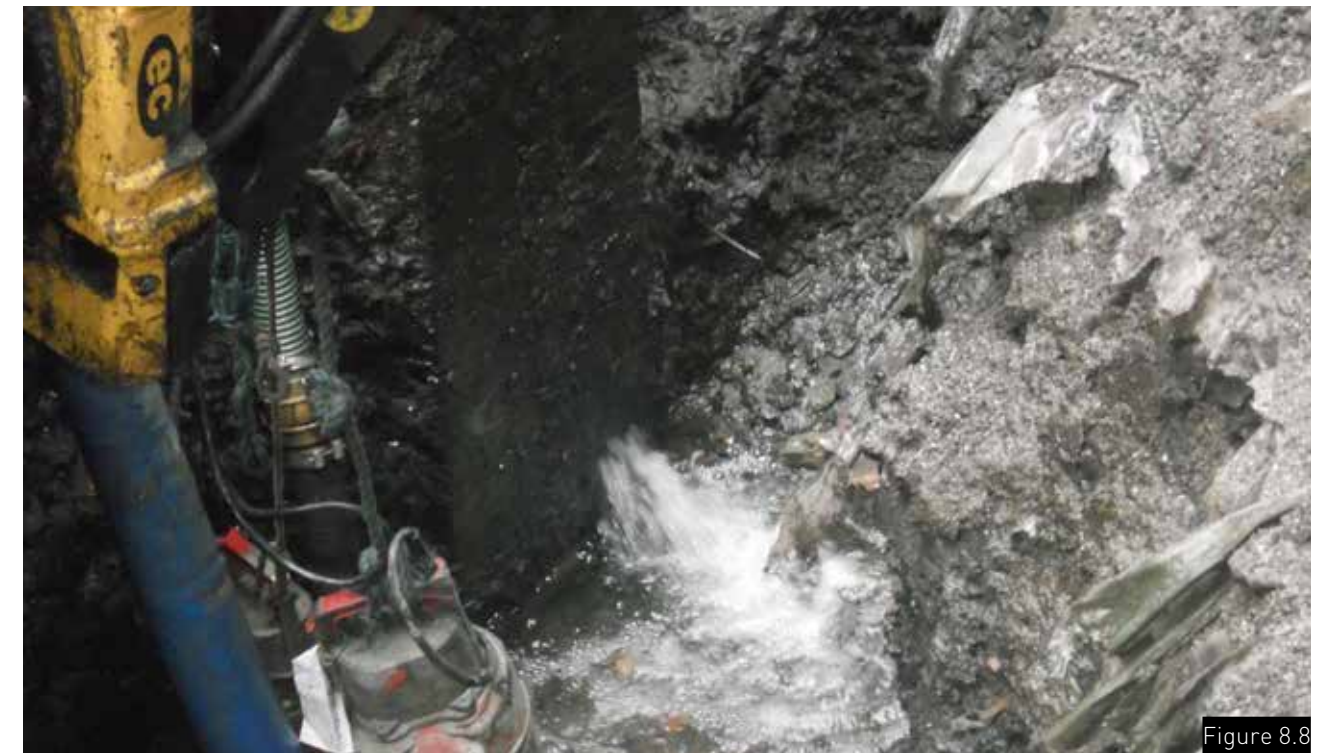
Figure 8.8 Photo showing deterioration of the sheet piling and a point with substantial leakage. Photo: J. Hausvik, Bergen Bydrift.

Accordingly, the drainage inspection well at the western corner was supplied with a vertical pipe with a new overflow level at 0.45 m asl in November 2010. This led to an immediate increase of the drainage level and, as a result, the groundwater pressures in monitoring wells below the archaeological deposits as well as in wells close to the hotel rose.<sup>161</sup> However, the groundwater level (pressure) under the hotel did not rise to the newly installed drainage level of 0.45 m, indicating that other overflows had been activated elsewhere along the sheet piling in the southwestern part of the parking area. Inspection of the sheet piling confirmed this. Groundwater was leaking out through large cavities (or partly missing sheet piles) where sewage and other pipes crossed the wall, and the smaller holes cut to receive the upper ends of the many slanting ground anchors (anchor holes).

A considerable amount of work was devoted to sealing as many as possible of these anchor holes. At locations where parts of individual sheet piles had been damaged or deliberately removed, the wall was repaired by adding a concrete barrier on top of the sheet piles up

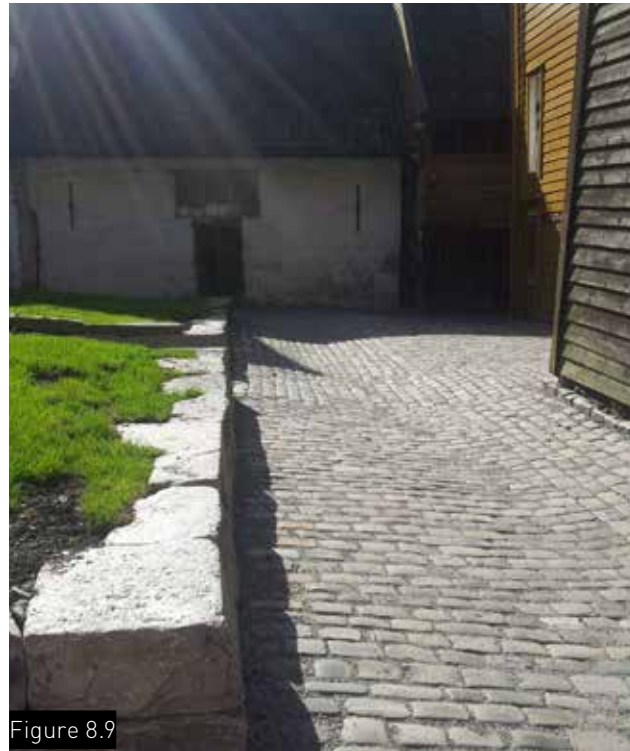
Figure 8.9 Swale (left) and channel in the cobblestones (right).  
Photo: J. de Beer, NGU.

In those areas where the ground was highly compacted, the topsoil was reworked and partly replaced by gravel with high infiltration capacity. At critical locations, the fine-grained layer supporting the cobblestone pavements was exchanged with more permeable material to facilitate rainwater infiltration. These measures have reduced stormwater runoff considerably and improved local infiltration of rainwater. So-called swales have been constructed at two locations behind Bryggen to capture surface runoff and facilitate infiltration (Fig 8.9).

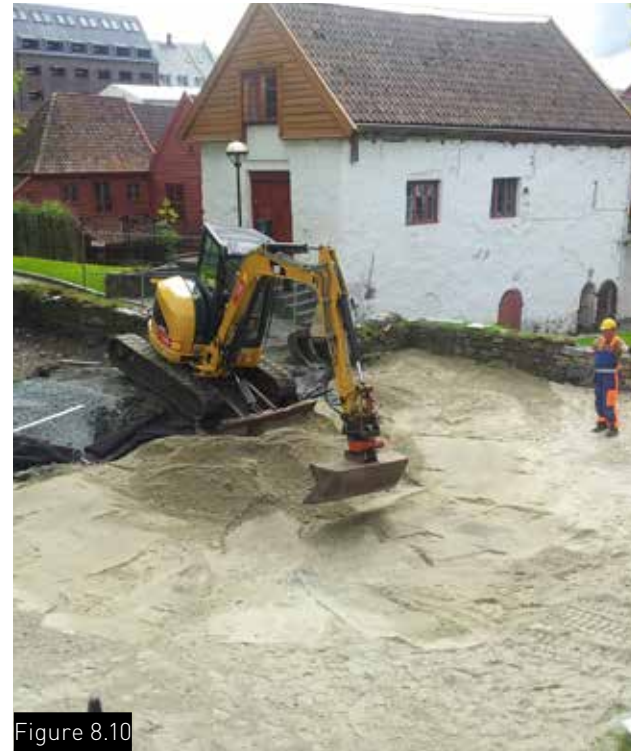
Figure 8.10 Rainwater garden under construction.  
Photo: J. de Beer, NGU.

A rainwater garden (Fig. 8.10) has been constructed between Øvregaten (the High Street) and Bryggen. Stormwater from the urban area upstream of Øvregaten is connected to the garden, enabling a large amount of water storage and gradual infiltration to the underlying archaeological deposits. The construction of the rainwater garden ensures the capture of pollutants present in stormwater; contaminated topsoil can be replaced at regular intervals. Details of the rainwater garden are described in chapter 10.

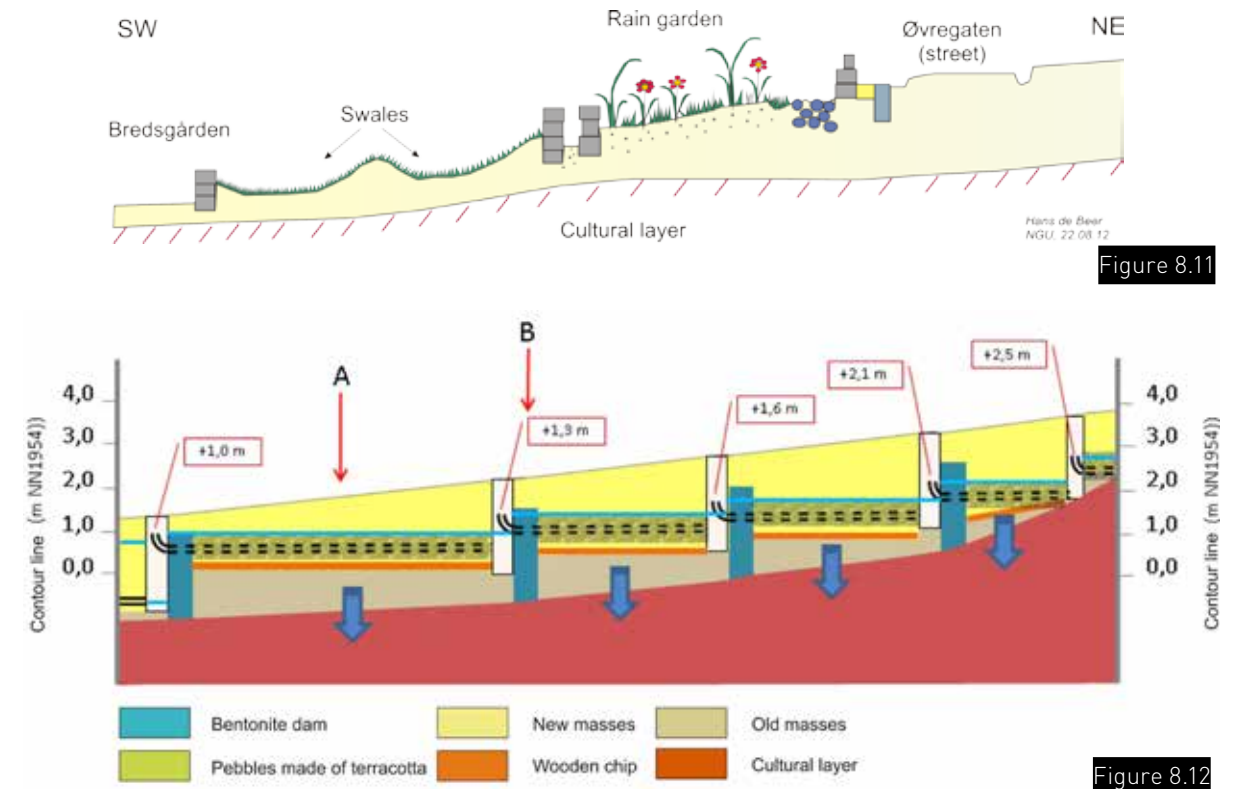
Figure 8.11 Schematic illustration of the water 'treatment train' at the rear of Bryggen.  
Drawing: J. de Beer, NGU.

The rainwater garden, swales and permeable pavement together form a so-called 'treatment train'. A schematic illustration of the treatment train is given in Fig. 8.11.

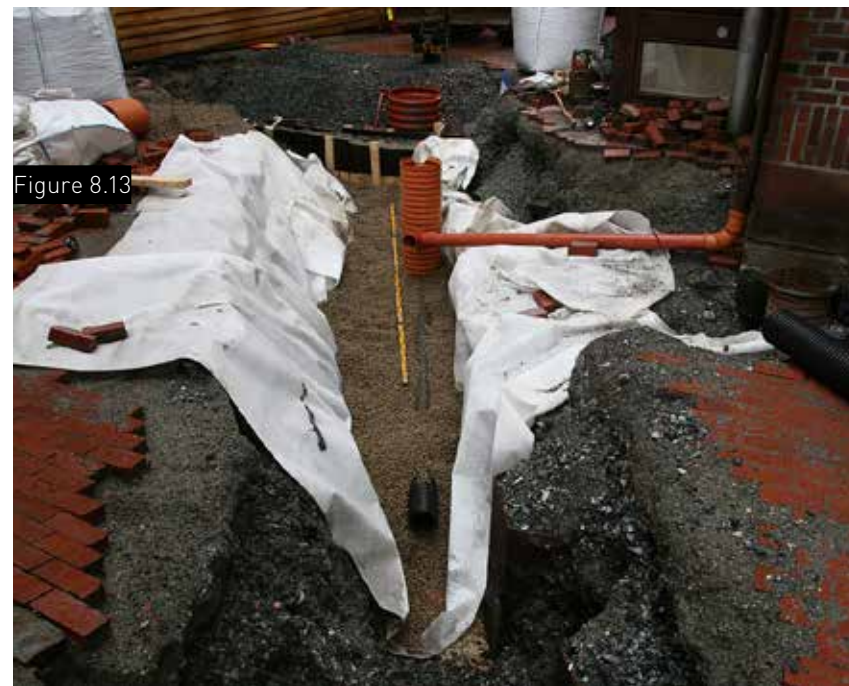
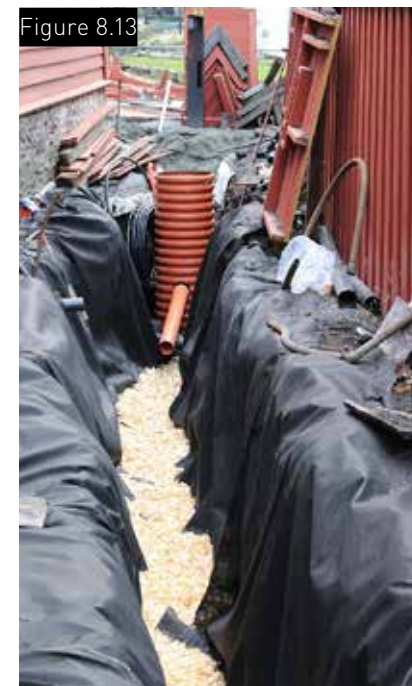
Figure 8.13 The I/T-system under construction. Photo: A. R. Dunlop, NIKU.

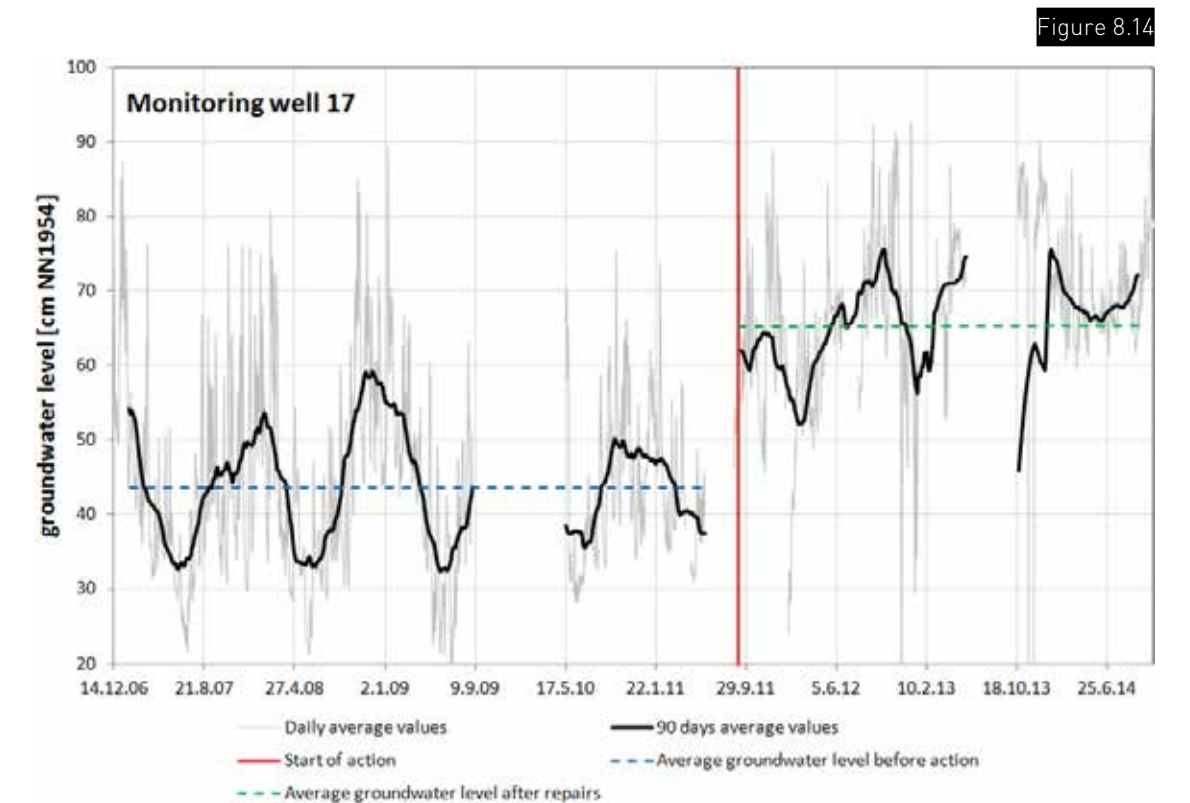
Figure 8.14 Groundwater level in monitoring well MB17. The grey line shows daily variations of the groundwater level. The black curve gives a simplified impression of the groundwater level, by showing average values over three-month intervals. Through a combination of several mitigation measures, it has been possible to raise the groundwater level (by on average c. 20 cm). Drawing: A. Seither, NGU.

The impact of active infiltration of water into the ground is best illustrated with the measurements series from well MB21 (Fig. 8.15). As with well MB17, the overall groundwater level rose after the first measure, but seasonal variations still had a distinct influence on the groundwater level. Such seasonal lows pose a threat to the archaeological deposits, because the deposits dry out temporarily and come into contact with higher concentrations of oxygen. The construction of the I/T-system and the swales provided the deposits with an almost continuous supply of water. The system compensates for water shortages in drier periods and ensures water-saturated conditions at most times, independent of weather conditions.

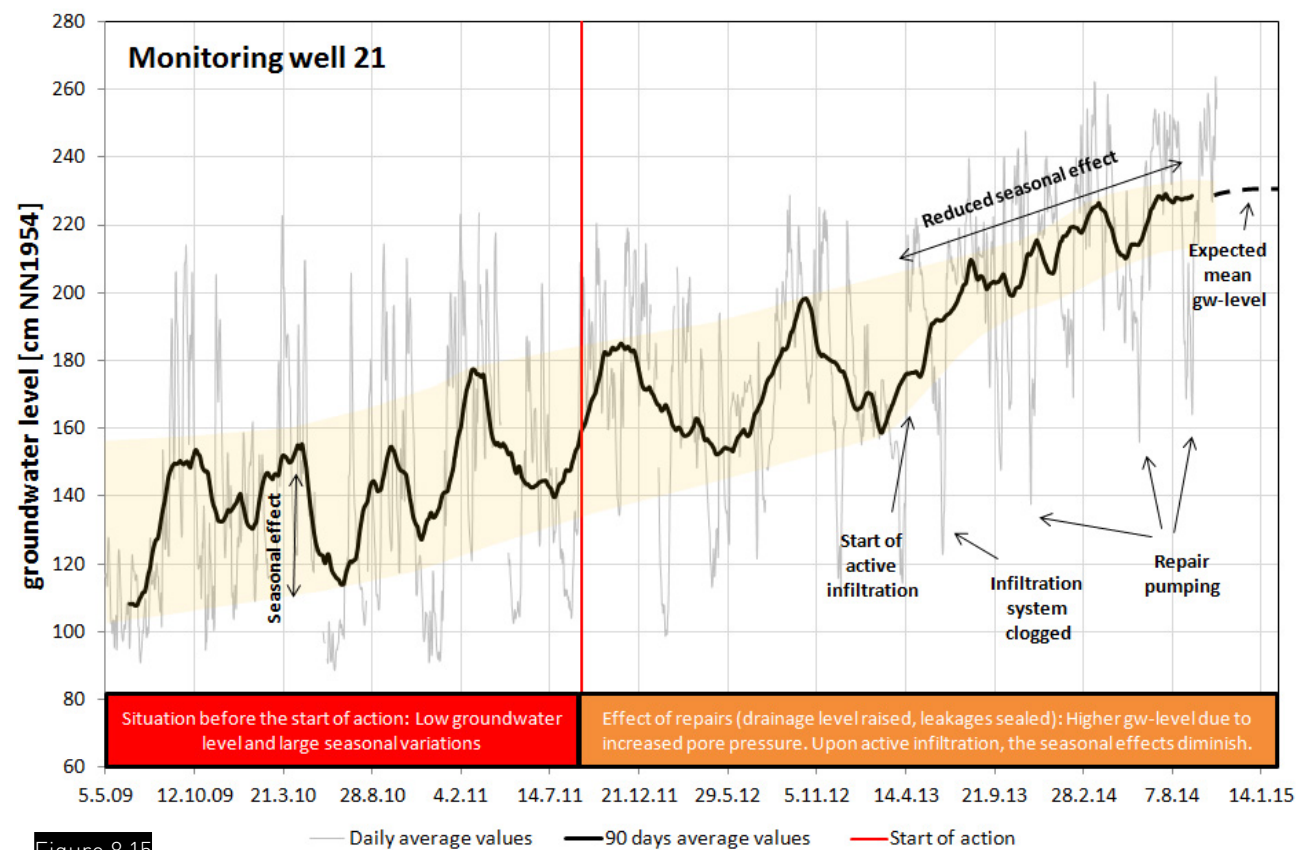
Figure 8.15 Groundwater level in monitoring well MB21. The grey line shows daily variations of the groundwater level. The black curve gives a simplified impression of the groundwater level, by showing average values over three-month intervals. Drawing: A. Seither, NGU.

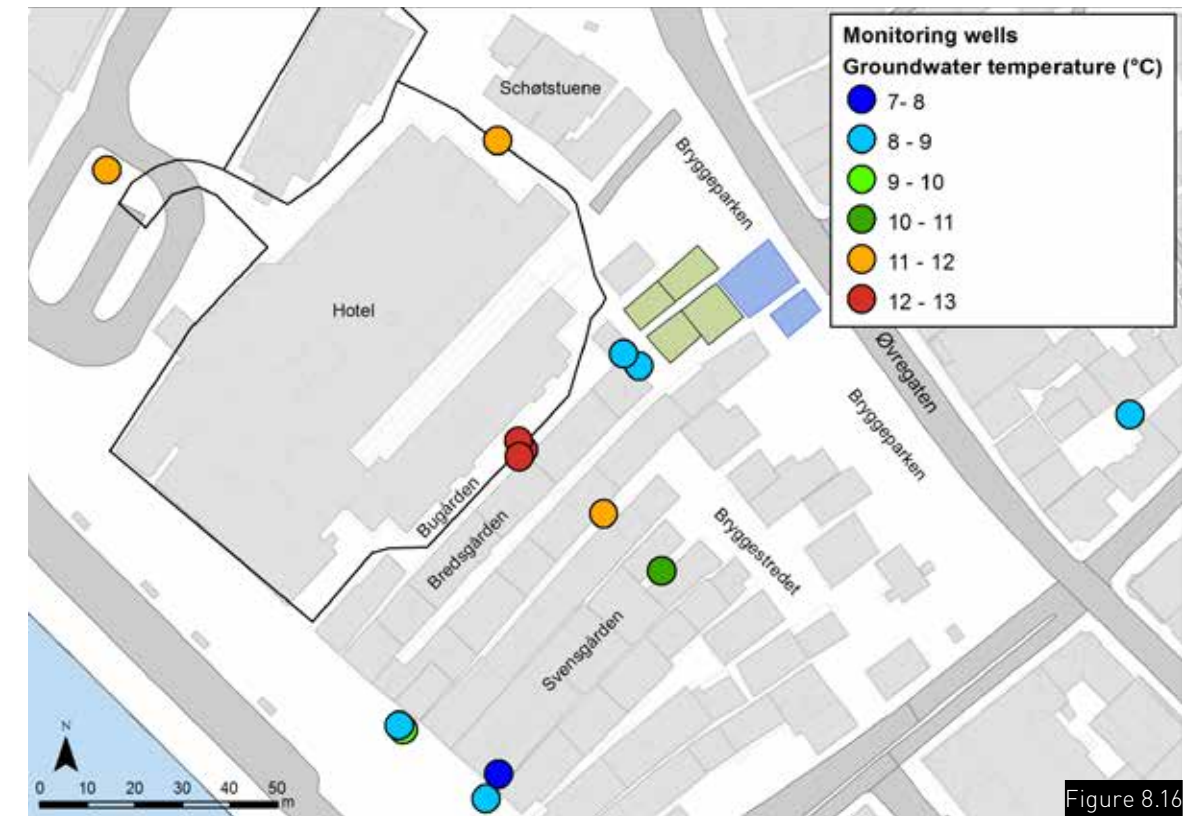
Figure 8.16 Average groundwater temperatures in monitoring wells at Bryggen. Map: A. Seither, NGU.

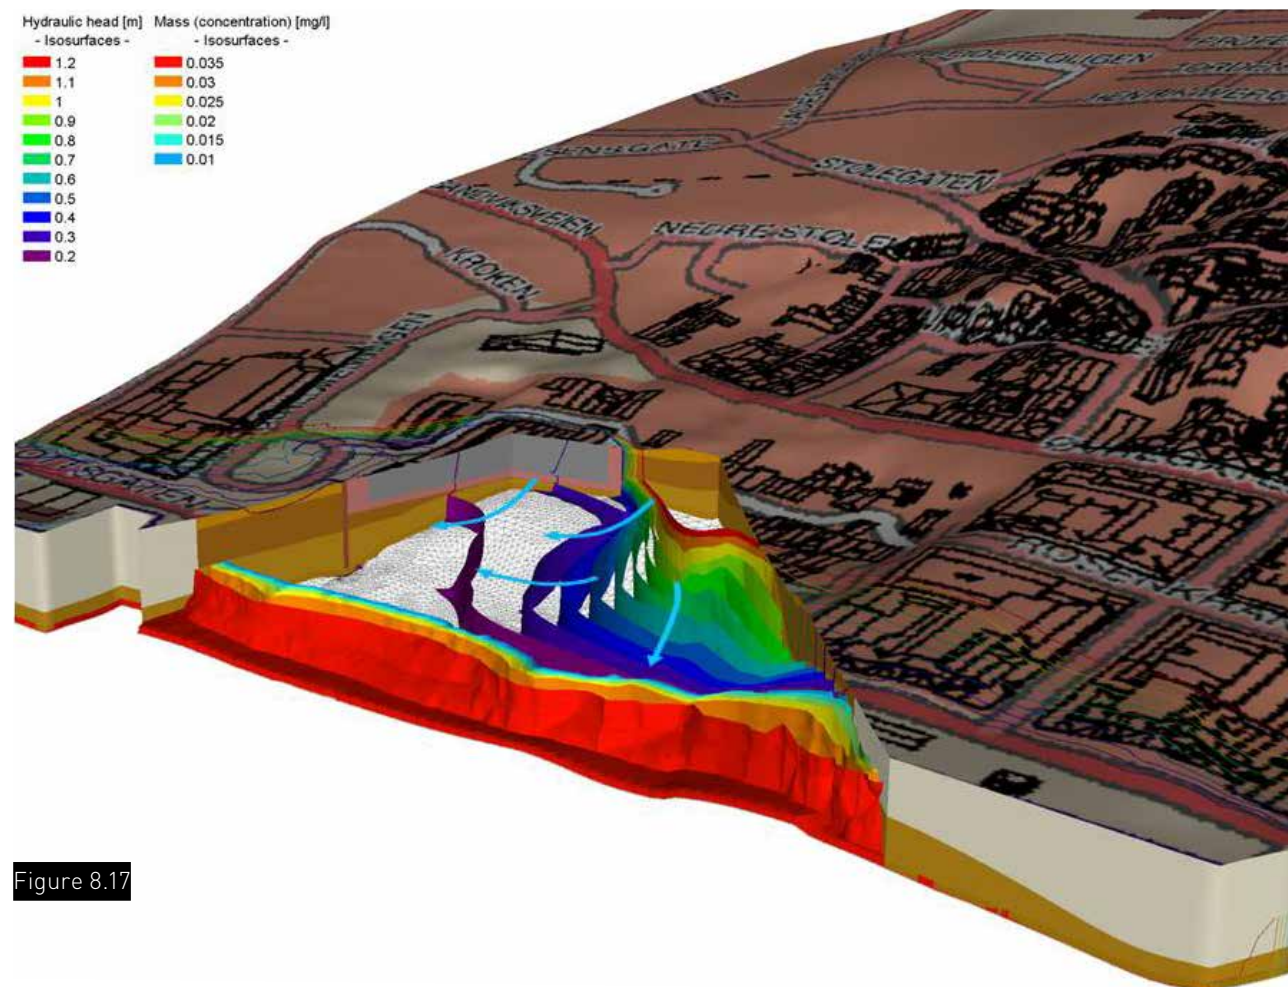
Figure 8.17 3D view of the groundwater model of Bryggen. Map: J. de Beer, NGU.

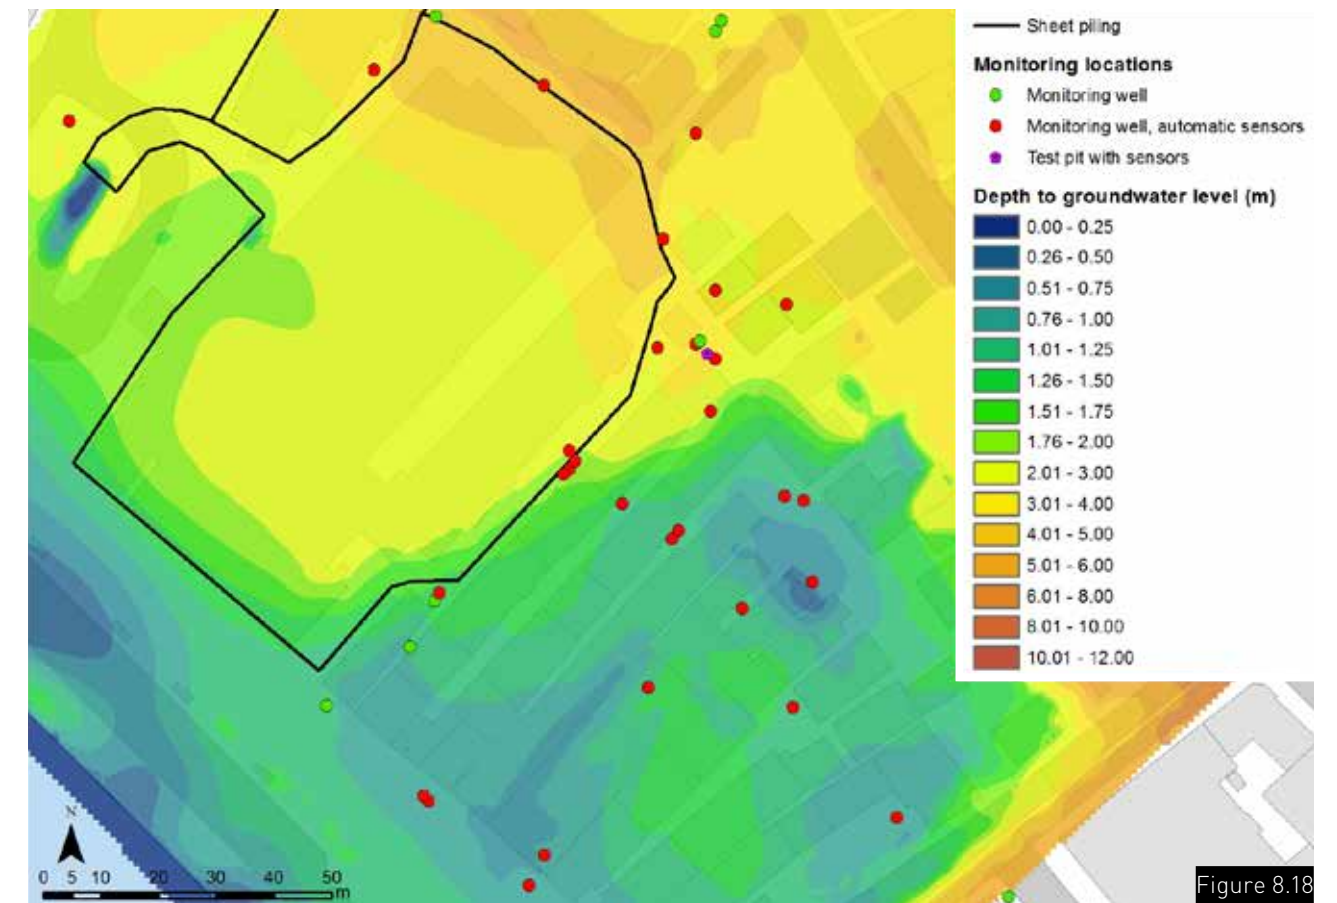
Figure 8.18 Calculated thickness of the unsaturated zone, during a representative dry period. Map: J. de Beer, NGU.

Fig. 8.7 shows the average lowest annual groundwater levels. By subtracting the groundwater levels from the surface levels, one obtains the calculated thickness of the unsaturated zone, shown in Fig. 8.18.
