MONITORING  
MITIGATION  
MANAGEMENT

THE GROUNDWATER PROJECT - SAFEGUARDING THE  
WORLD HERITAGE SITE OF BRYGGEN IN BERGEN

## RIKSANTIKVAREN 2015

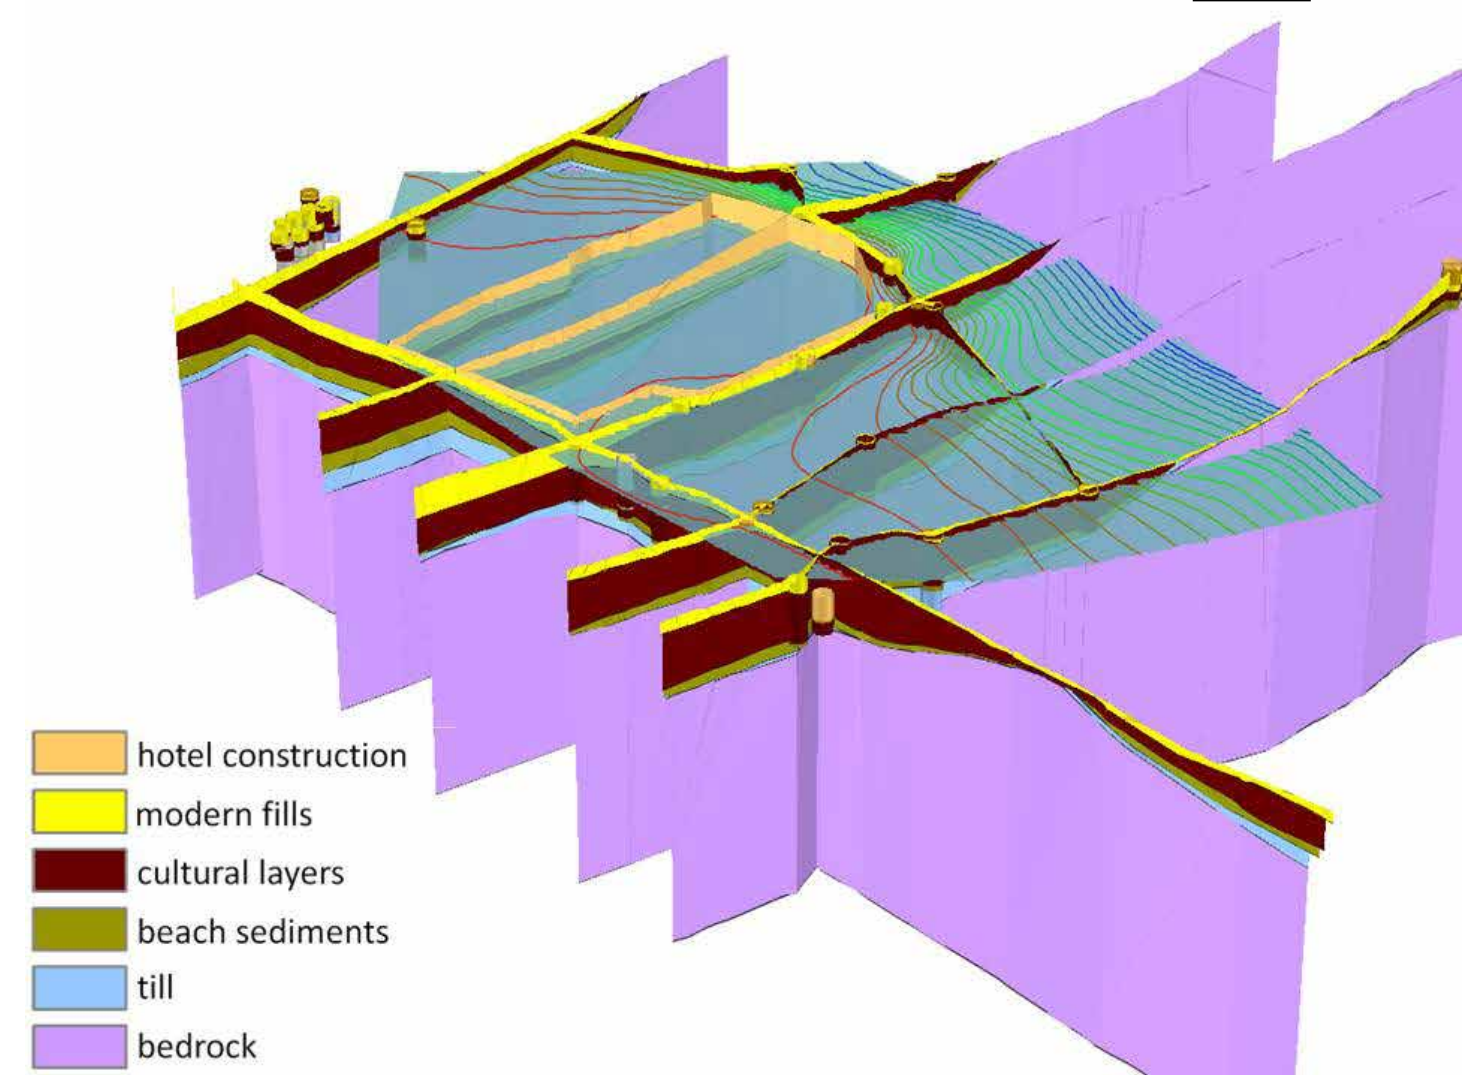
Figure 8.19 3D section view with a representative annual-low level of the watertable. J. de Beer et al. 2012.

In combination with the recorded thickness of the archaeological deposits, risk maps can be created that show the decay potential in 3D. Figure 8.19 shows a 3D section view combined with the average lowest annual representative water table. Locations where the archaeological deposits (dark brown) are positioned above the water table are at risk of accelerated decay.

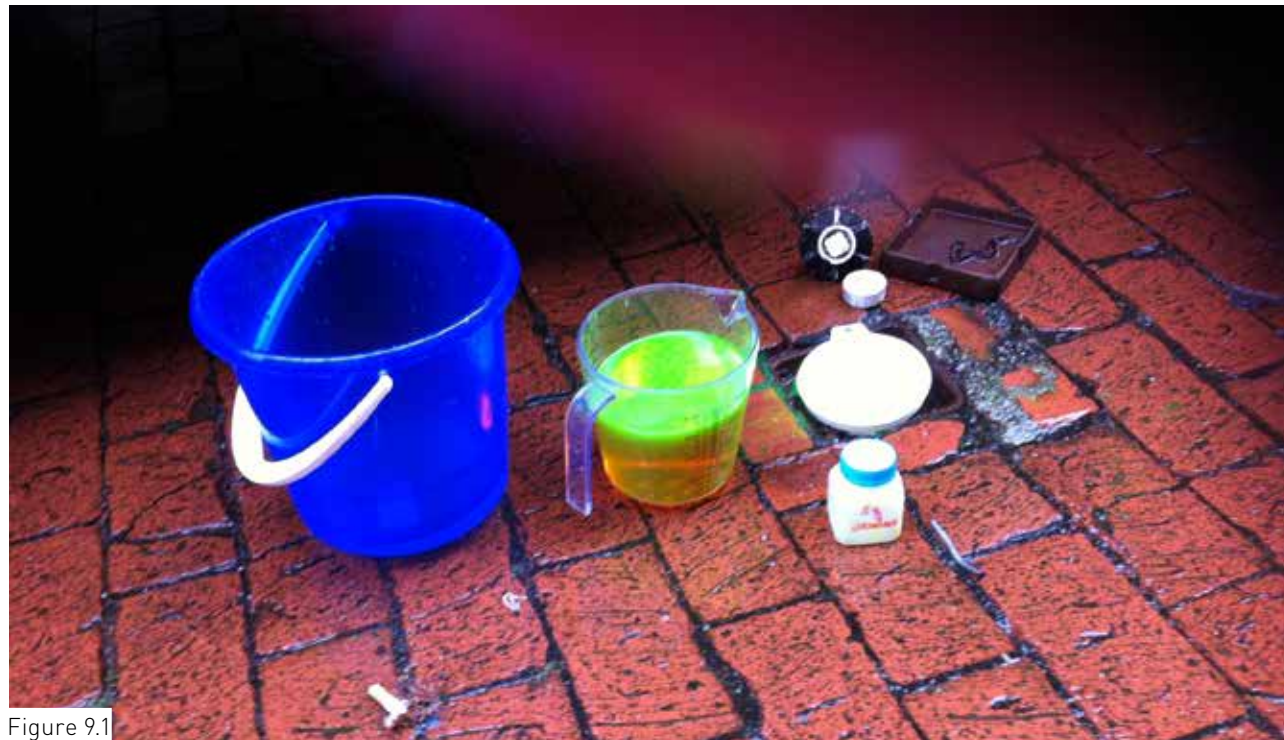
Figure 9.1 Colour dye to be added to borehole with white cap, in colour tracer test. The tracer was captured with activated carbon passive samplers in nearby monitoring wells. Photo: L. Basberg, Norconsult AS.

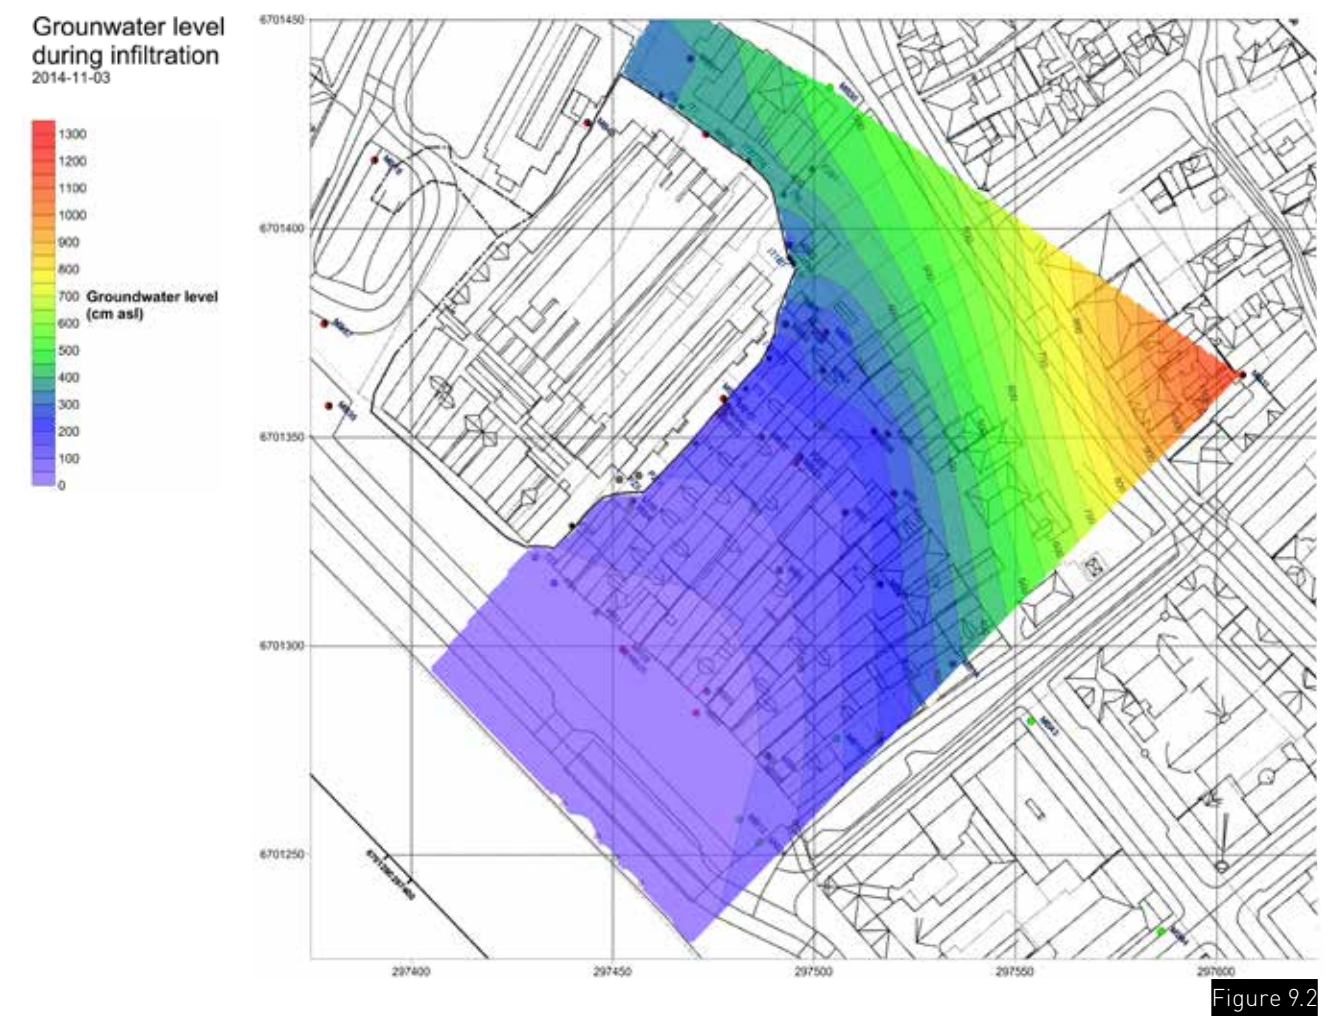
Figure 9.2 Groundwater level in upper deposits at Bryggen on the 3rd of November, 2014. This groundwater map illustrates the elevation of the water table in cm above sea level. Map: L. Været, Norconsult AS.

Groundwater-level measurements taken on the 3rd of November 2014 indicate that the groundwater level has nearly risen to the designated project goal level.

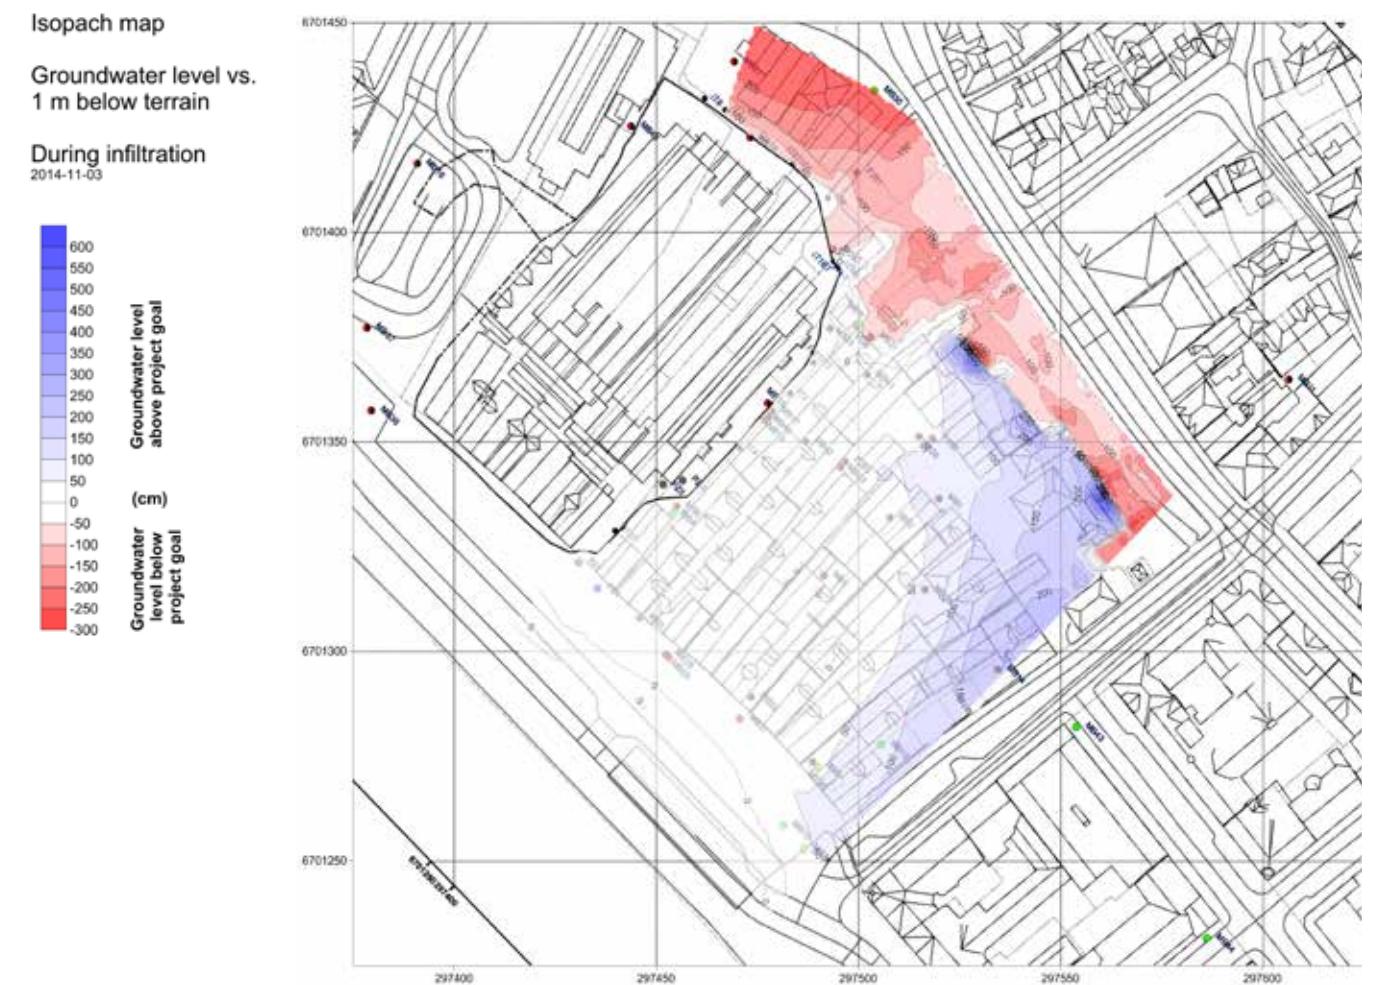
Figure 9.4 Difference in groundwater levels and the project's target levels for the groundwater replenishment, based on measurements taken the 3rd of November, 2014. Largest divergence from target levels is in areas with irregular terrain elevations. Map: L. Været, Norconsult AS.

Areas that have not reached the designated elevation lie within approximately 40 cm of the set goal. This result may be adequate for the initial project goal of reducing the annual subsidence rate to less than 1 mm. It can be argued that with the groundwater level only 40 cm below the set elevation, capillary forces in the soil/archaeological deposits may be sufficient to keep the organic deposits water saturated and strongly reduce the oxidation and decay of the archaeological deposits, and therefore also strongly reduce the subsequent surface subsidence.

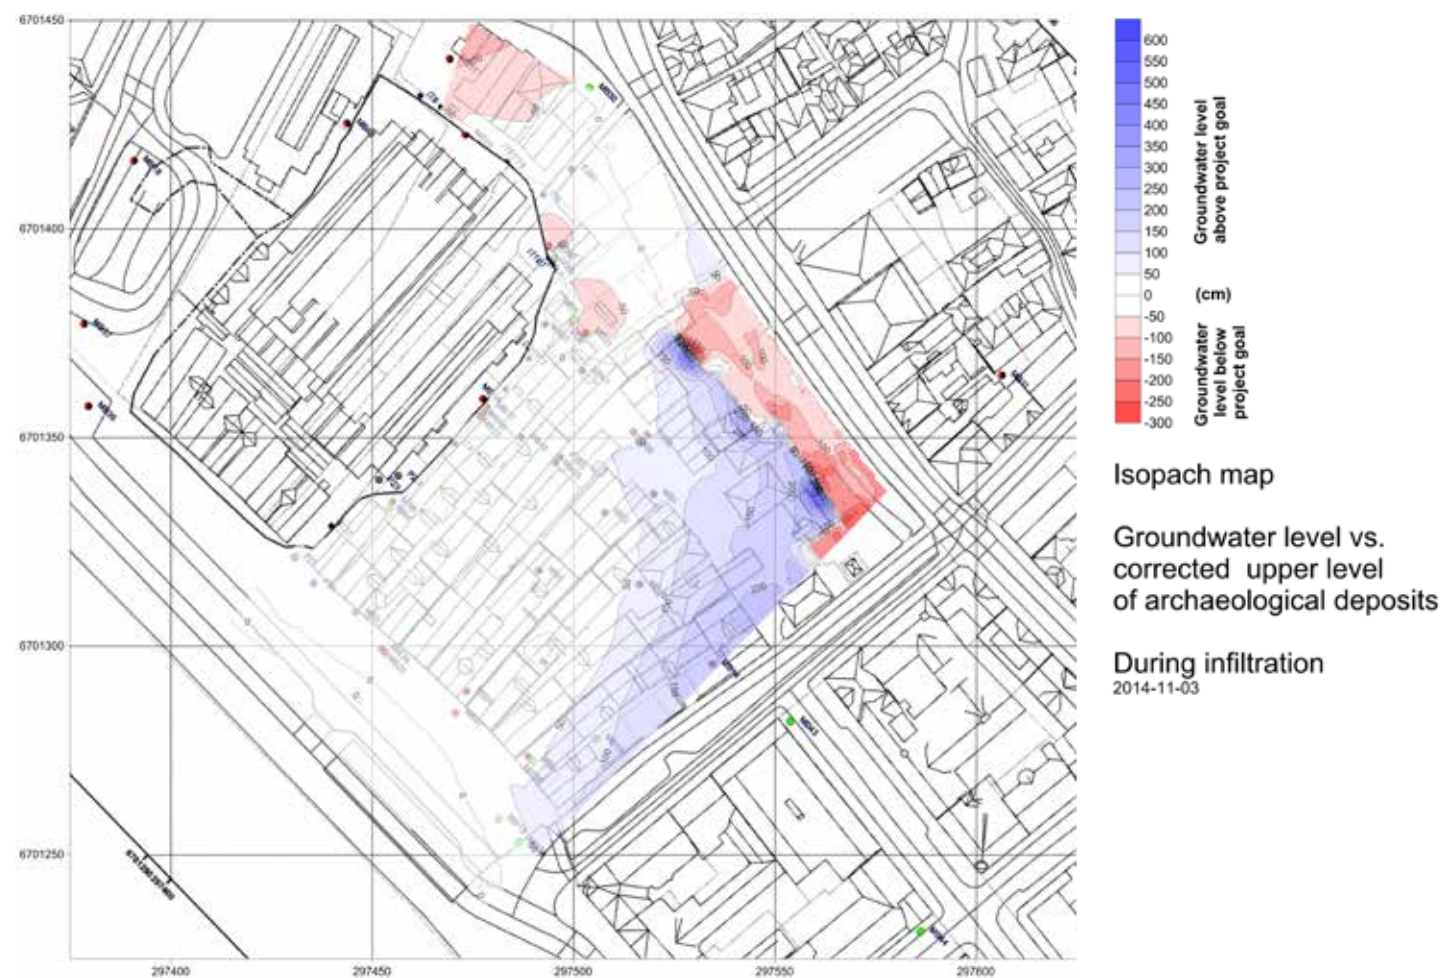
Figure 9.5 Difference in groundwater level and the interpreted upper surface of the organic archaeological deposits at the upstream end of the project area.

In areas where the terrain has been filled in with material above the organic archaeological deposits, the distance between the groundwater level and elevation 1 m below the terrain may give an incorrect representation of the saturation level of organic deposits. Fig. 9.5 below has been created to show our interpretation of the upper organic level of the archaeological deposits, after discussions with Rory Dunlop.<sup>165</sup> The upper elevation of the organic archaeological deposits has been estimated to be between 4 and 5.25 masl in the area up-gradient of the hotel, with a surface gradient ratio of 1:20.

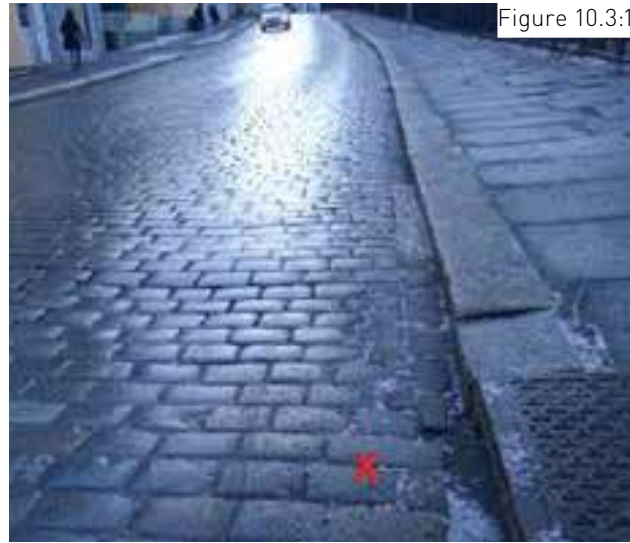
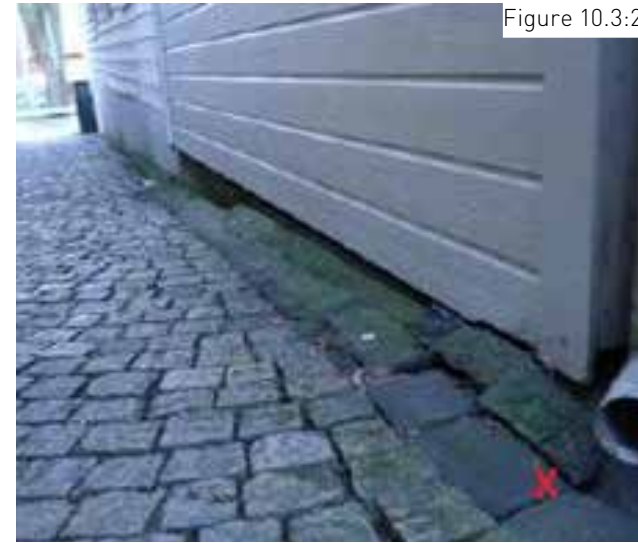
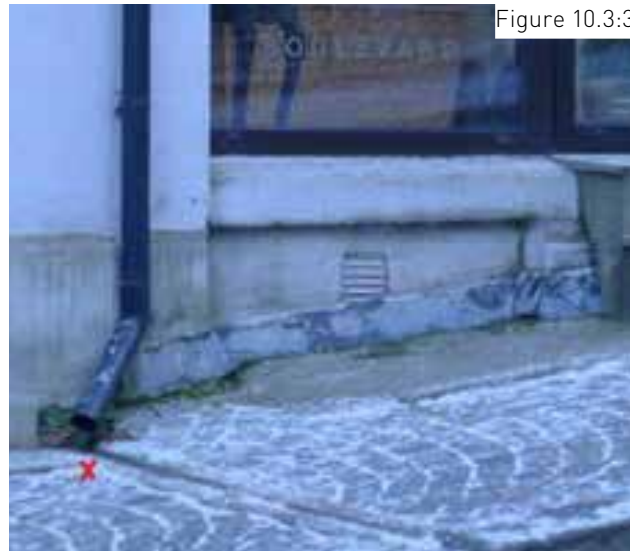
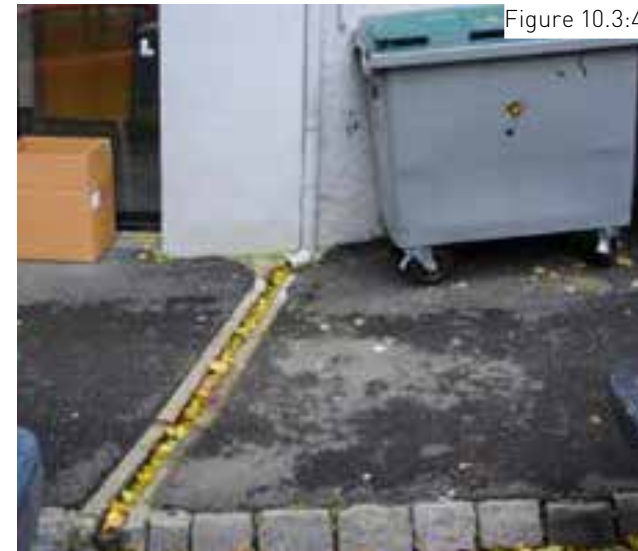
Figure 10.3:1-4 Photo, sampling points 7.2.2013. Photos: F. Boogaard, TAUW.

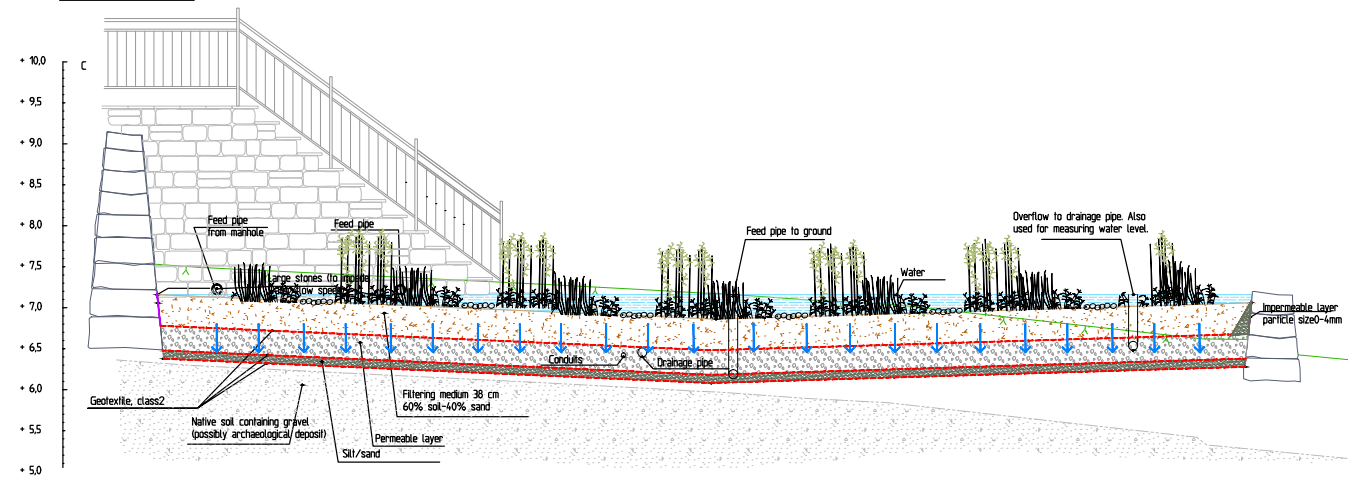
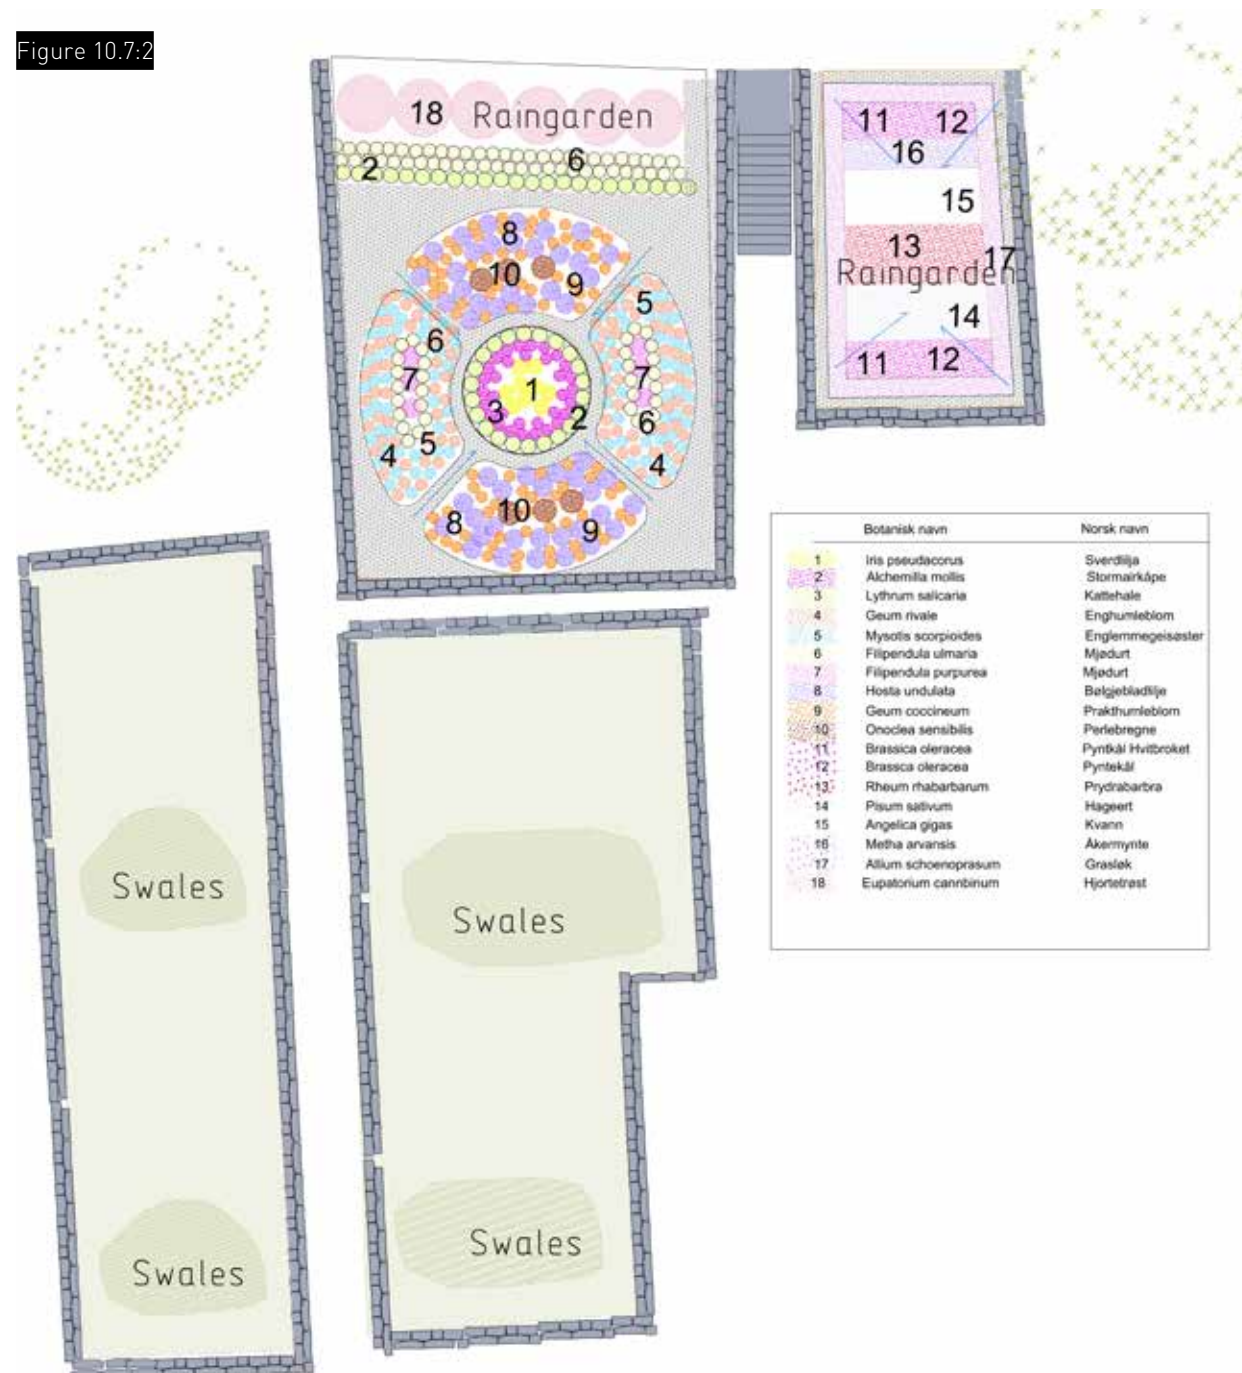
Figure 10.7:1

Figure 10.7:1-2 Cross-section (1) and detailed schematic of rainwater garden (2) in Bryggen. Drawing: Multiconsult AS.

The hydraulic performance of the rainwater garden depends on many factors. Plants play a significant role regarding the hydraulic conductivity of the filtering media.<sup>180</sup> There is a storage capacity for water of 30 cm on top of the rainwater garden (see fig 10.7). When this height is exceeded the water flows into an overflow and down to the swales. In the case of Bryggen an infiltration capacity around 0.5 m/day can be expected (see next paragraph on swales).

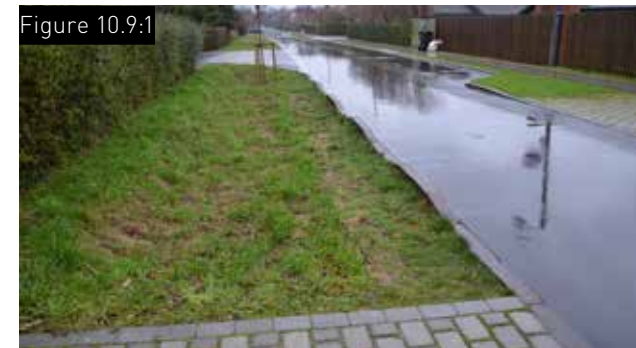
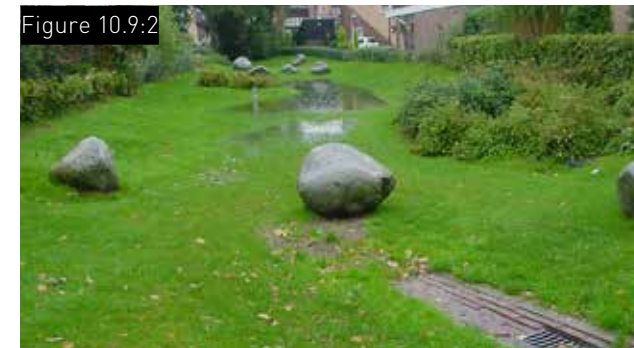
Figure 10.8	TSS		Hydrocarbons		Phosphor		Nitrate		Heavy metals	
	min	max	min	max	min	max	min	max	min	max
Removal efficiency	50	80	50	80	50	60	40	50	50	90

Figure 10.8 Indication of pollutant removal in bioretention derived from several studies.<sup>181</sup>

An indication of the removal efficiency of the rainwater garden can be derived from a number of studies. Fig 10.8 (following page) gives an indication of the removal efficiency for several pollutants that can be achieved with filtration, with figures derived from current research.

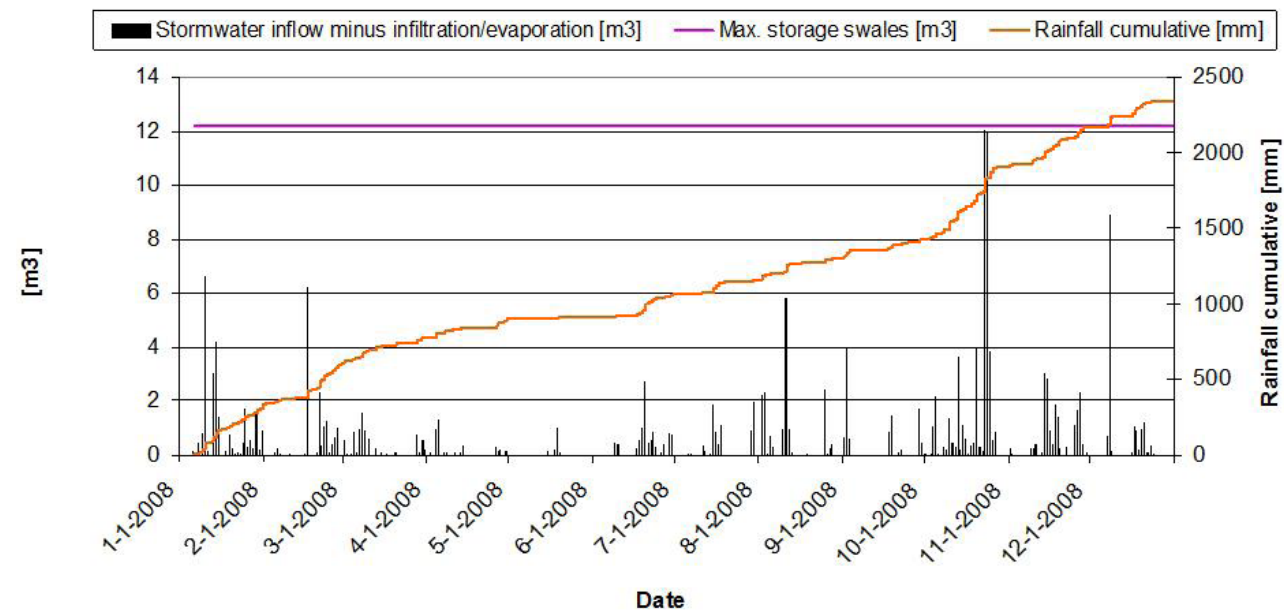
**Howswales function based on 2008 rainfall data**  
 (Storage: 12.2 [m3] Kd: 0.7 [m/d], connected area: 0.032 [ha])

Figure 10.12 Hydraulic performance of the swales to determine the design values.<sup>183</sup>

With rainfall and evaporation data of Bryggen a first estimation has been made on the hydraulic performance of the swales to determine the design values [see Fig 10.12 following page]. The storage volume has been designed to fit in the available space without altering the aesthetic value of this area: the maximum depth is about 25 cm. The minimum storage is about 12 m<sup>3</sup>, where most of the rain that falls directly on the swale and the rainwater discharged from a connected area of 0.023 ha to the swale will be stored and infiltrated into the ground. A rainfall event of about 35-50 mm/day might well be enough to fill up the entire storage volume of the swale.

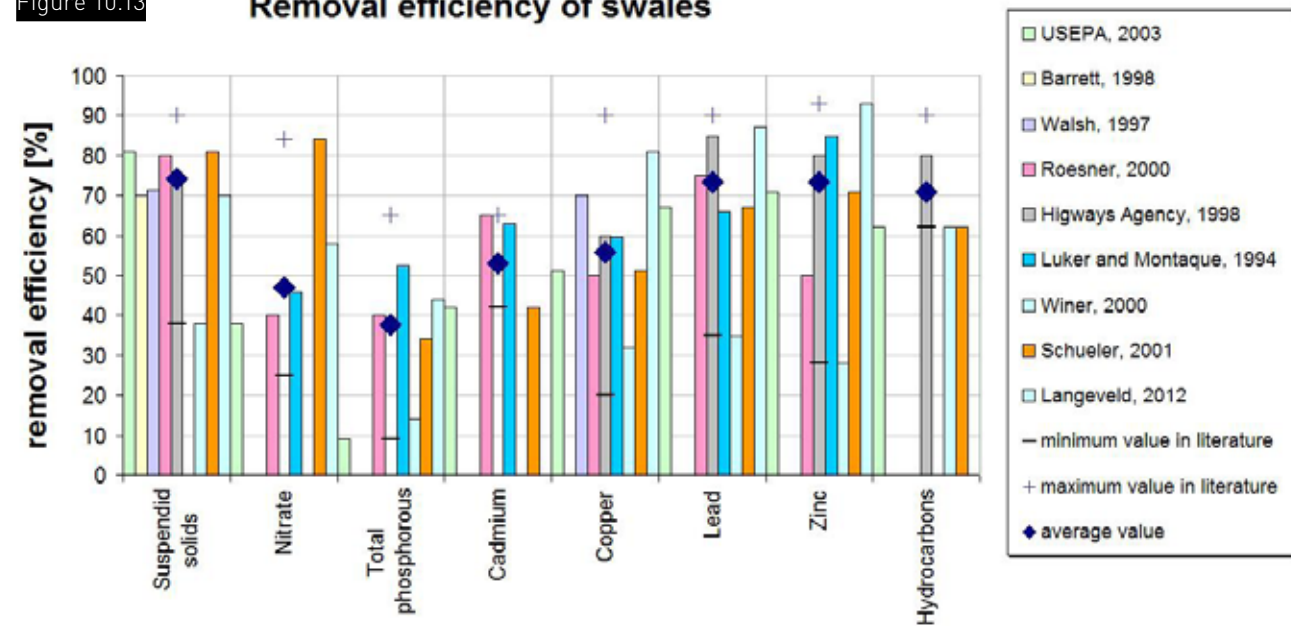
**Removal efficiency of swales**

Figure 10.13 Removal efficiency of swales around the world.<sup>184</sup>

Micro-pollutants (PAH and heavy metals) accumulate in the swale's topsoil. The removal efficiency of swales is confirmed by several studies world-wide (Fig. 10.13). The efficiency depends on the local situation and dimensions of the swales, but the research gives an indication of the minimum and maximum values that can be expected with topsoil infiltration.

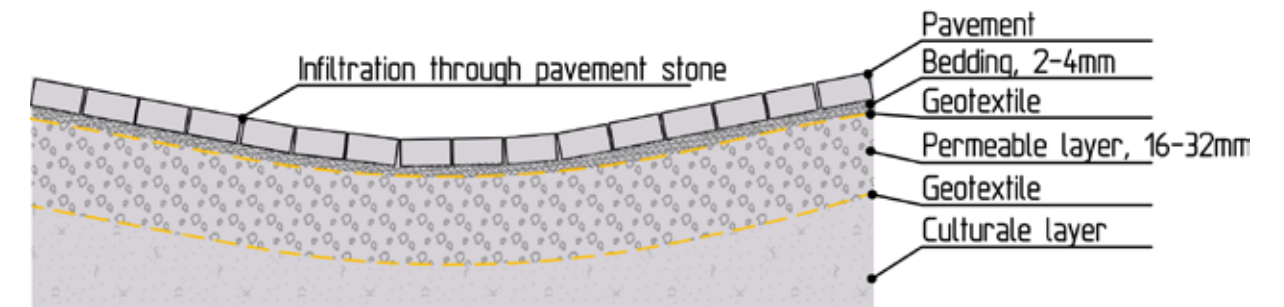
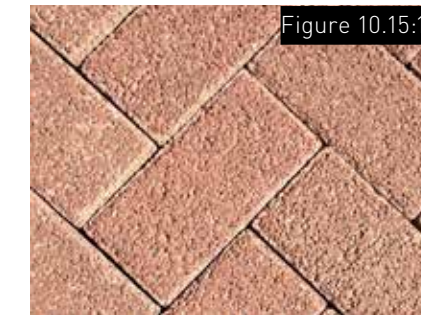
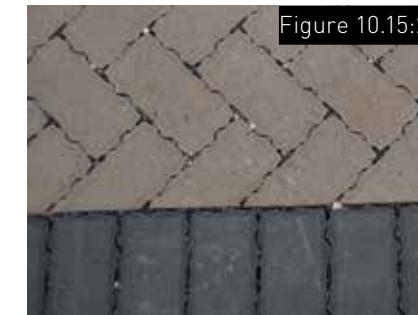
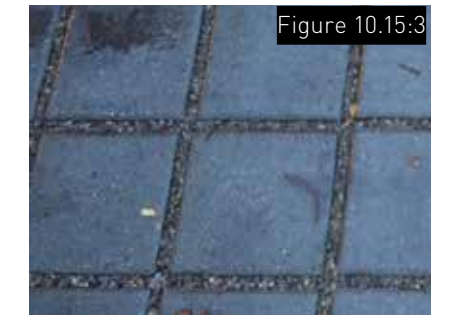
**Typical Permeable Pavement Structure:**

Figure 10.14 Typical permeable pavement structure. Drawing: Multiconsult AS.

There are several types of permeable pavement typically used in Europe, including concrete pavers with wide joints or apertures, and porous concrete pavers, either with or without wide joints. These are usually manufactured as blocks and are generally referred to as permeable concrete interlocking pavers (PICP). Concrete and plastic grid pavers (CGP and PGP) are also often used in Europe. The design and function of CGPs and PGPs are similar to PICP; however, the surface area of the individual pavers is generally much larger than those used for PICP systems (Figs. 10.15:1-3). They also have more void spaces to promote infiltration. Stormwater is able to infiltrate through the large gaps in these pavers, which are usually filled with gravel, or topsoil planted with grass.

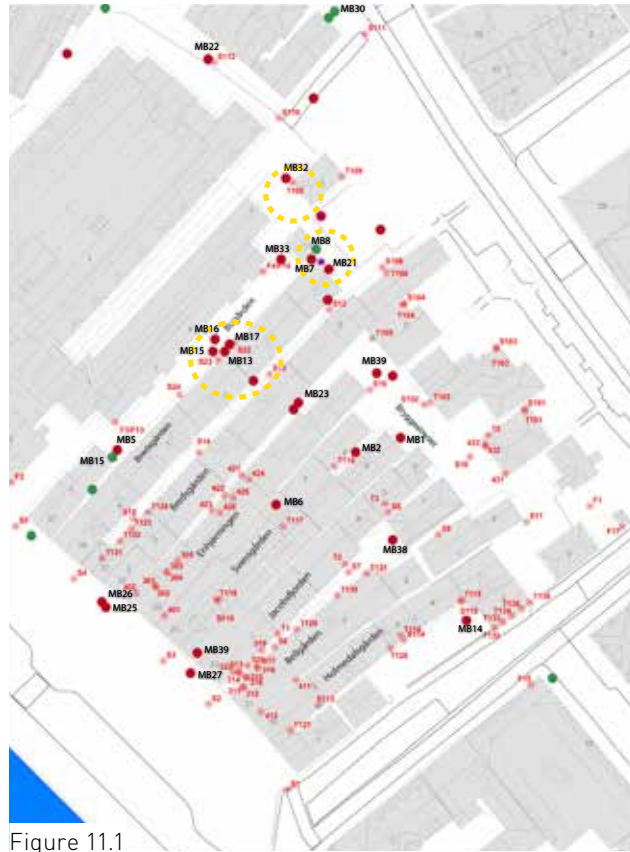
Figure 11.1 Locations of monitoring wells mentioned below are marked by yellow stippled circles.  
Map: Multiconsult AS.

We have assessed subsidence rates before and after mitigation in four areas at or near the sheet pile wall, as shown in Fig. 11.1 and 11.2 (measurement points S12, S13, S22-S24 and T108) to demonstrate the effect of the mitigation.

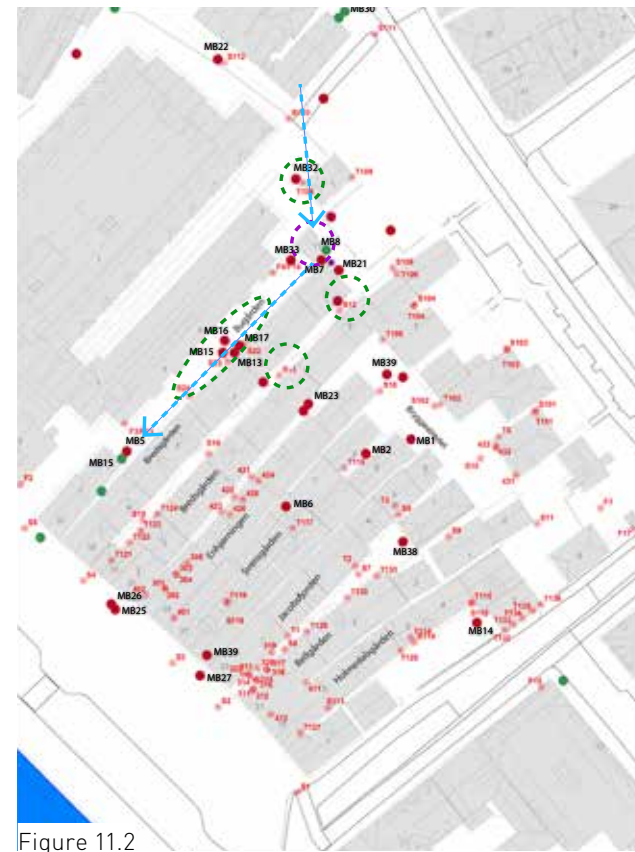
Figure 11.2 Green stippled ellipse and circles show the subsidence measurement points mentioned below. Lilac circle marks the division between the upper and lower parts of the I/T-system. Blue arrows show roughly the location of the I/T-ditch and the direction of infiltration water running in the pipe. The I/T-ditch runs not far from the surface along the outside of the sheet piling.  
Map: Multiconsult AS.

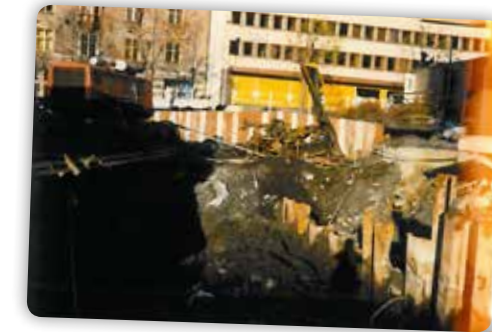
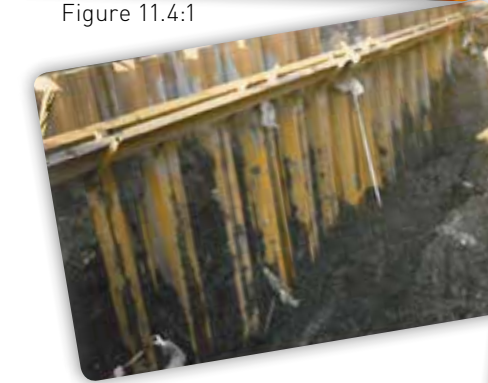
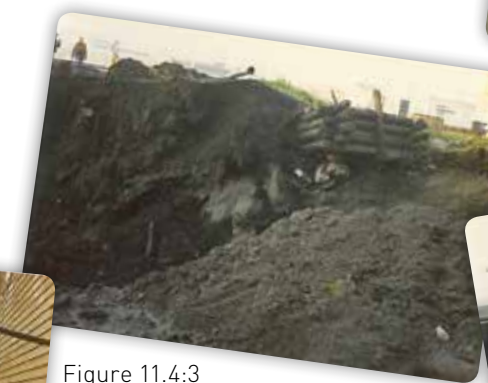
Figure 11.4:1-3 Archaeological deposits (disturbed) and wooden foundations over deposits of sand and gravel (seabed layers) during excavation for sheet piling installation in 1979. The groundwater level had then been artificially lowered by pumping inside the excavation area.  
Photo: Noteby AS.

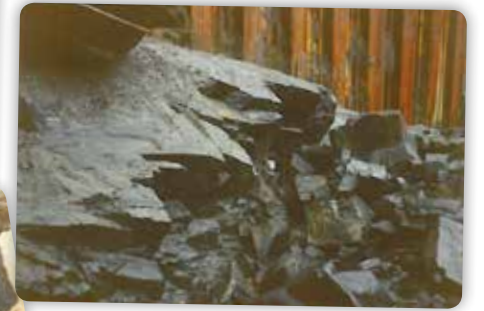
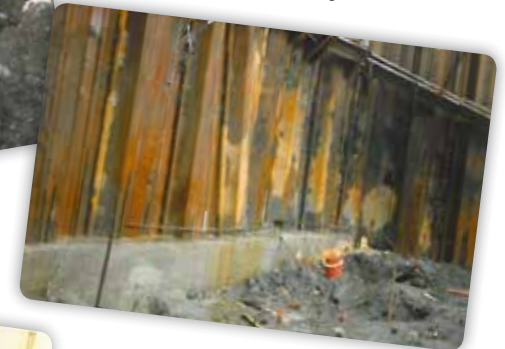
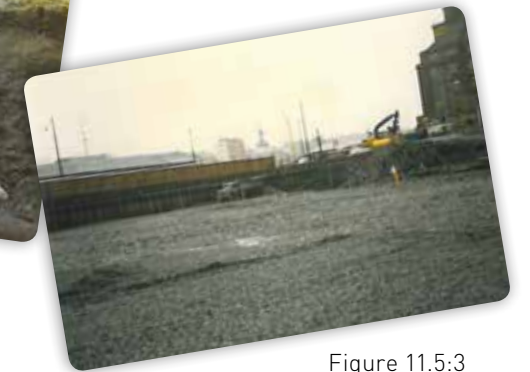
Figure 11.5:1-3 Shows sub-grade blasted bedrock below sheet piling at Schøtstuene. Fig.11.5:2 in-situ bedrock before blasting at «Meyers Steinkjeller» (point T108) and signs of water penetration through the wall. Fig.11.5:3 (bottom) shows filled and compacted bottom of excavation area. Fill consists of permeable crushed stone.  
Photo: Noteby AS.

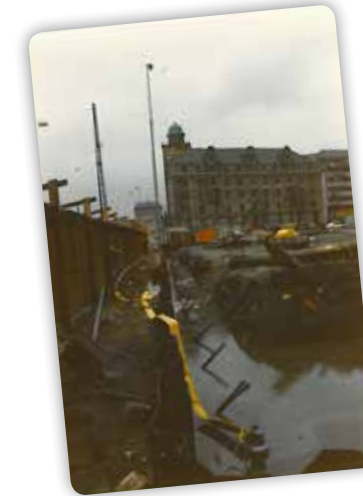
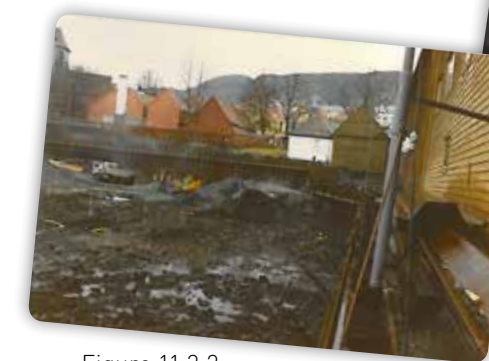
Figure 11.3:1-2 Sheet piling alongside Bugården/Bredsgården. Transition to sub-grade blasted bedrock is below wooden building (by the point S107 at «Bugårdens ildhus», transition between upper and lower part of the I/T-system). The white building is «Meyers Steinkjeller» and the red buildings belong to the Schøtstuene complex.  
Photo: Noteby AS.

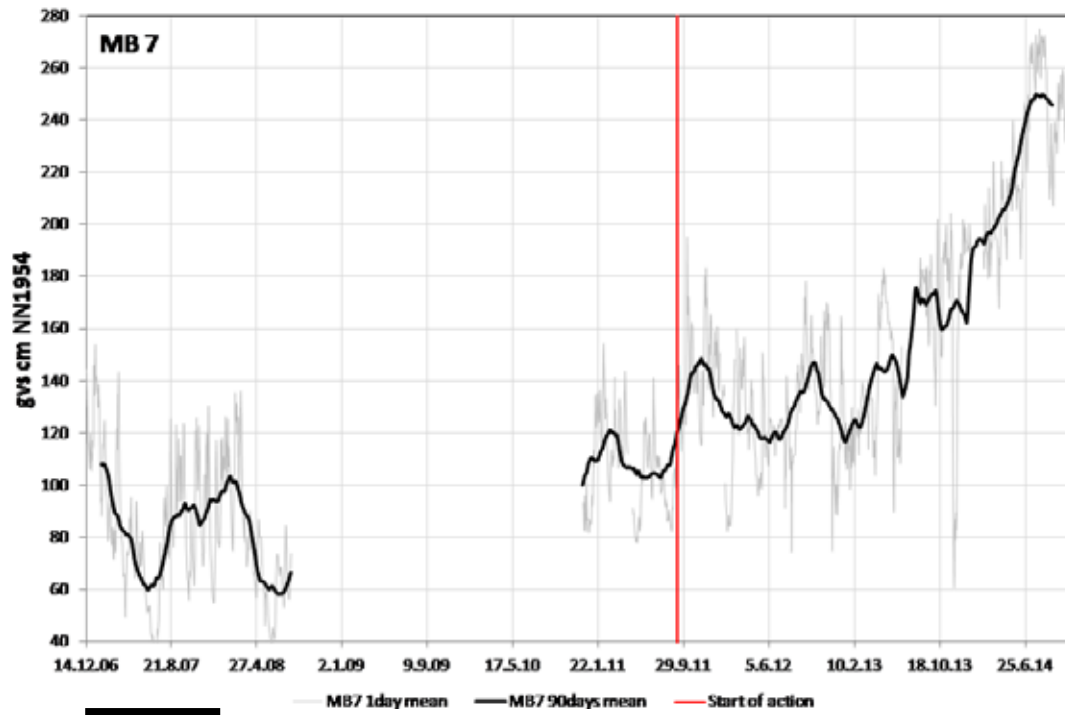
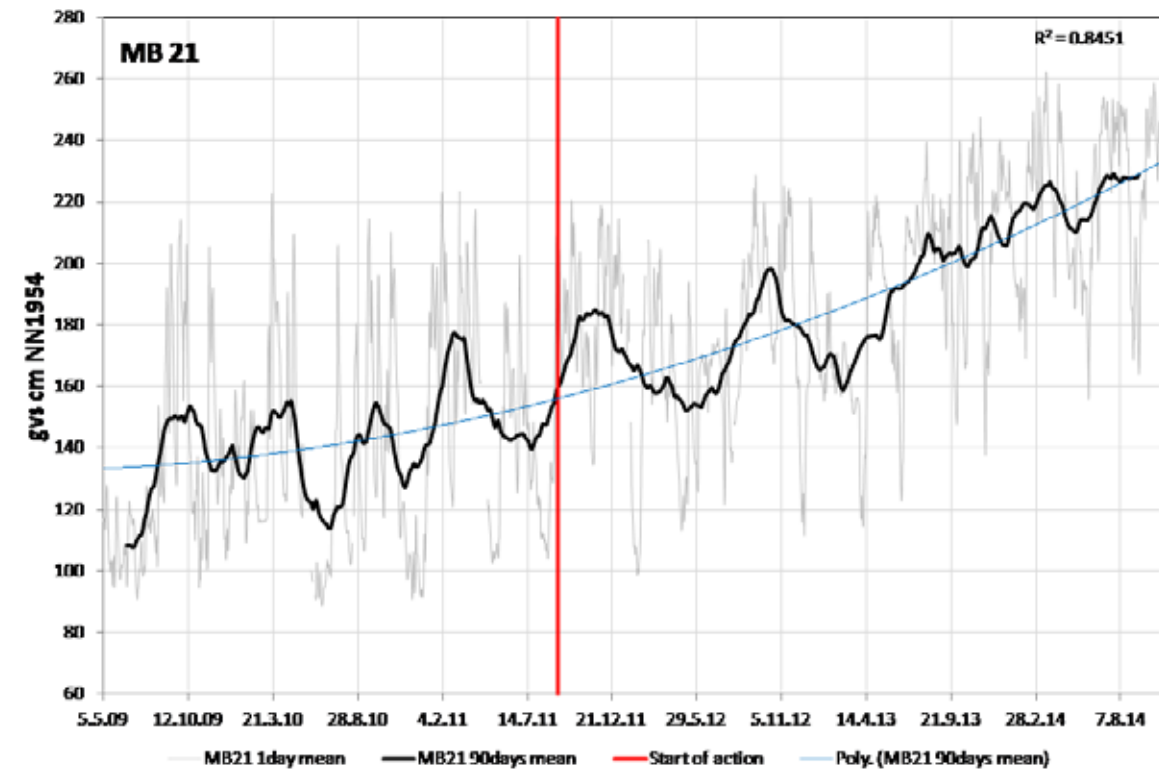
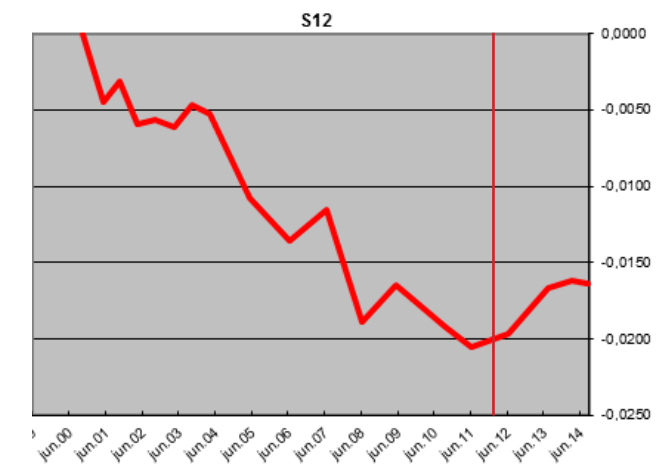
Figure 11.6:1-3 Development of subsidence at point S12 and water levels in monitoring wells MB7 and MB21 at the back of Bredsgården/Bugården. Measurement points and wells are all situated more than 10 m away from the sheet pile wall. Multiconsult AS.<sup>188</sup>

measures through infiltration were implemented nearby and downstream of monitoring wells MB7/ MB21, situated close to measurement point S12. The start-up time for water infiltration in the lower section of the I/T-system (from the manhole close to point S107 and downstream) is shown with a vertical, red line in Fig.11.6. Minor measures, like raising the groundwater

MB7 the increase was ca. 1.30 m: from ca. 1.20 m asl to ca. 2.50 m asl (ground surface at 4.2 m asl). In the same period, the subsidence at the nearby point S12 has stopped and been reversed to uplift. The point has had an uplift of 4.1 mm in the period. The uplift is most likely an elastic response to the raising of the groundwater level, and this trend will not continue. The overall aim of the project is to reduce the subsidence rate to 1.0 mm/year or less, and this has probably been achieved at this point. We see here a significant connection between the raising of the groundwater level and the reduction of subsidence at nearby measurement points.

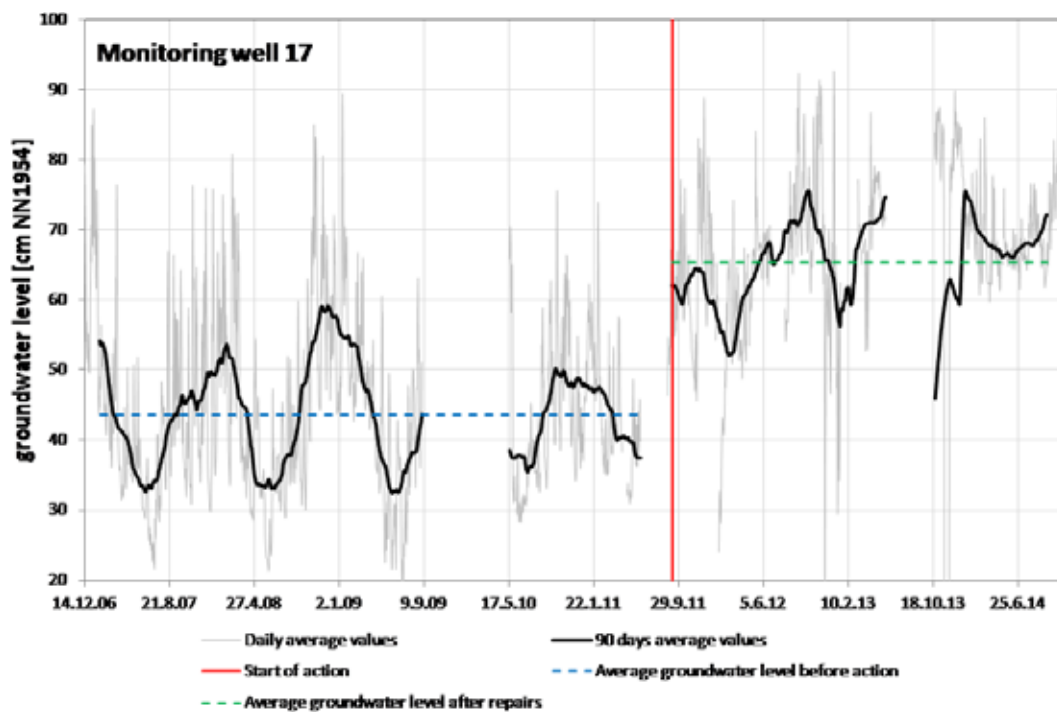
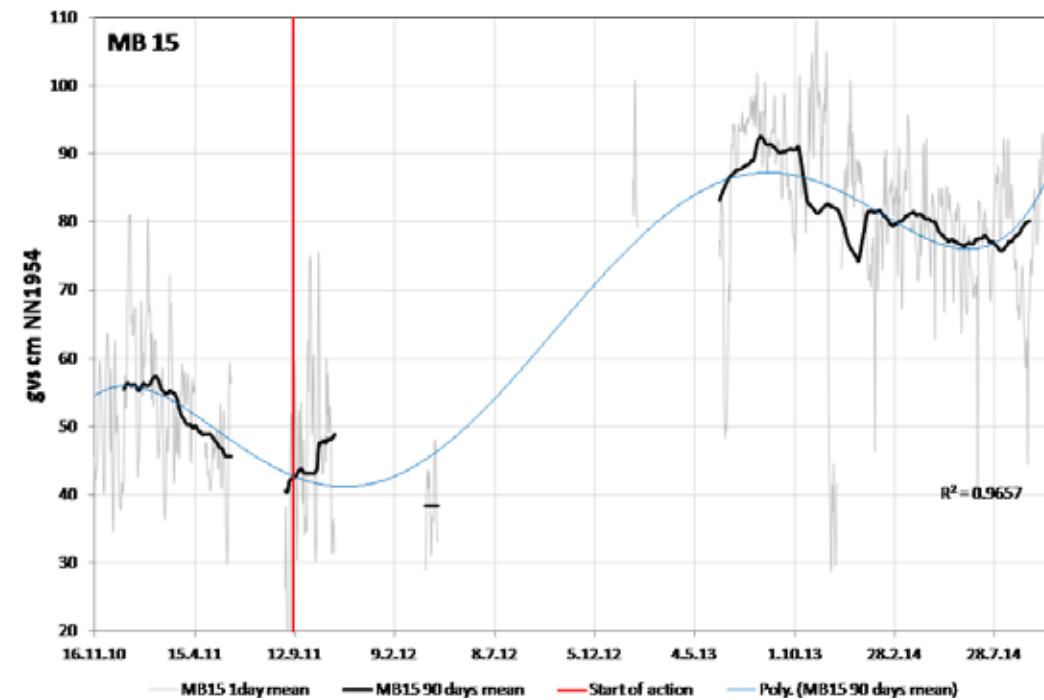
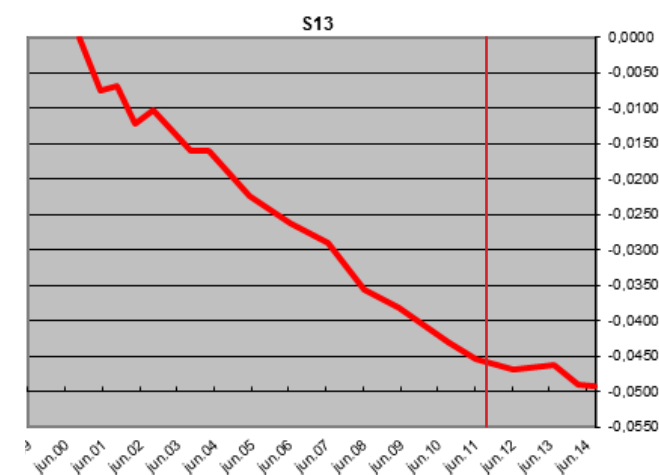
Figure 11.7:1-3 Development of subsidence at point S13 in Bredsgården and water levels in monitoring wells MB15 and MB17 in Bugården, parallel to S13 in the Bredsgården passageway. Point S13 is situated about 10 m away from the sheet piling, while the wells are situated close to the pile wall. The groundwater situation at S13 thus is probably more favourable to preservation than in the vicinity of the two wells, since the groundwater level here is probably closer to the surface. Multiconsult AS.<sup>189</sup>

In the period from October 2000 to June 2011, a total subsidence of 45.3 mm has been observed at point S13, obtained through a fairly constant subsidence rate of 4.1 mm/year. This has been the case until groundwater mitigation measures through infiltration were implemented nearby and downstream of monitoring wells MB15/MB17, situated close to measurement point S13. The start-up time for water infiltration in the lower

section of the I/T-system (from the manhole close to point S107 and downstream) is shown with a vertical, red line in Fig. 11.7. Minor measures, like raising the groundwater level by a few decimetres inside the sheet piling, and point-by-point sealing of the top of the pile wall, had been undertaken earlier, from the autumn of 2010.

In the period from June 2011 to August 2014, as shown by the water-level measurements, the average level in MB15 has risen by ca. 0.45 m: from ca. 0.45 m asl to ca. 0.90 m asl (surface at 2.1 m asl); and in MB17 the increase was ca. 0.20 m: from ca. 0.45 m asl to ca. 0.65 m asl (surface at 2.1 m asl). In the same period, the subsidence at the nearby point S13 has been considerably reduced. This is one of the points that have had the greatest amount of

subsidence in all of Bryggen before the implementation of groundwater measures. After the implementation of such measures (June 2011 to August 2014), it has had a total subsidence of 3.8 mm, which equals a subsidence rate of 1.27 mm/year. The aim of the project is to reduce the subsidence rate to 1.0 mm/year or less, and this has nearly been achieved in this point. The groundwater level at this point, S13, is probably closer to the surface than it is in the two monitoring wells lying close to the sheet piling. Thus, the aim of a groundwater level ca. 1.0 m below surface could be nearly achieved here.
