MONITORING  
MITIGATION  
MANAGEMENT

THE GROUNDWATER PROJECT - SAFEGUARDING THE  
WORLD HERITAGE SITE OF BRYGGEN IN BERGEN

## RIKSANTIKVAREN 2015

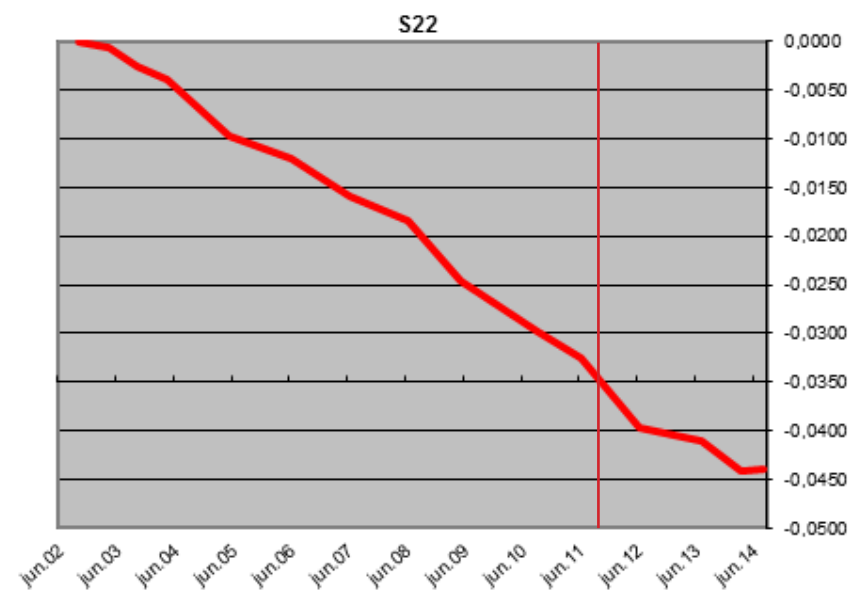
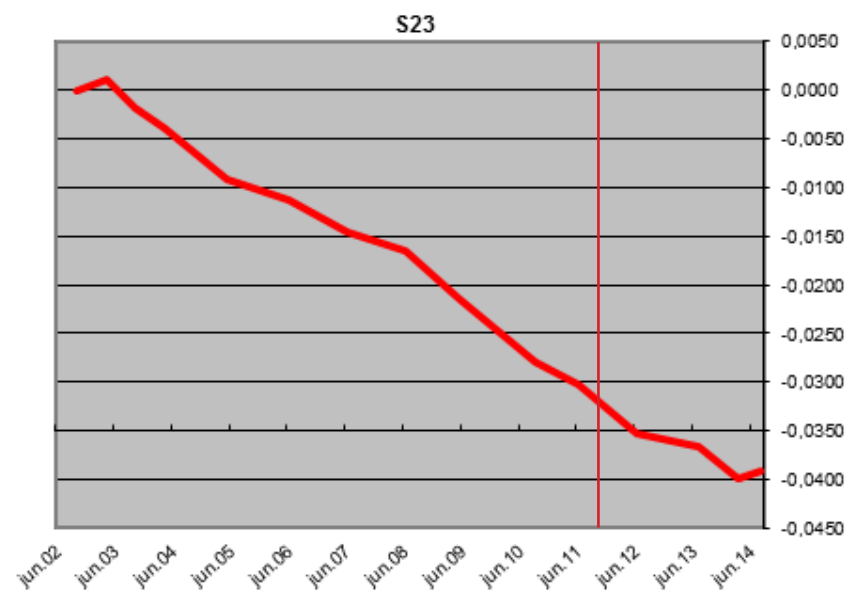
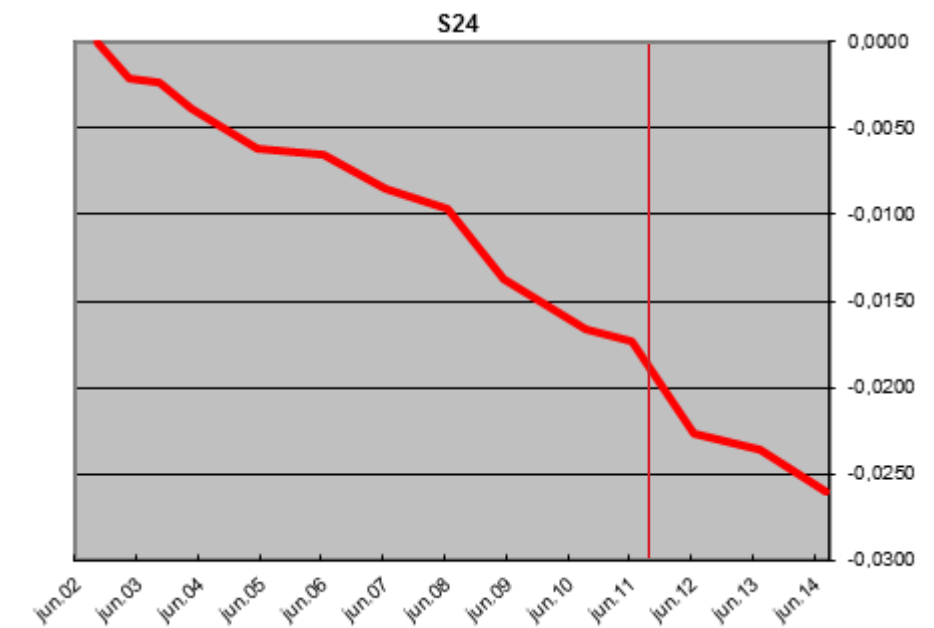
Figure 11.8:1-3 Development of subsidence at points S22, S23 and S24 in Bugården close to and below monitoring wells MB15 and MB17 in Bugården, parallel to S13 in the Bredsgården passageway. Both the wells and the measurement points are situated right outside the sheet piling. Multiconsult AS.<sup>190</sup>

monitoring wells MB15 and MB17, one has observed a total subsidence of 32.3 mm, 30.3 mm and 17.3 mm respectively, obtained through fairly constant subsidence rates of 3.6 mm/year, 3.4 mm/year and 1.9 mm/year respectively. This has been the case until considerable groundwater mitigation measures through infiltration were implemented nearby and upstream and downstream of the three measurement points. The start-up time for water infiltration is shown with a vertical, red line in Fig. 11.8.

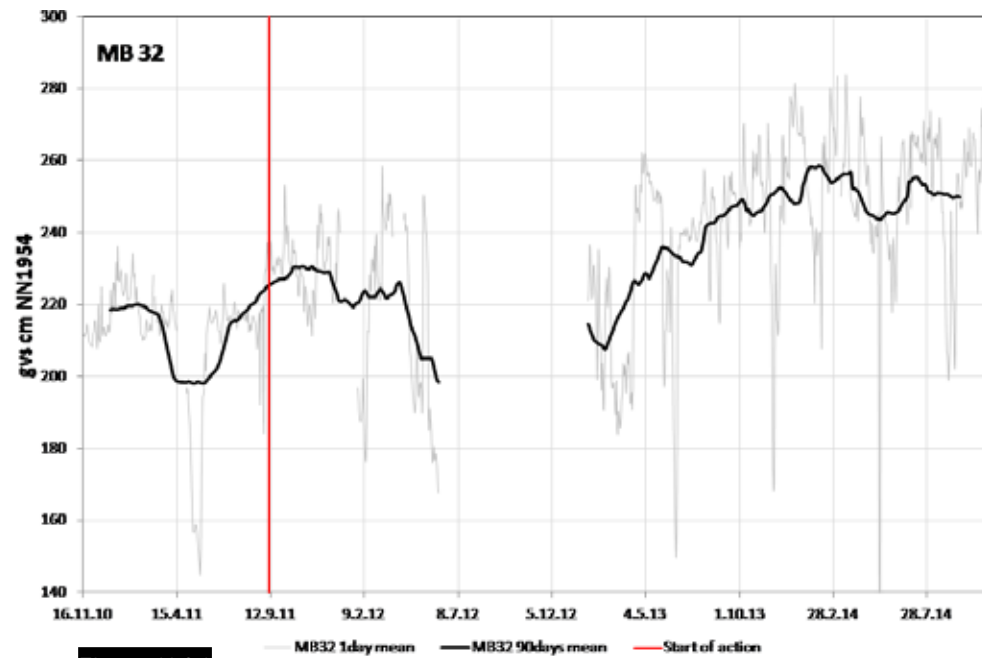
Figure 11.9:1

Figure 11.9:1-2 Development of subsidence at point T108 in the building «Meyers steinkjeller» and water levels in monitoring well MB32 nearby. Both the well and the measurement point are situated right outside the sheet piling in the lower part of the upper section of the I/T-system. Multiconsult AS.<sup>191</sup>

In the period from September 2010 to July 2013, in point T108, one has observed total subsidence of 3.5 mm, giving a subsidence rate of 1.2 mm/year. This point is located by the lower part of the upper section of the I/T-system, which has been supplied with water since the spring of 2014. Simultaneously, water has been fed to the rainwater gardens upstream of this area since June 2014.

I/T-system are shown with a red, vertical line and a green, stippled vertical line respectively in Fig. 11.9.

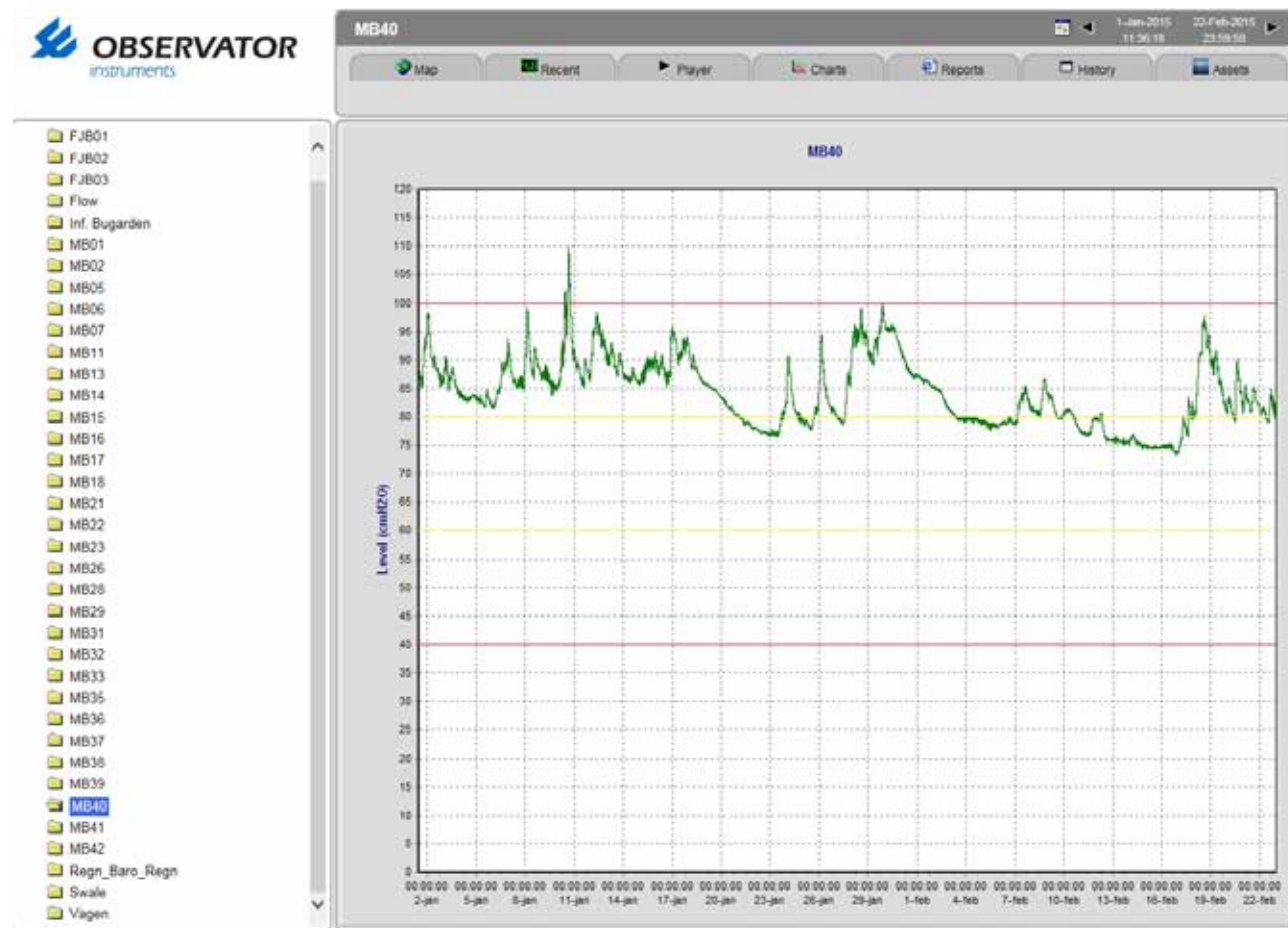
Figure 12.4 An example of the online data presentation. Illustration: NGU.

The above controls are being carried out by automatic steering with pressure sensors in the infiltration system and in the harbour, connected to an electronic warning system. In addition, pressure sensors in selected groundwater monitoring wells are connected to the warning system (see p.173). The groundwater pumps and electronic steering system will need regular technical maintenance.

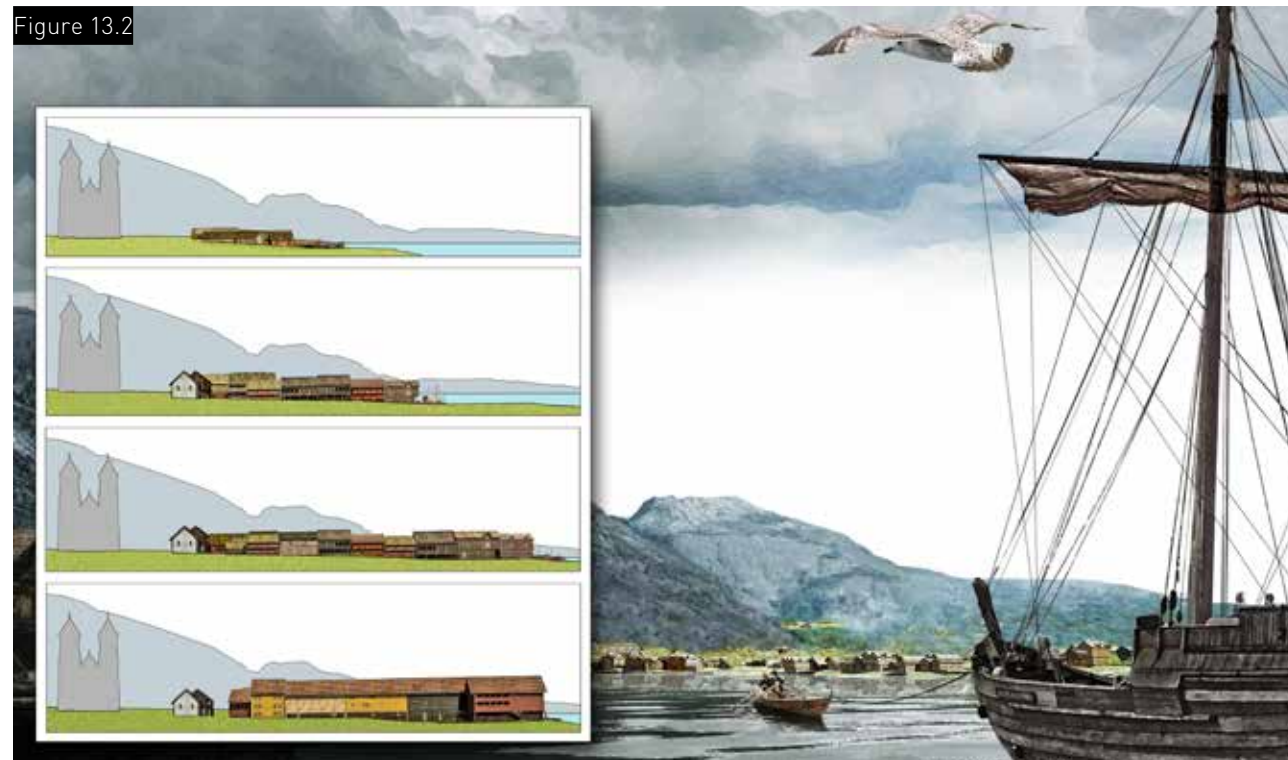
Figure 13.2 Schematic representation of stages of Bryggen's development, with background panorama. Drawing: T. Sponga, © Riksantikvaren.

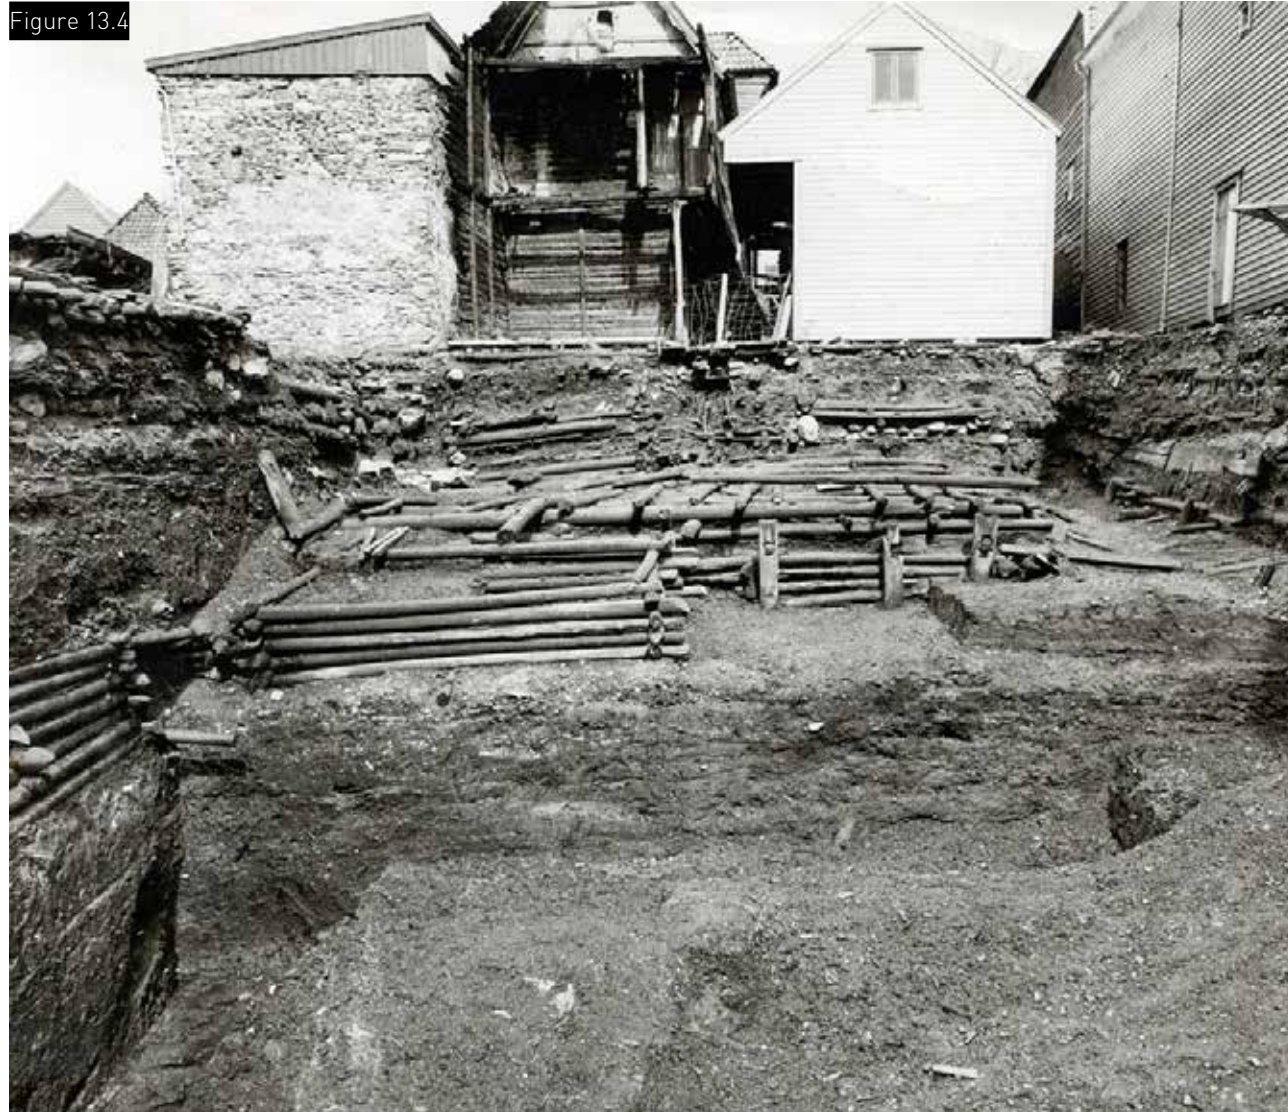
Figure 13.4 Buildings erected after the 1702 fire on top of metres-thick organic archaeological deposits. Photo: Universitetsmuseet i Bergen.
