“Revitalisation of the Giorgi Chitaia Open Air Museum of Ethnography”

The Final Report to RIKSANTIKVAREN

Institution: Georgian National Museum

MAY, 2012

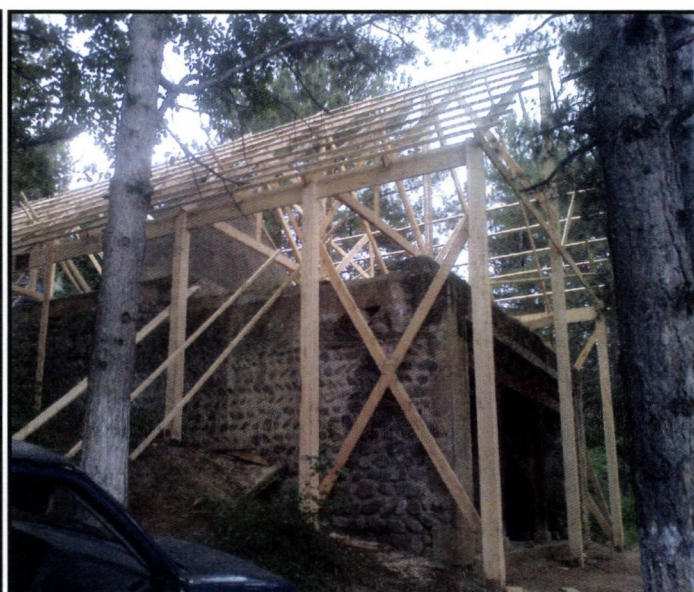
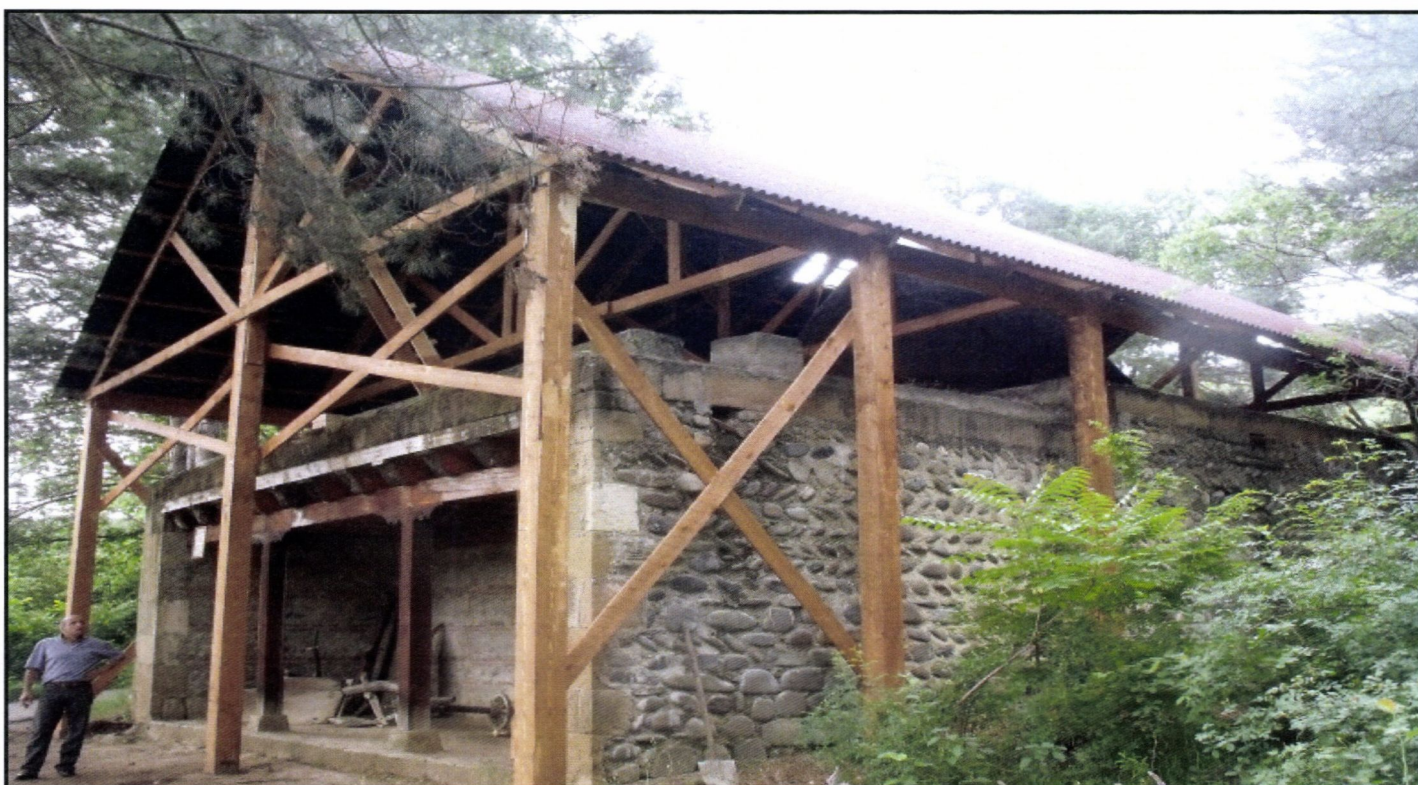
The original roofing of the building was damaged through influence of atmospheric precipitation, on account of what water flowing on the walls and penetration in the house was a big problem for the "Kartlis Darbazi".

Before starting practical works proper technical documentation has been prepared including architectural and structural parts, subsequently, according to local legislation was organized tender for constructing the temporary roofing. Because of the tender was not successful for several times the donor was asked for permission to allocate funds from another activity of the project (where we had reduction of prices while tender process), eventually, practical works have been started and were completed for the end of June. As result, the house is carried out from further effecting of atmospheric precipitation. Should be underlined that functionally, as exposition, the “Kartlis Darbazi” is not be closed and visitors are welcomed to visit the house as it happened before arranging the roofing.

Following to technical professionals' consideration, before the feasibility of the building's reconstruction by foreseen all authentic elements, it was advisable to arrange temporary roofing

for the house, in order to stop flowing of atmospheric precipitation through the roofing and walls.

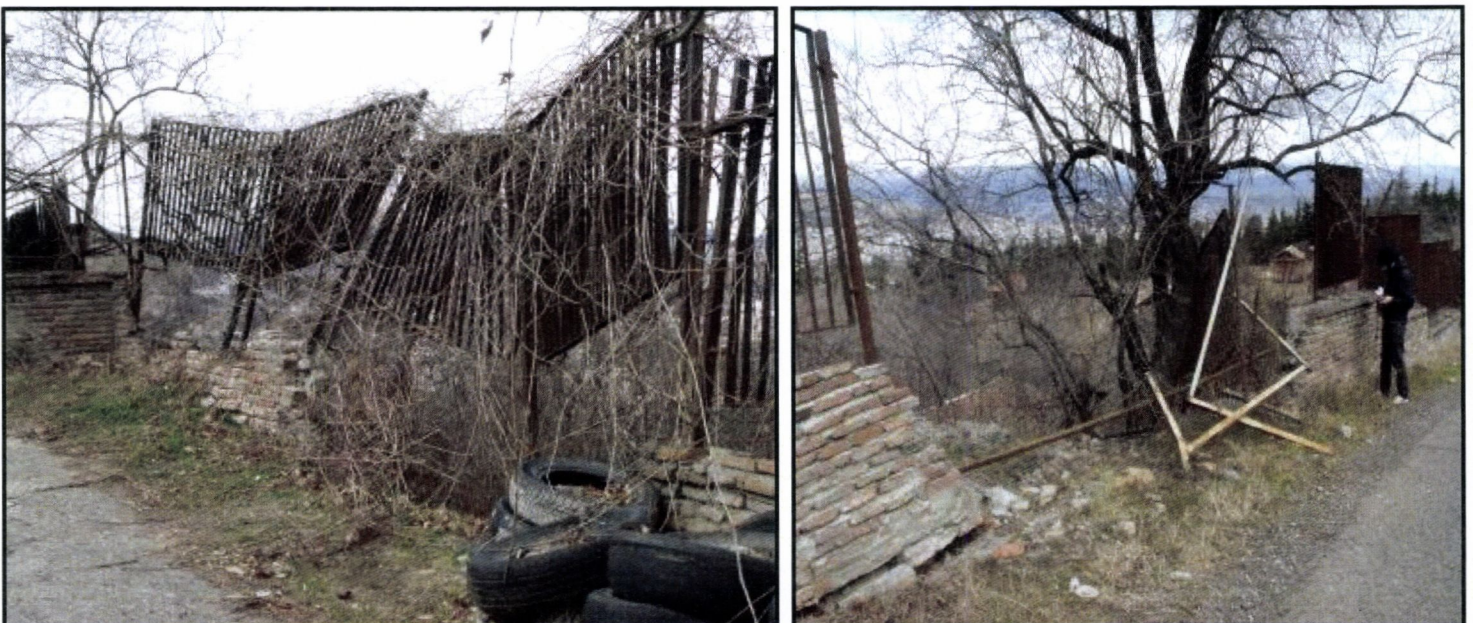
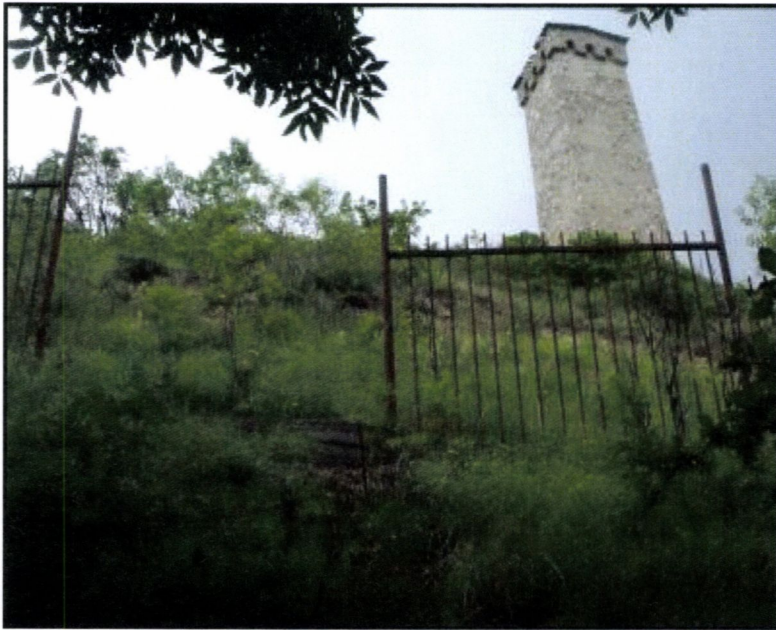
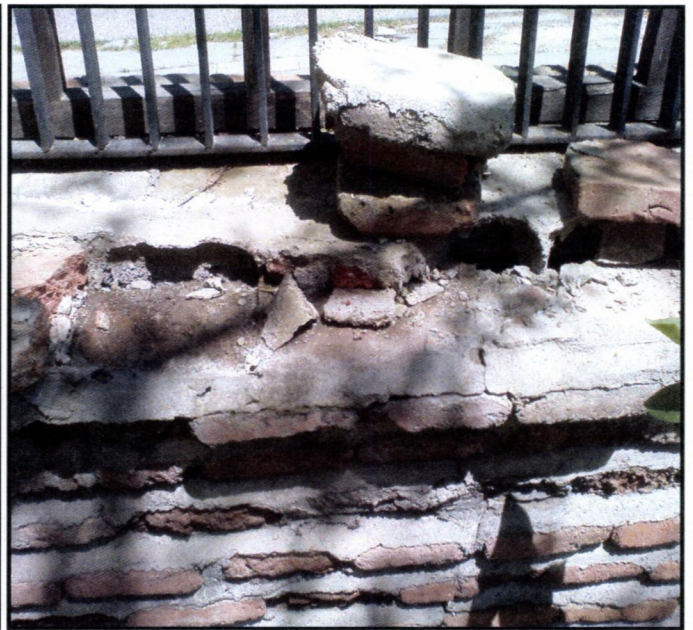
BEFORE RECONSTRUCTION:

The museum has been enclosed with such type of fence in 70th of the past century, part of which was damaged and destroyed in due course. Some sections (with brick walls) of the fence is nearby to the highway what could be considered one of the reasons (auto crashes) of its damage, besides through flowing atmospheric precipitation the metal fence foundations where ruined, and some sections of metal construction were diminished.

- Reconstruction of concrete foundations by necessity as along to the highway as in hardly accessible sections.
- Rehabilitation of brick walls
- Welding of diminished sections as along to the highway as in hardly accessible sections.
- Treatment of reconstructing fence with corrosion preventing material.

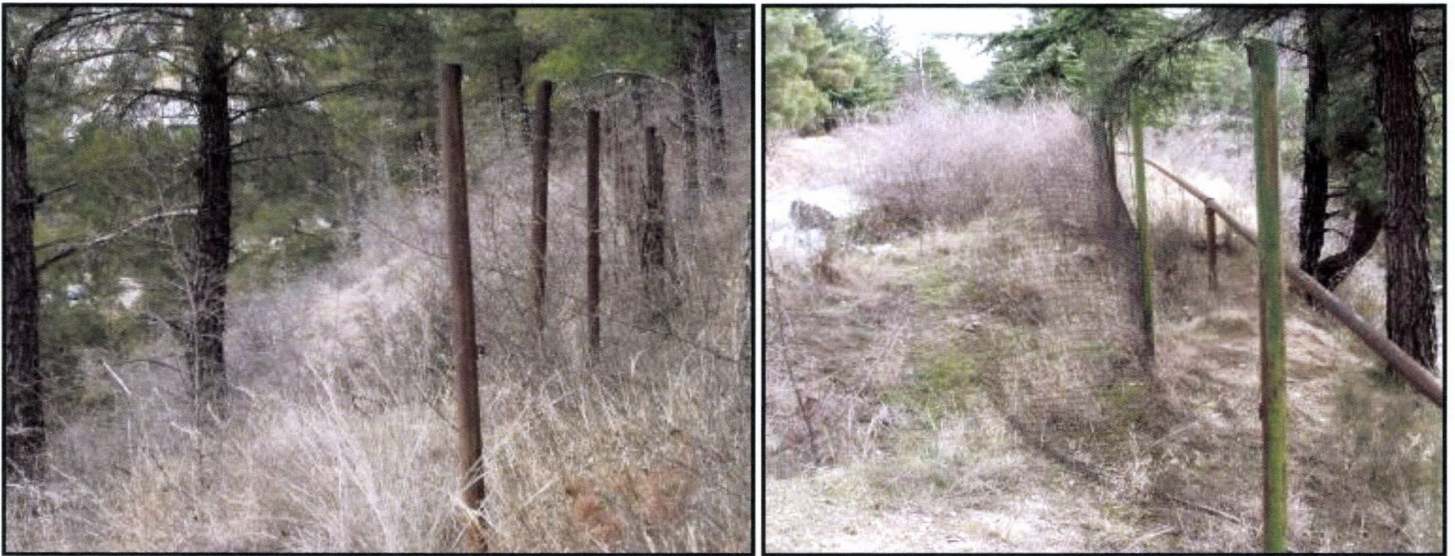
BEFORE RECONSTRUCTION:

Several sections of the grid-based fence enclosed around big part of the museum were damaged and most of such type fence has been diminished in due course. Subsequently the Museum’s territory was opened for animals and people who used to use it as short road to several directions.

As result of the organized tender the damaged sections of the fence have been reconstructed. Part of the fence sections was equipped with new fixing pipes with concrete foundations.

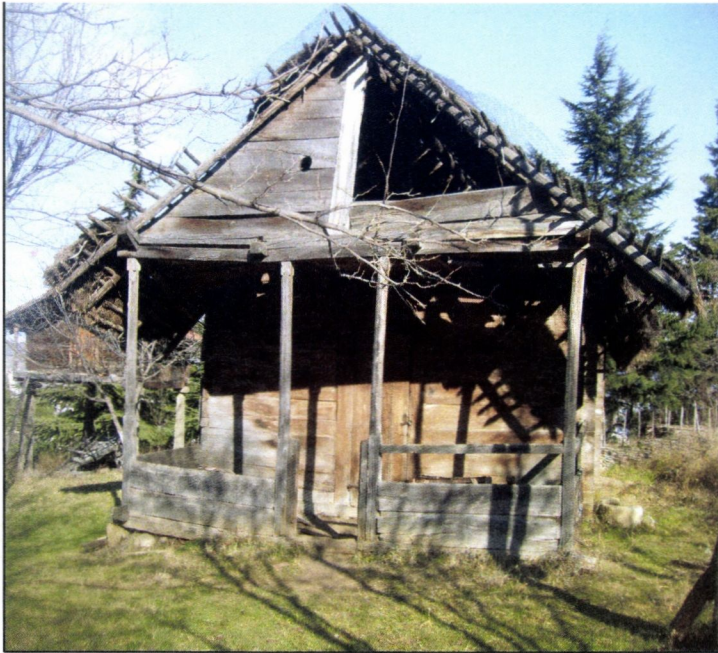
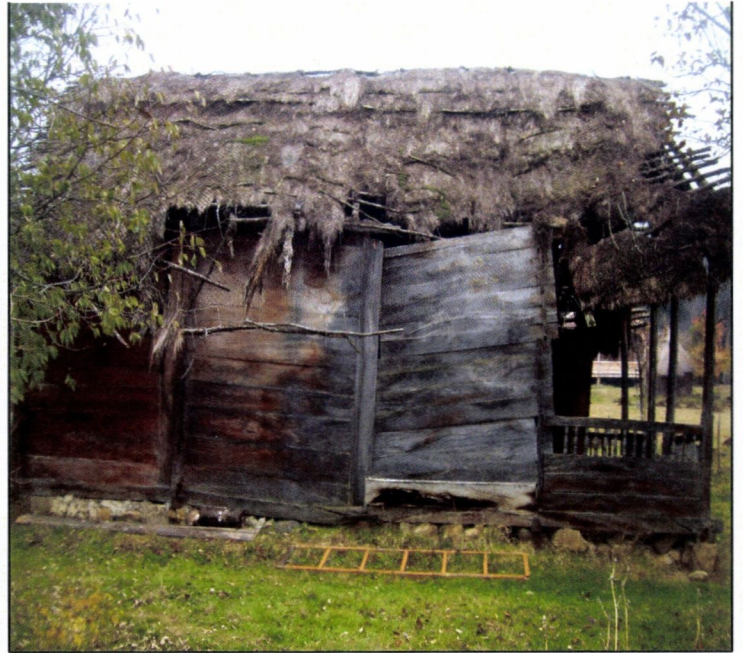
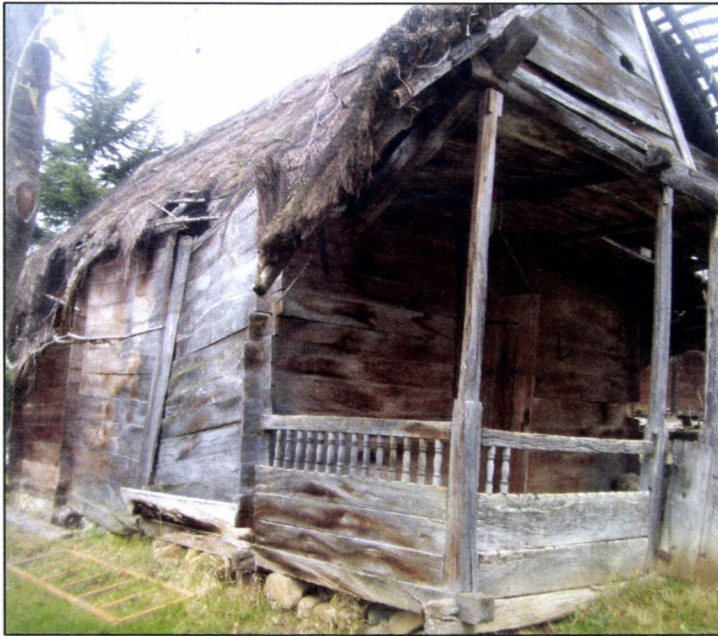
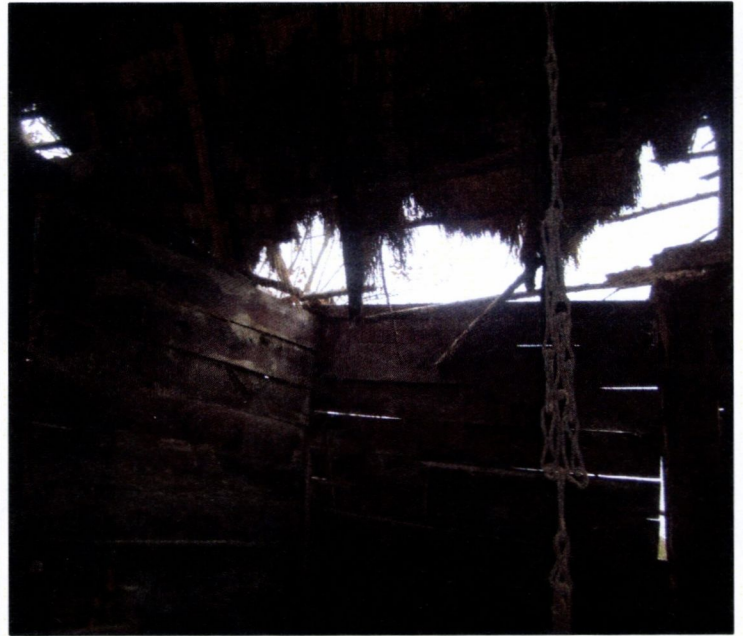
The structure and walls of the house were deformed so that they could collapse at any time. The roofing was entirely rotten, through which the building was effected by atmospheric precipitations. The sedge cover was thoroughly damaged too. Situation gradually was worsening.

The Nigvziani House before reconstruction

- Full dismantling of the damaged buildings
- Arranging stone foundation by foreseen of replacing cracked stone with new material.
- Full replacing of all holder wooden logs, pillars and griddles.
- Restoration of the doors (by foreseen of replacing lost or damaged details of wooden and metal sections).
- Restoration of walls (by foreseen of replacing lost or damaged wooden sections).
- Restoring of the balconies (by foreseen of replacing lost or damaged wooden sections).
- Full replacing of the roofs (including the sedges).

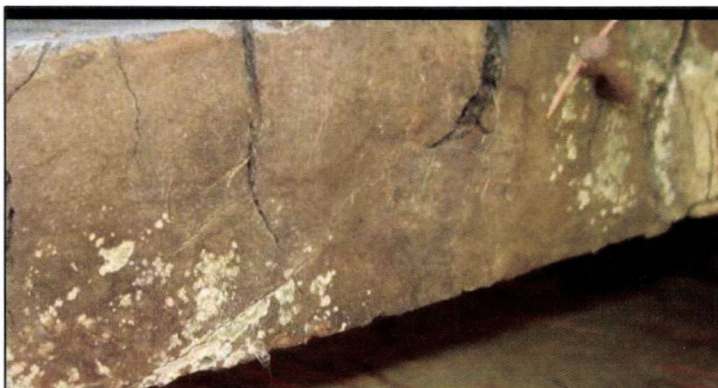
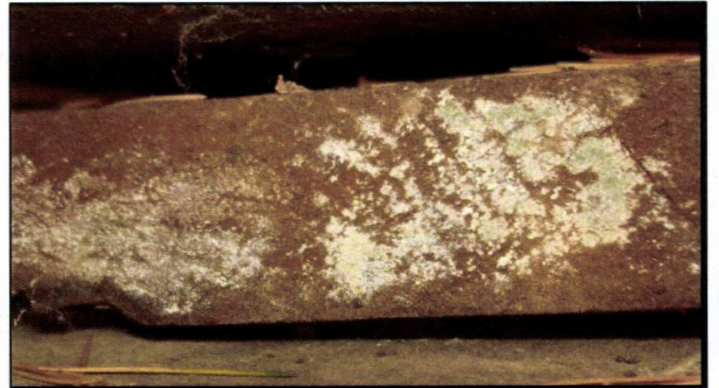
Besides, on some sections of the house fungous damages, mould and worms were designated.

Example of the bio-deteriorated boards

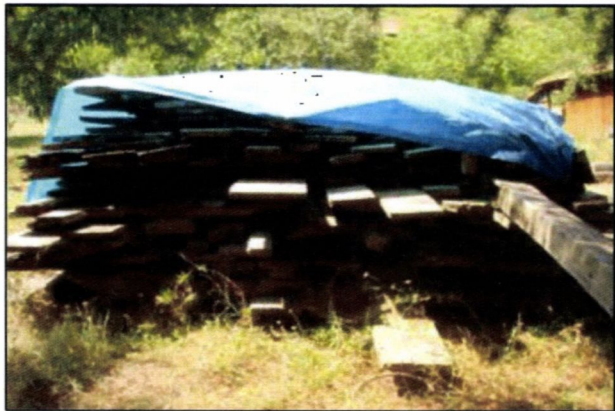
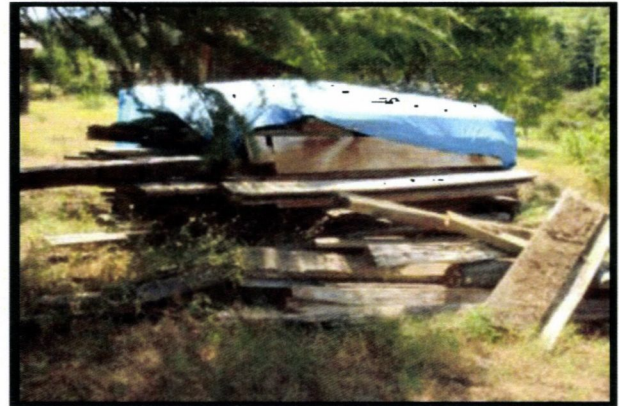
1. The timber with better condition, which could have been used again during restoration process.
2. The timber which needed special actions of restoration before reusing again.
3. The timber which was in critical condition and was not reusable again and should have been changed with new timber.

Usable and restorable authentic timber of the Nigvziani house

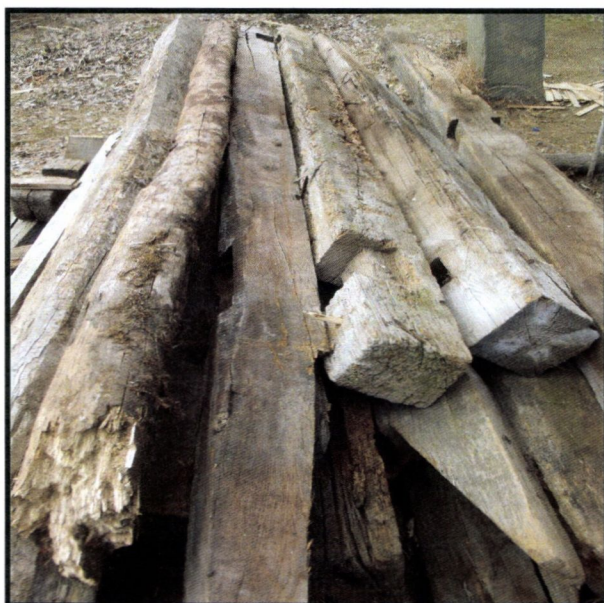
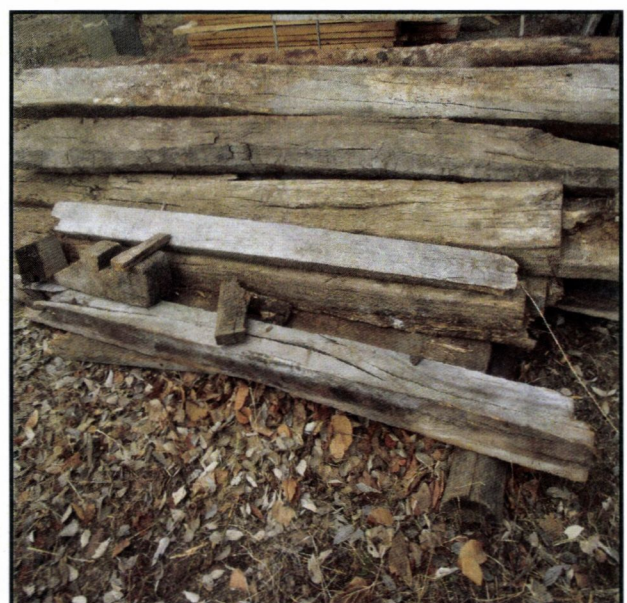
Sample of unusable authentic timber of the Nigvziani house

Following the technical specifications prepared by architects new timber was purchased to replace authentic unusable and lost timber for both of the houses.

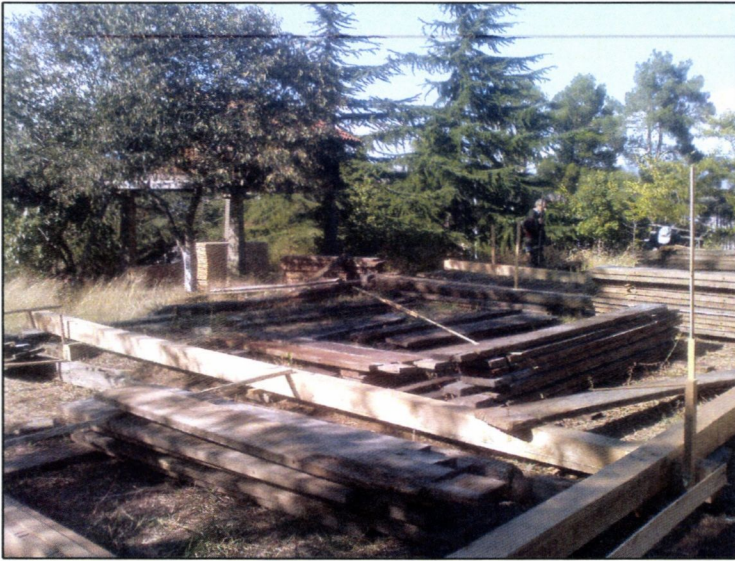
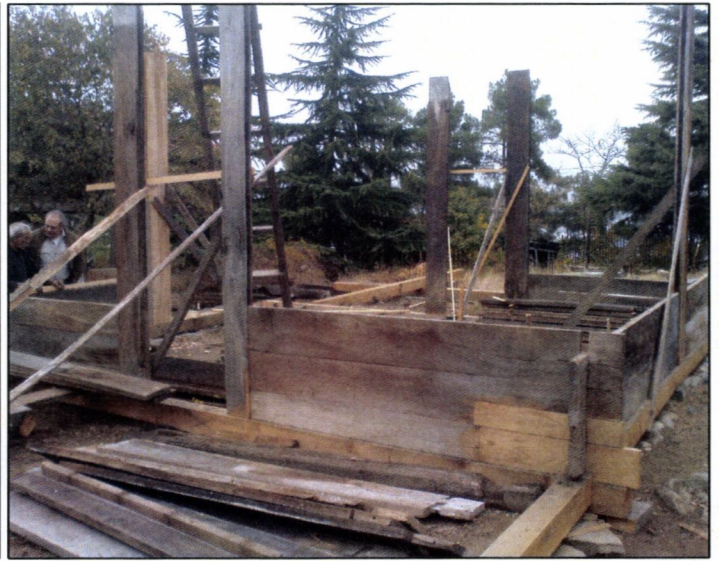
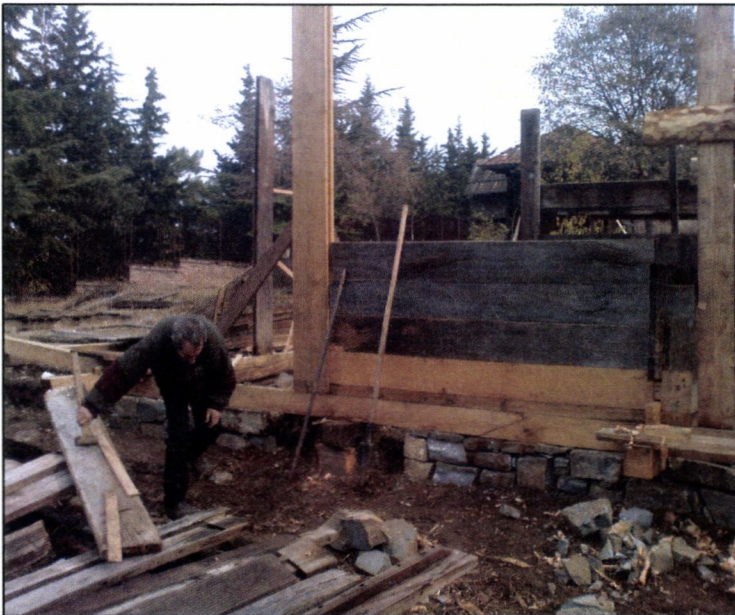
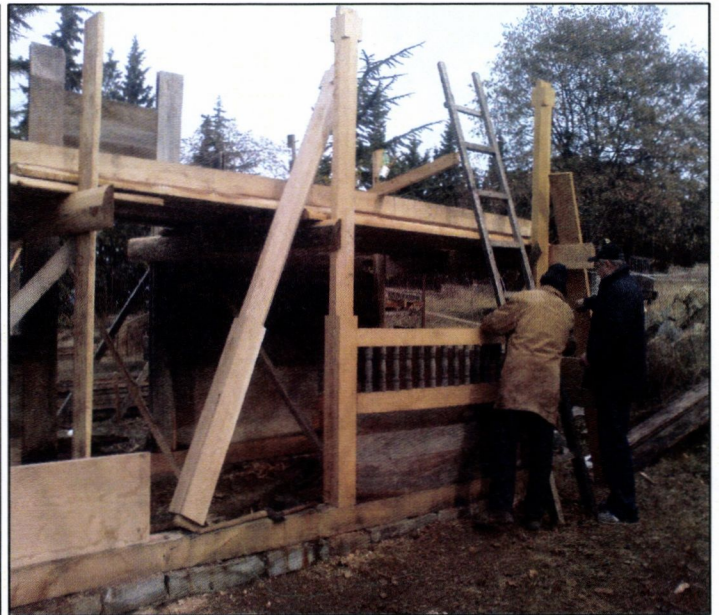
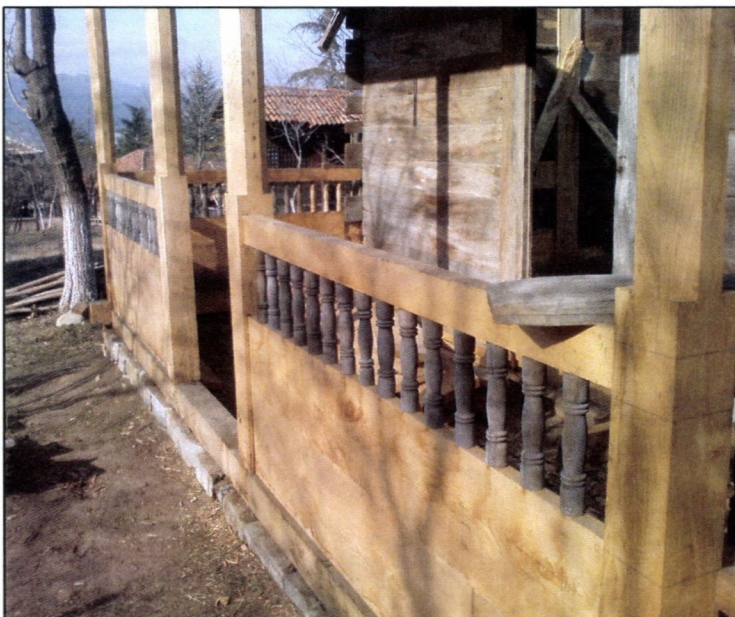
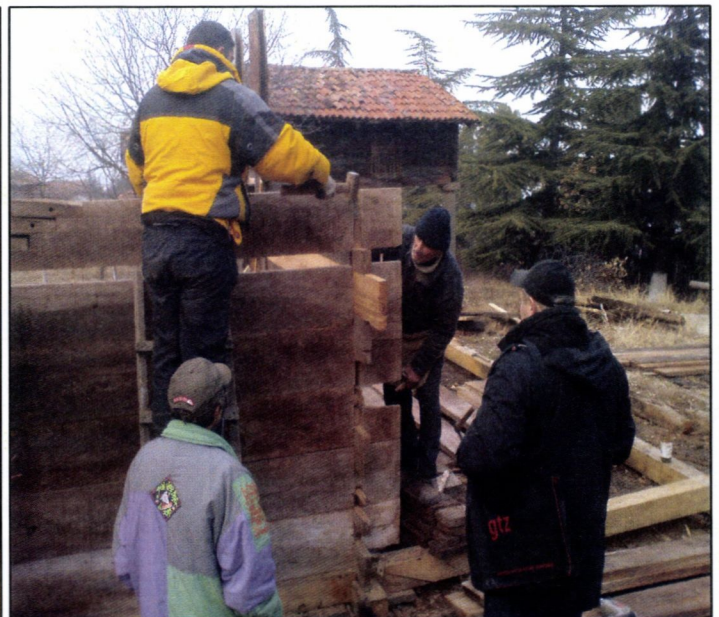
Restoring the Nigyziani house (Photos):

Thusly, after tender procedures and purchasing materials practical works on restoration has been started with works on Nigvziani house. First phase of the works started with establishing foundation and arranging wooden carcass together with cliff boulders.

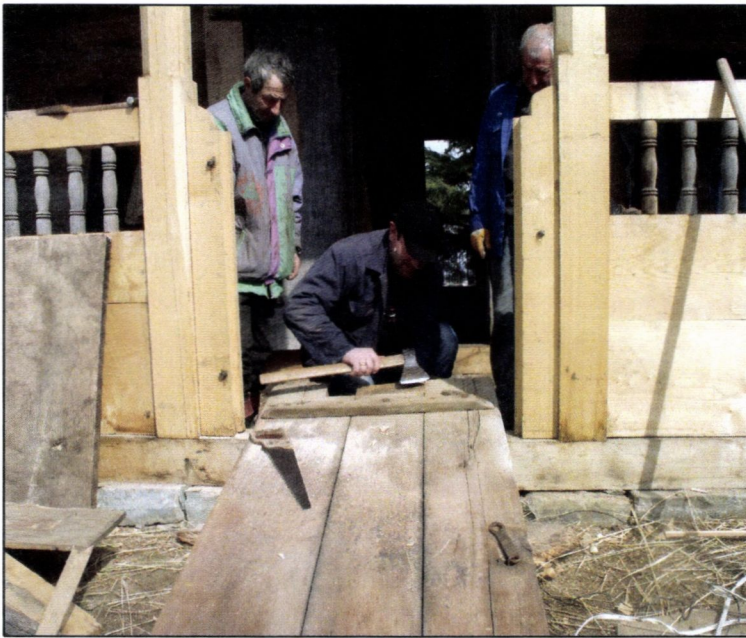
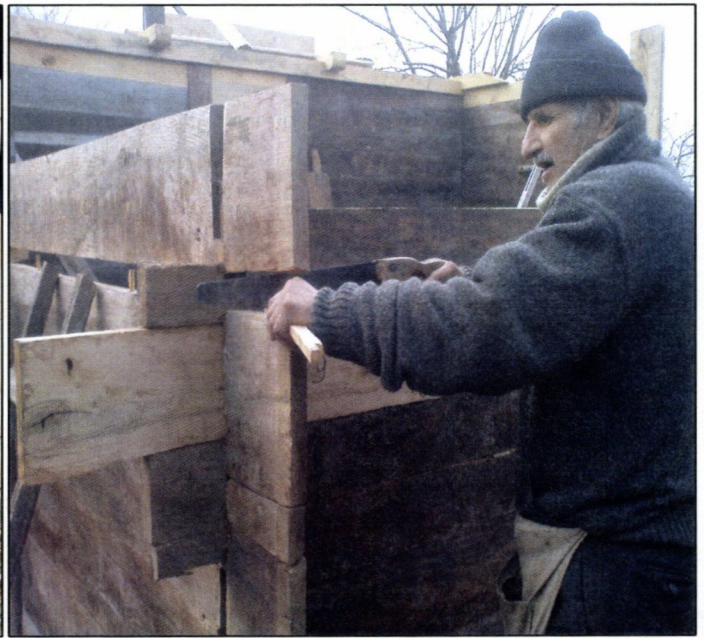
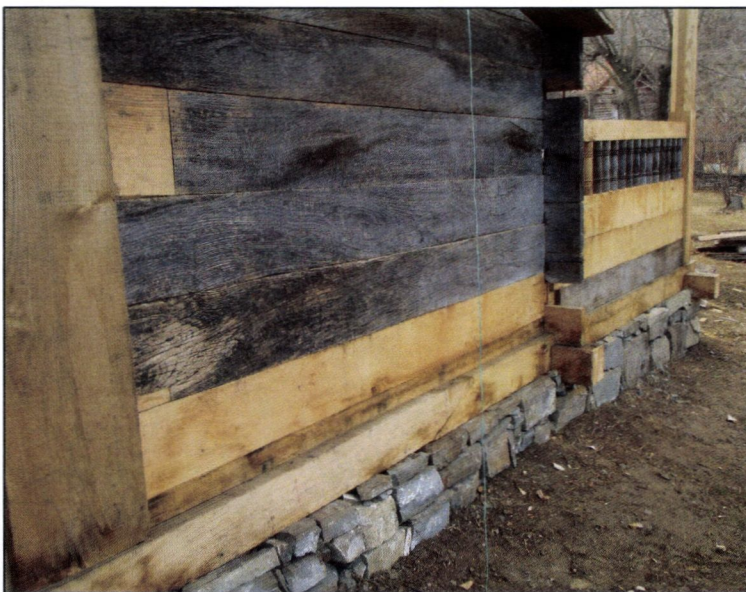
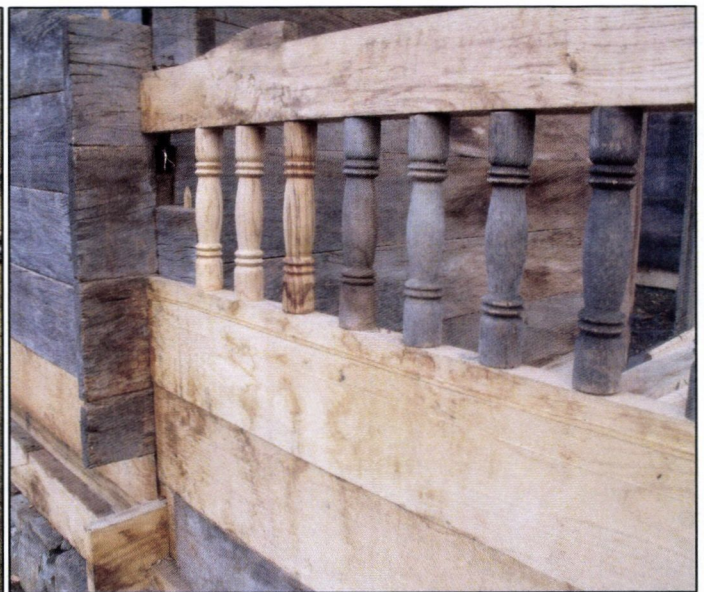
It shall be highlighted that as the exposition houses are originals and not copies, architects, ethnographers and carpenters were trying to use old authentic materials as much as possible if they were not rotten. Such material was basically wall boards, respectively reused authentic material was that wall boards. In case if those boards had small rotten parts, carpenter-restorer was restoring them through “prosthesis”.

Mixing authentic and new timber on Nigvziani house

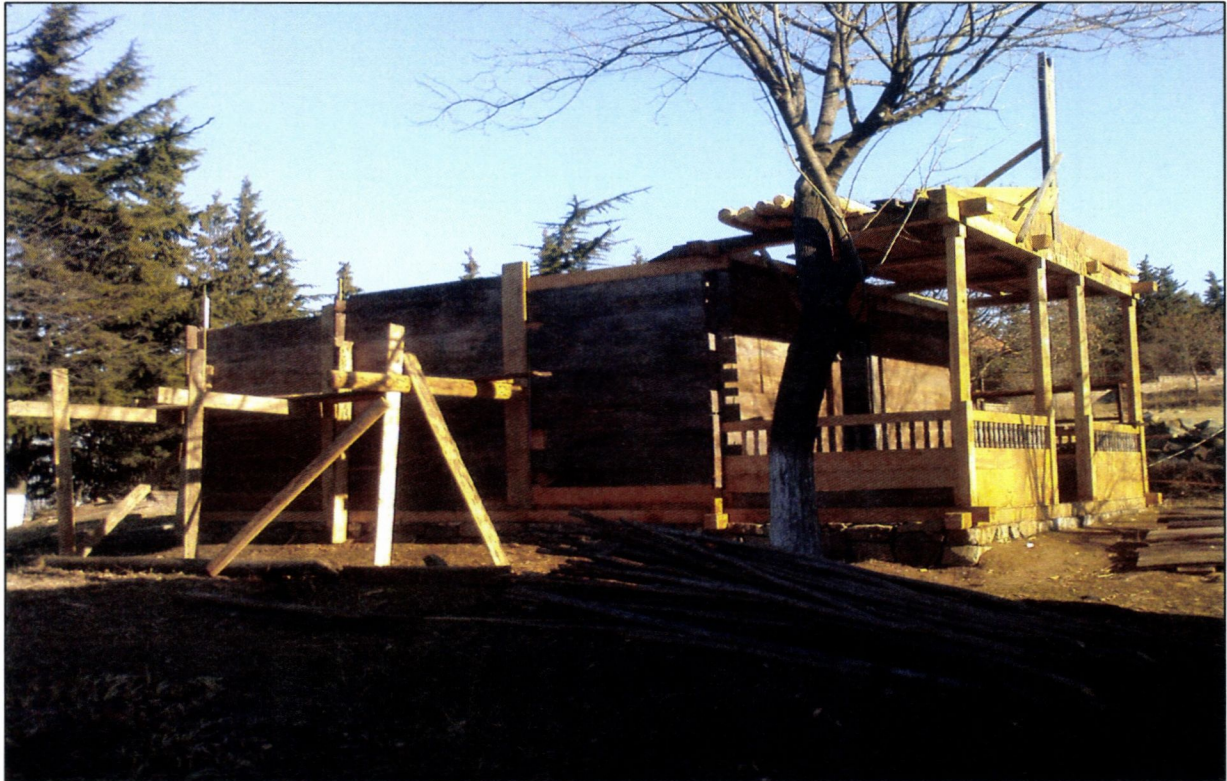
Nigvziani House before starting the roofing works

One of the most important phases during restoration process was roofing arrangement for the houses. As mentioned, they were thoroughly put out of action. Trusses, lathes and main wooden logs were entirely replaced with new timber. The sedge was replaced as well.

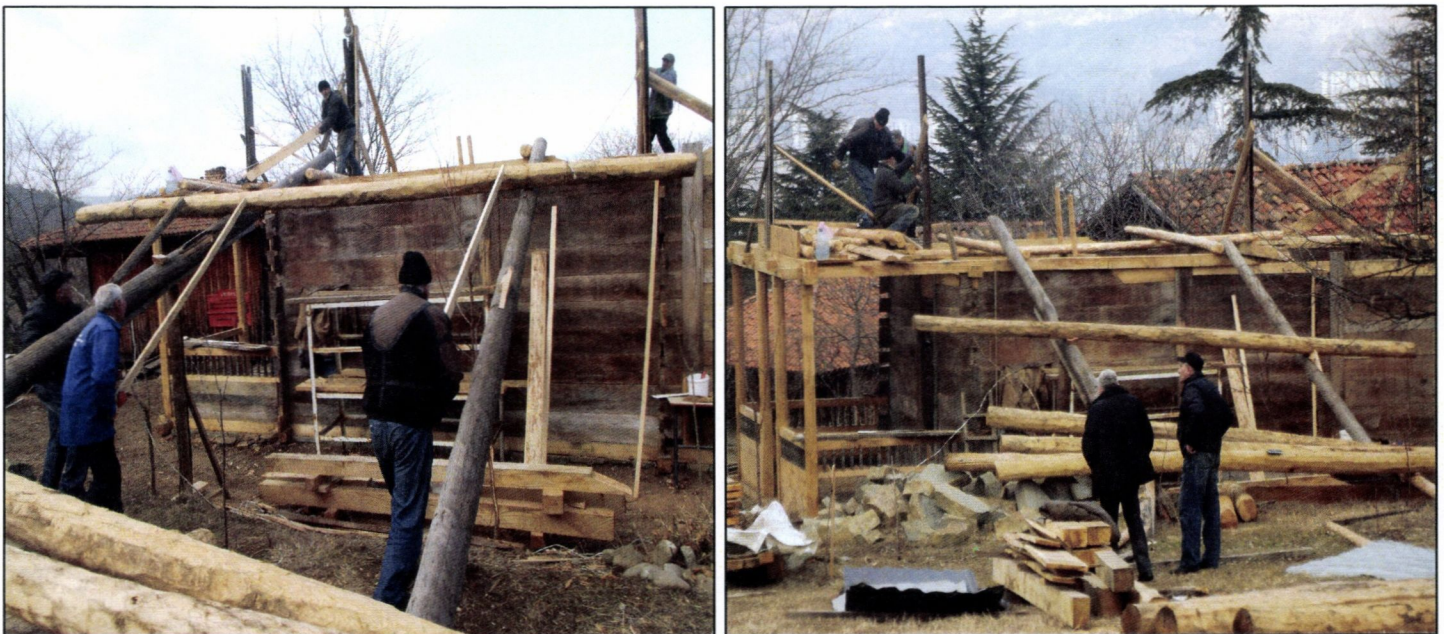
Should be pointed out that carpenters and workers lifted heavy wooden logs on the top of the buildings not by crane but according to traditional way of holding such type of work, which implies placing big logs on the roofing using ropes and levers.

Using traditional way of lifting and mounting wooden logs

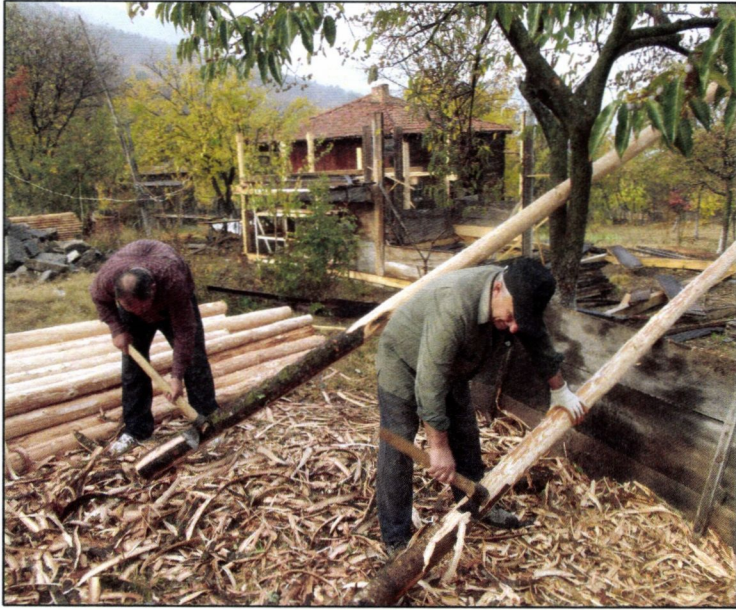
Traditional method of placing heavy logs above the building

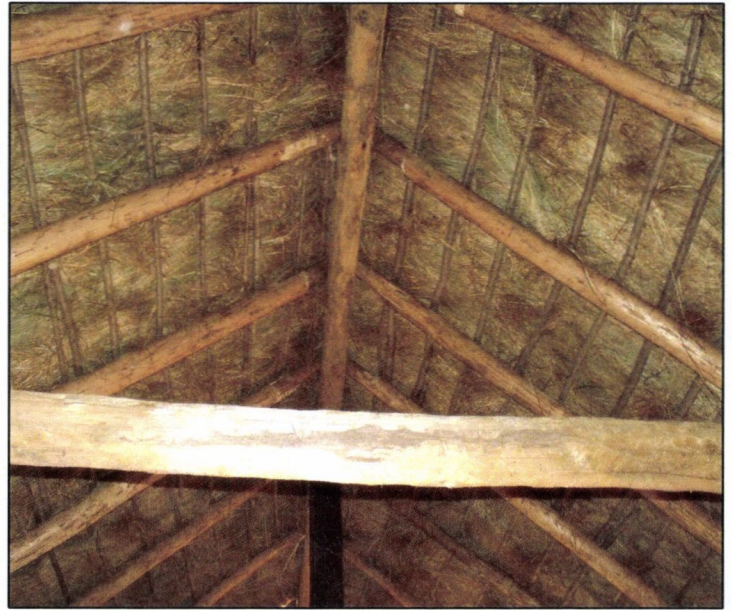
Structure of the renovated roofing from interior side

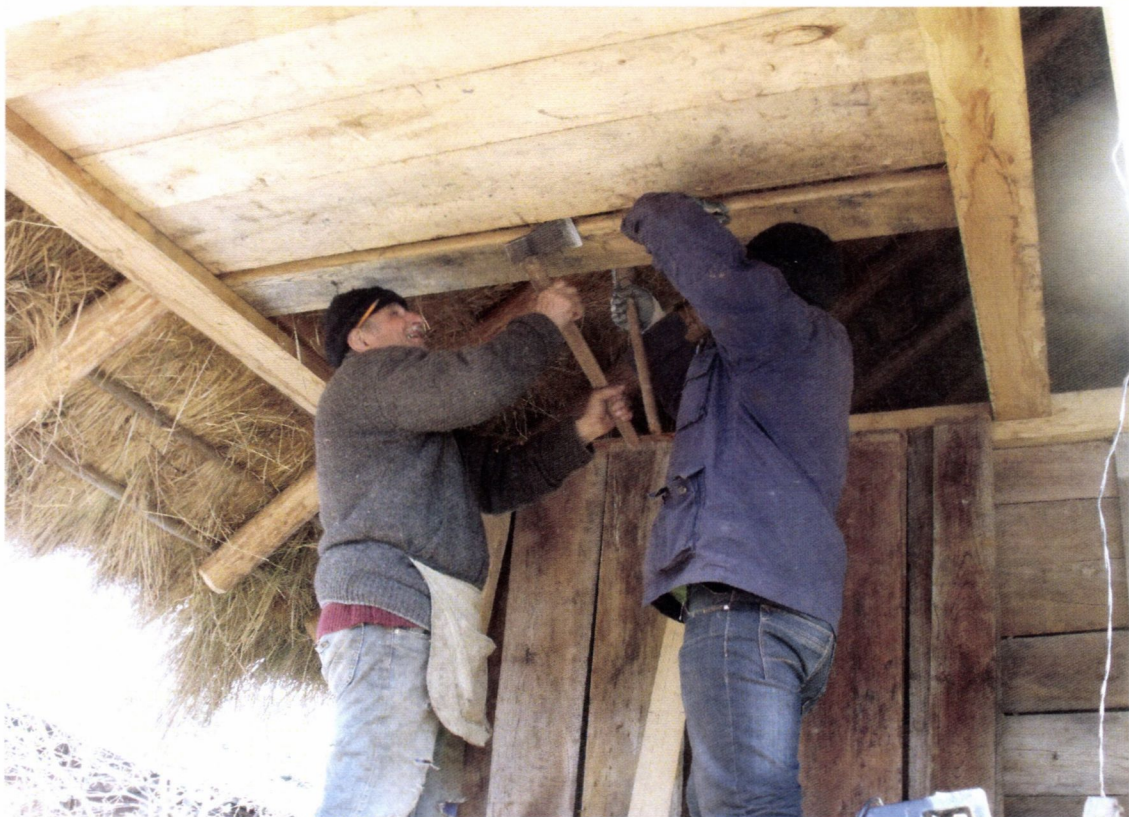
Boarding the ceiling of the balcony of "Nigvziani"

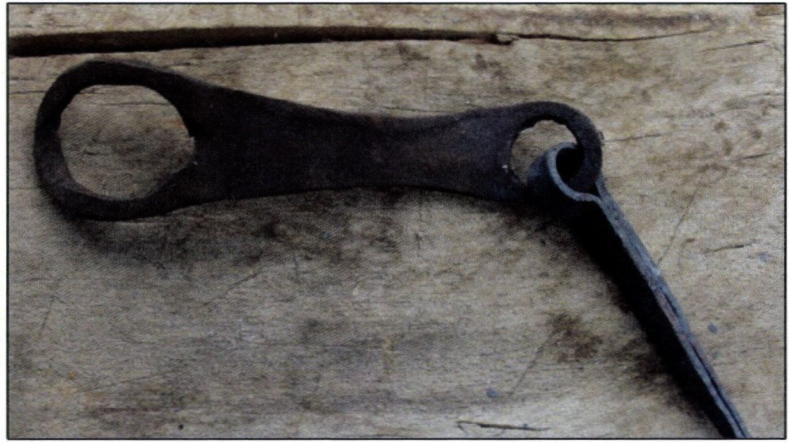
Newly forged lock

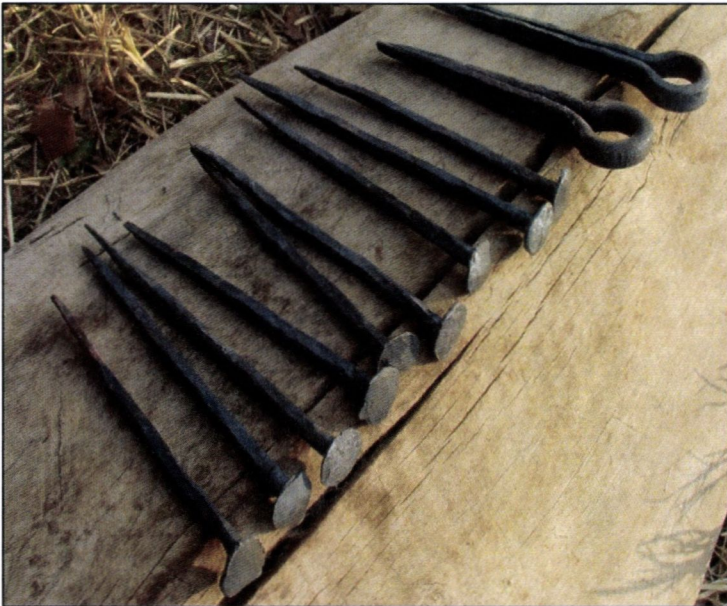
New steel details for the gate of the balcony

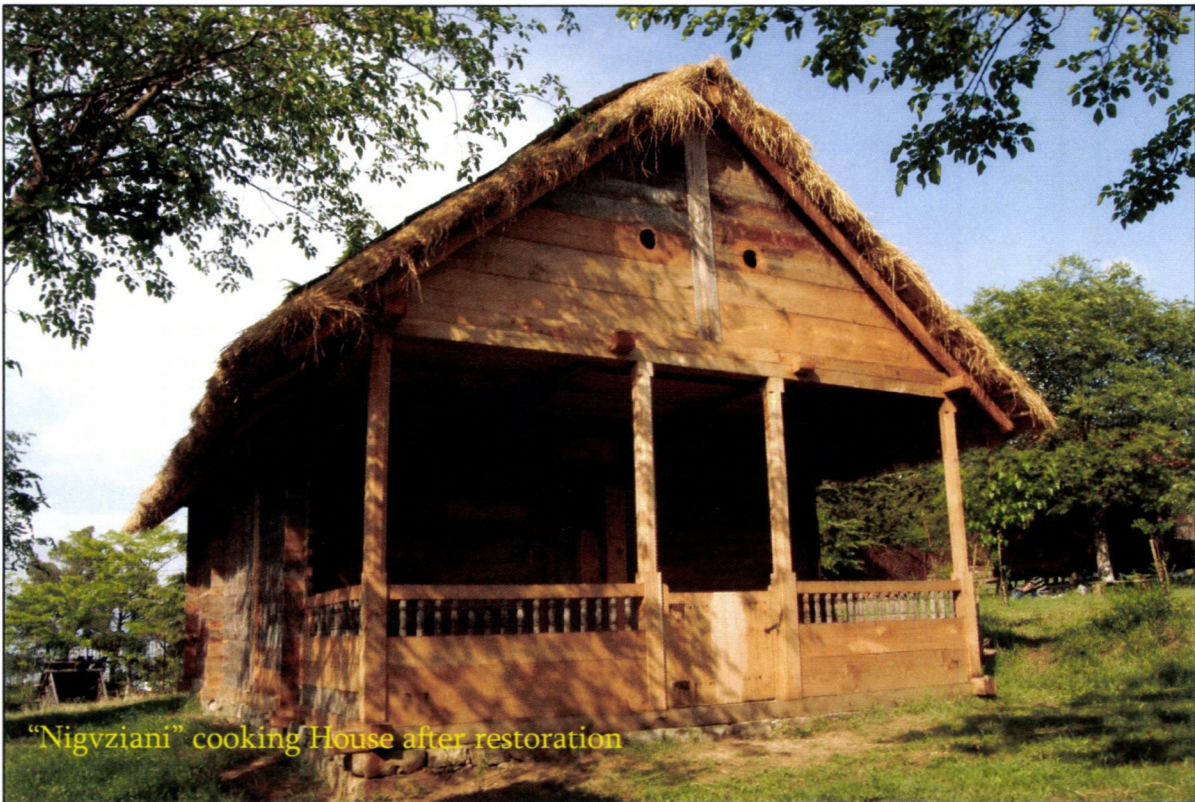
"Nigvziani" cooking House after restoration

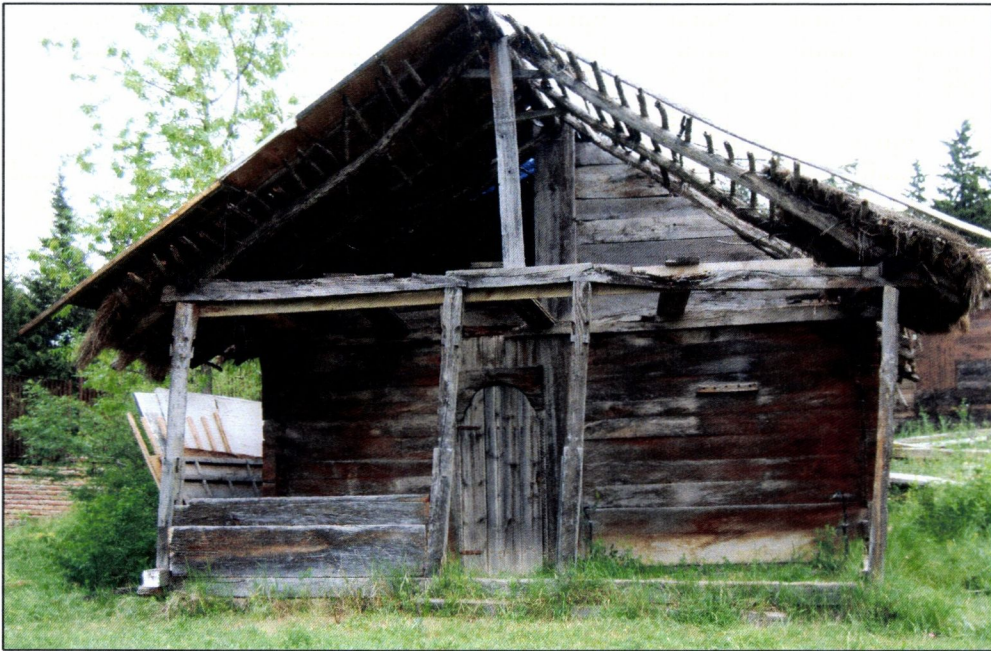
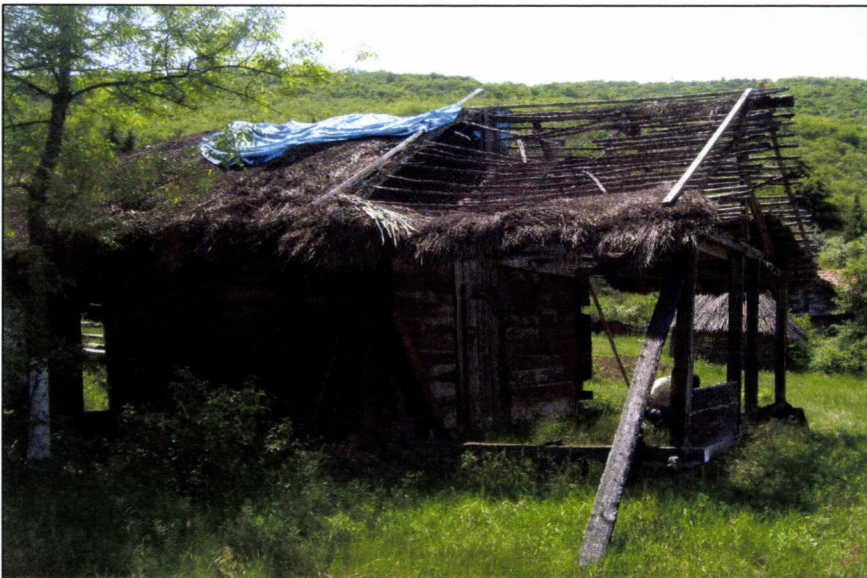
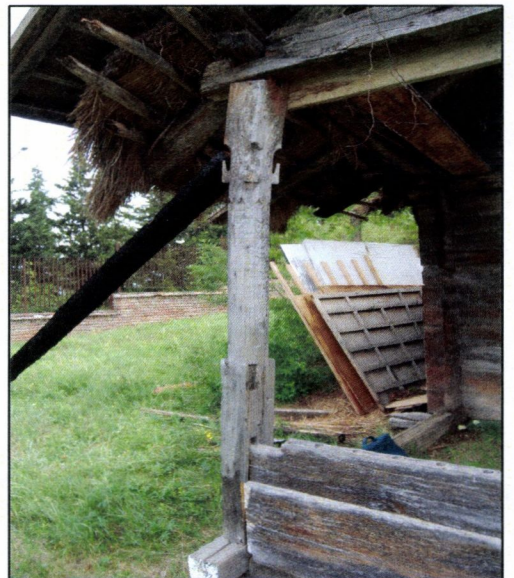
It was established that the building was in critical condition and needed urgent restoration and reestablishing works. Similar to Nigvziani’s case structure and walls of the house were deformed so that they could collapse at any time. The roofing was entirely rotten, through which the building was effected by atmospheric precipitations. The sedge cover was thoroughly damaged too..

*Goraberejouli
House before
restoration*

Restoration process and procedures of the Goraberejouli house was analogous to above mentioned reconstruction procedures of the Nigvziani house by foreseen of timber and steel details works.

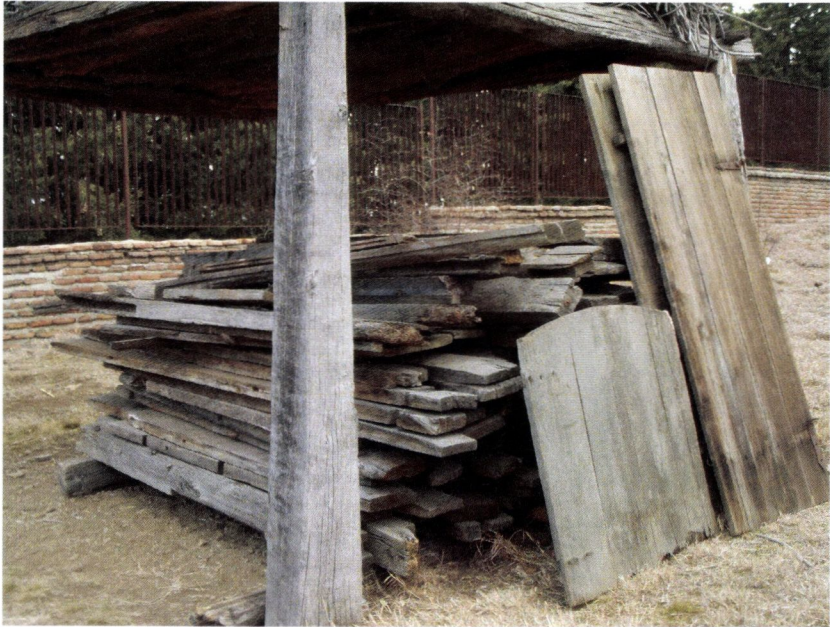
Applicable and restorable timber of the Goraberejouli house

As in case of Nigvziani house, the building was fully dismantled, after what appropriate authentic timber was selected for reusing, restoring (“prosthesis”) and dismissing (uselessness) as well.

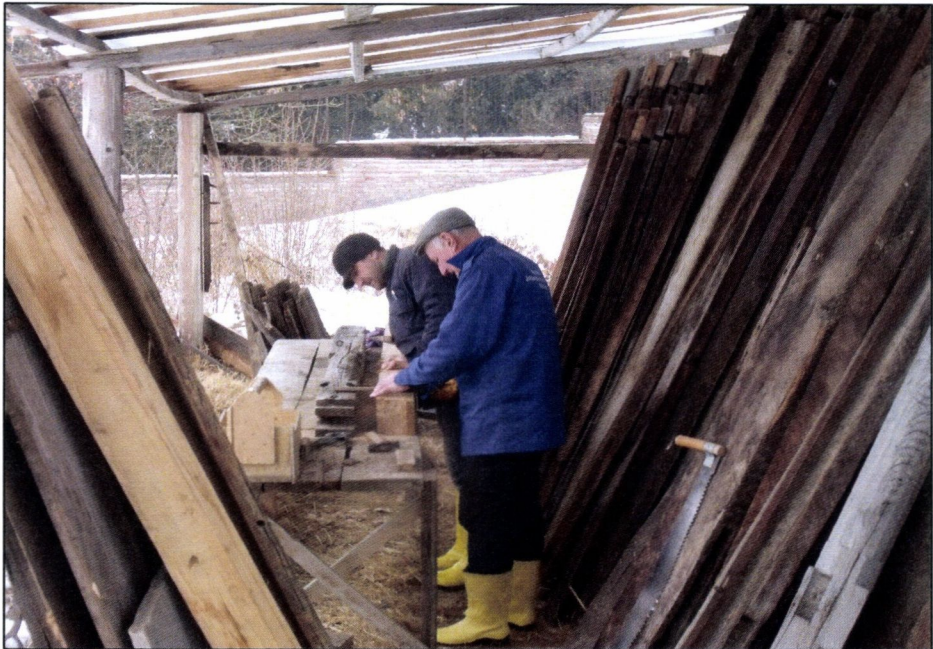
Selecting usable timber from authentic materials before starting restoration

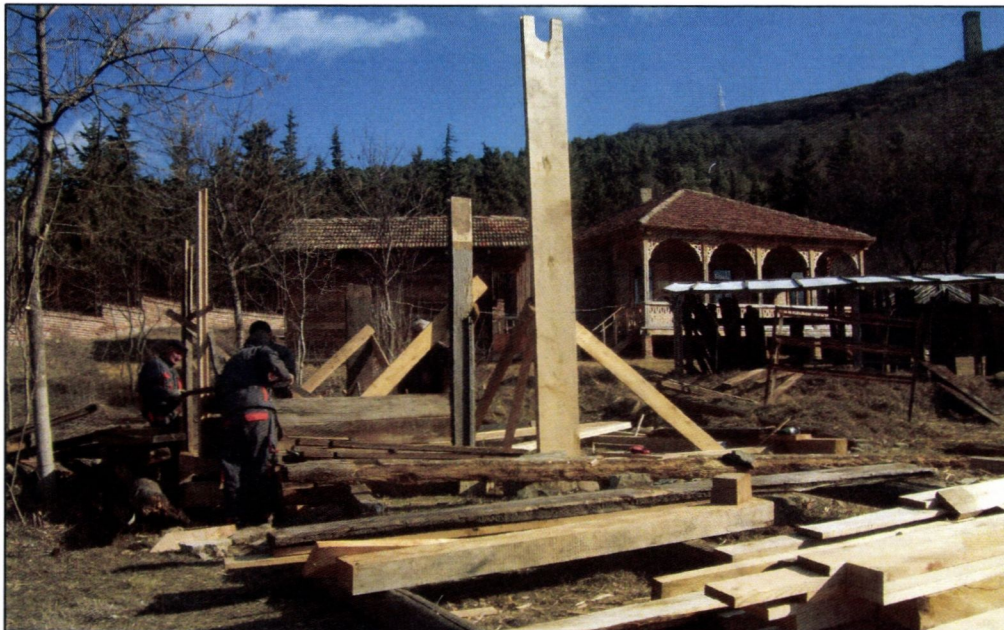
Restoration has been started
