“Revitalisation of the Giorgi Chitaia Open Air Museum of Ethnography”

The Final Report to RIKSANTIKVAREN

Institution: Georgian National Museum

MAY, 2012

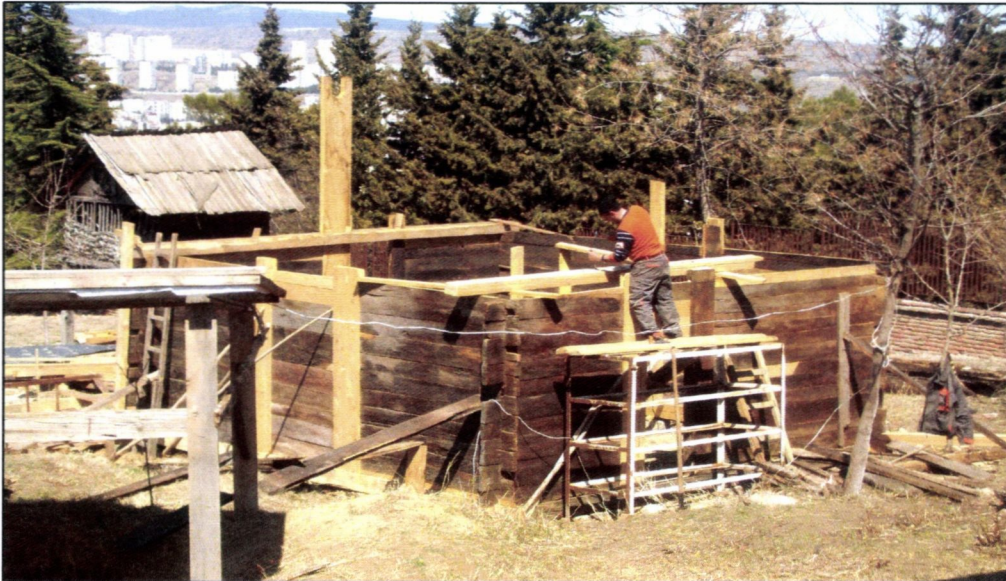
Finalizing the walls

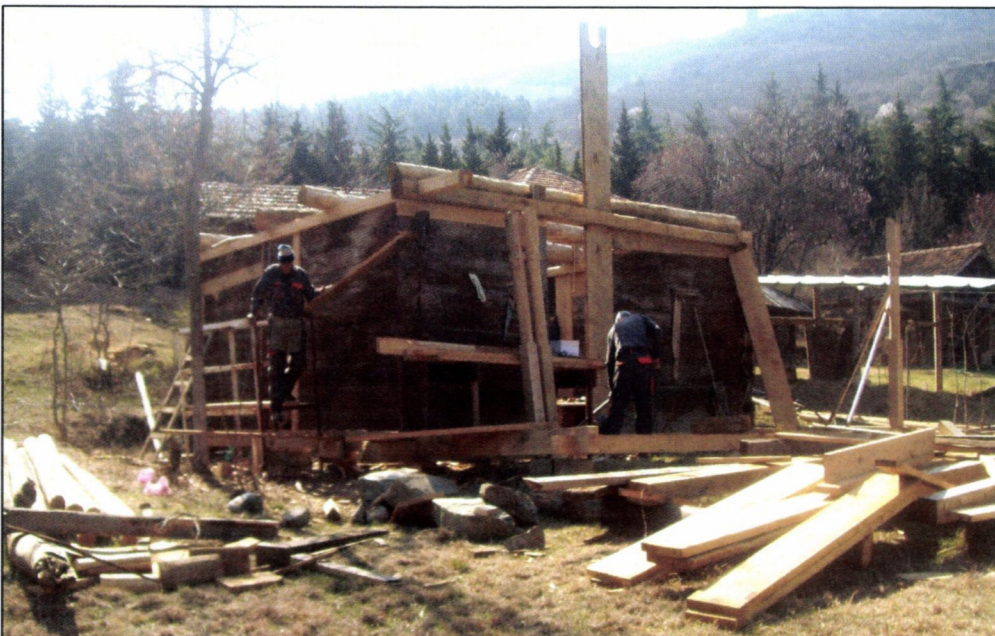
Placing wooden logs
