FINNEGÅRDEN 1A, BRYGGEN

Archaeological investigation of drillings
for two monitoring wells, 2014.

Tittel Finnegården 1A, Bryggen Archaeological investigation of drillings for two monitoring wells, 2014.	Rapporttype/nummer NIKU Oppdragsrapport 91/2014	Publiseringsdato 31.03.2015
	Prosjektnummer 15621249-2	Oppdragstidspunkt Mars 2014
	Forsidebilde Cramped quarters, MB49. Dunlop, NIKU, 2014.	
Forfatter(e) Dunlop, A. R.	Sider 22	Tilgjengelighet Åpen
	Avdeling Arkeologi

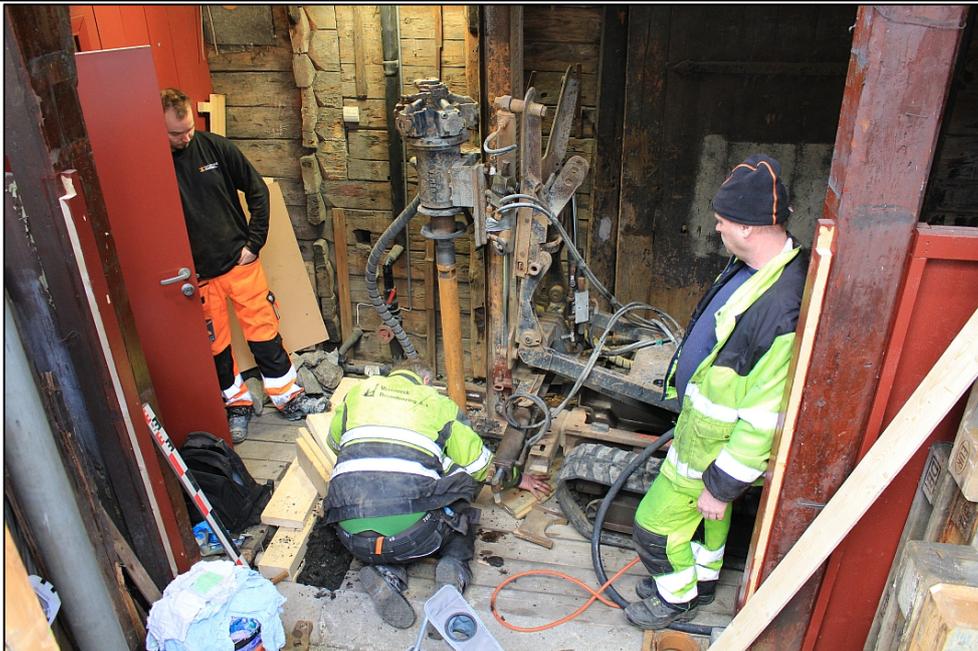
niku_ark_323551

MB48 is situated at the northeastern end of the covered gallery. Multiconsult AS determined its coordinates as N6701160.80/E297595.40, and the planking was at 1.10 masl. Investigation conditions were not ideal (cramped quarters, poor lighting).

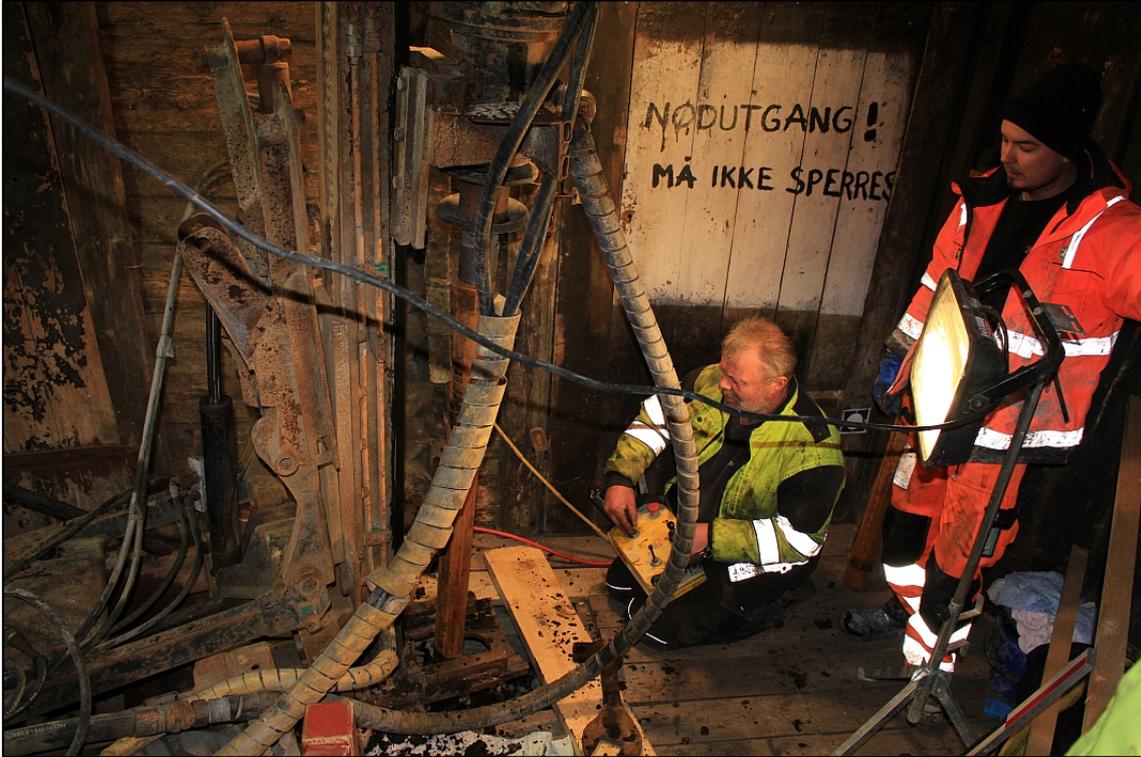
niku_ark_323563

MB49 is situated at the southwestern end of the covered gallery. Multiconsult AS determined its coordinates as X6701155.65/E297588.85, and the planking was at 1.05 masl. Investigation conditions were not ideal (cramped quarters, poor lighting).
