EXCAVATIONS IN ERKEBISPEGÅRDEN 1991  
Areas 1A and 1B: Stratigraphy and phasing

**EXCAVATIONS IN ERKEBISPEGÅRDEN 1991**  
**AREAS 1A AND 1B: STRATIGRAPHY AND PHASING**

Riksantikvaren, Utgravningskontoret for Trondheim

Trondheim 1993

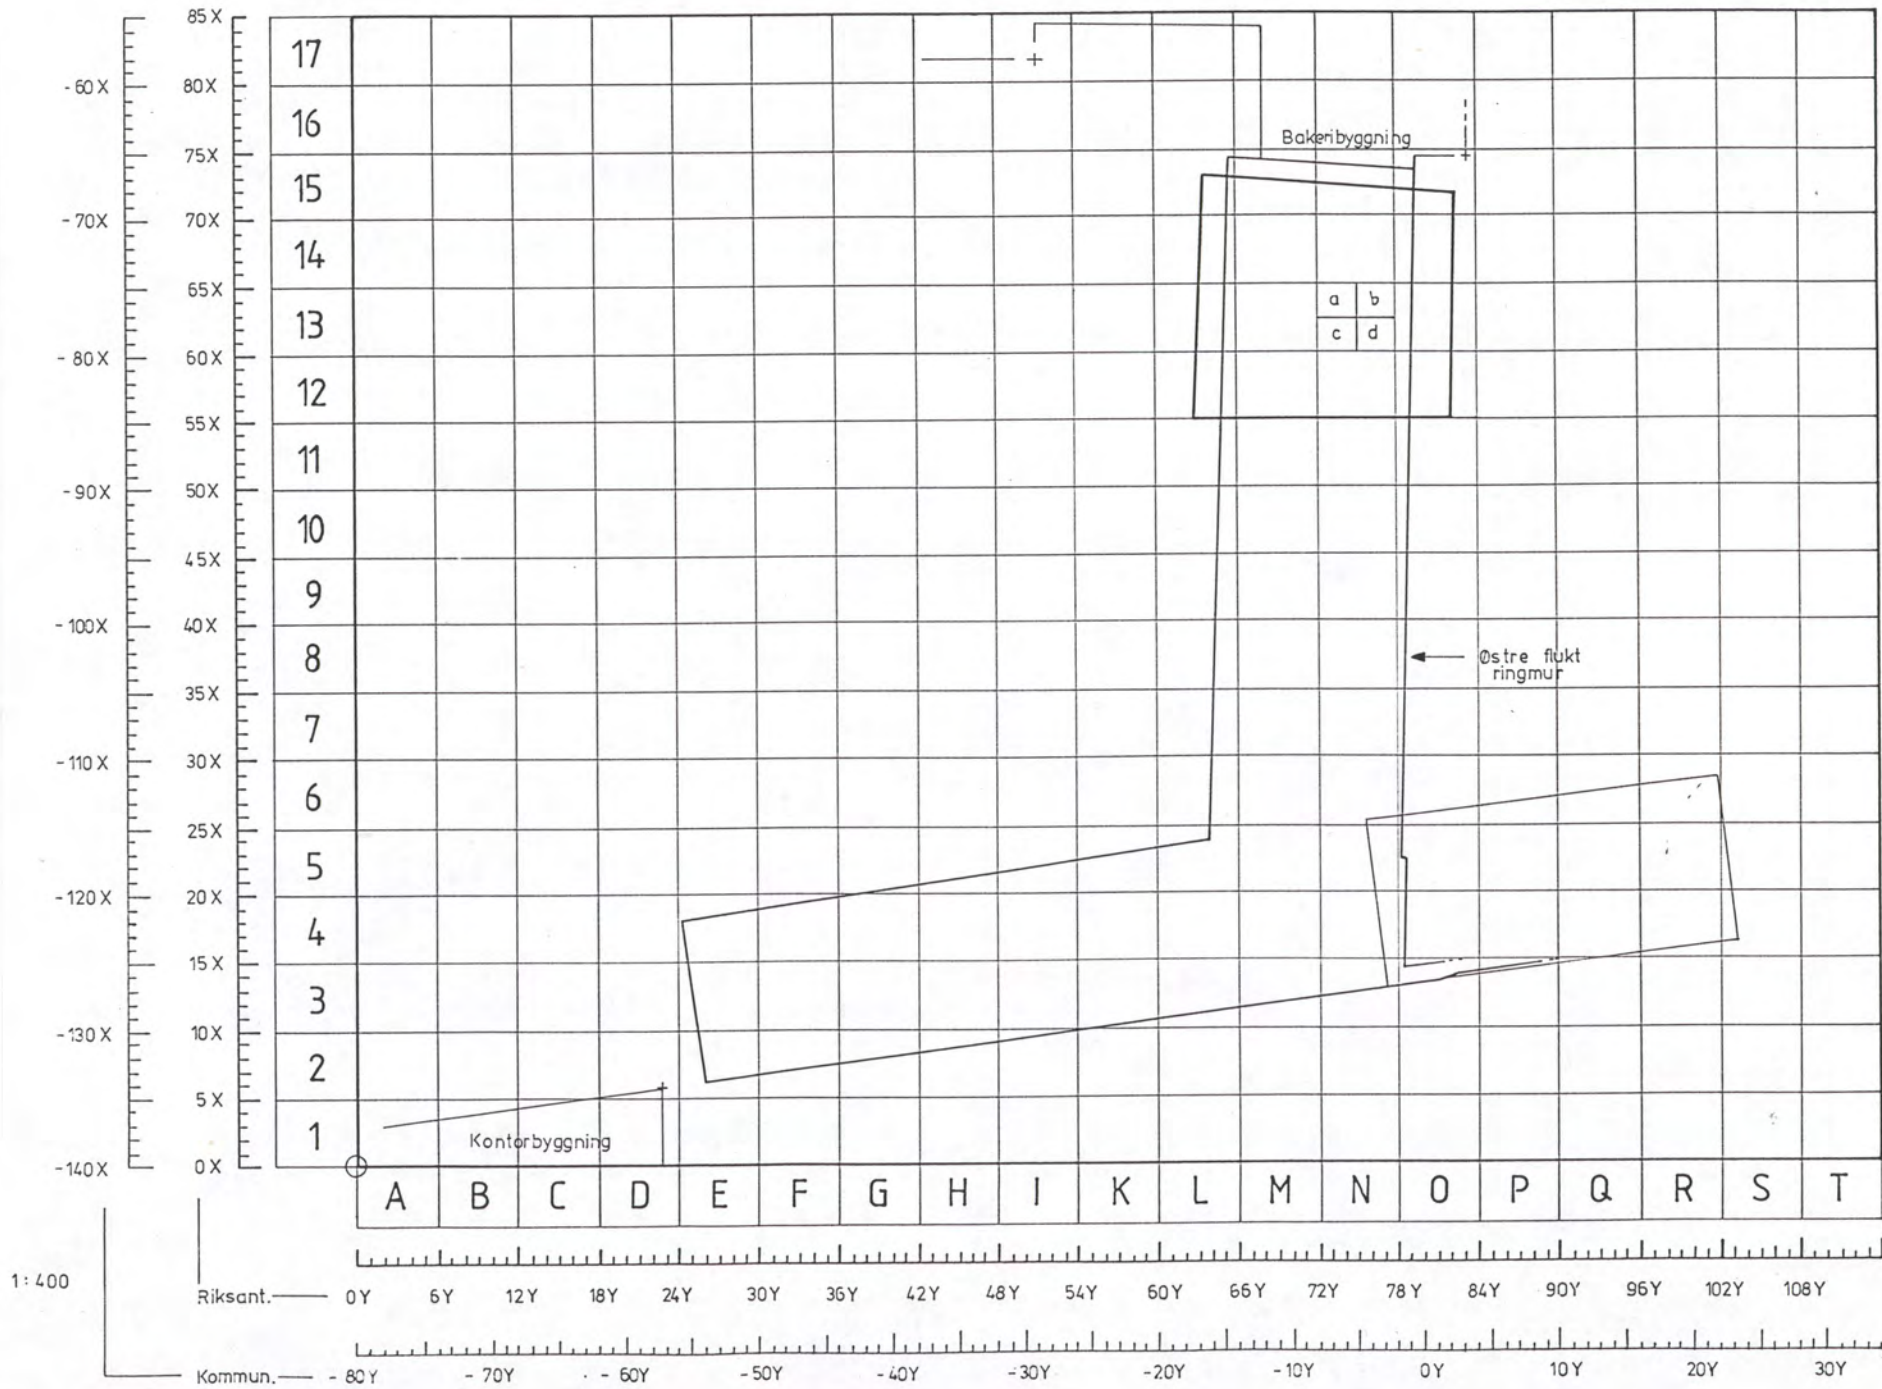
Fig. 4 The site coordinate system and town grid

The site coordinate system was based on the Trondheim Kommune coordinate system, which has its origin at the base of the Cathedral spire. However, since the Archbishop's Palace lies to the south of the Cathedral, the 91/1 sites have negative values for coordinates in the Kommune grid. To avoid using negative values on site, a site origin was located in the south-west of the Palace precinct (see **figure 4**). Eastings are therefore shown as increasing Y values and northings as increasing X values.

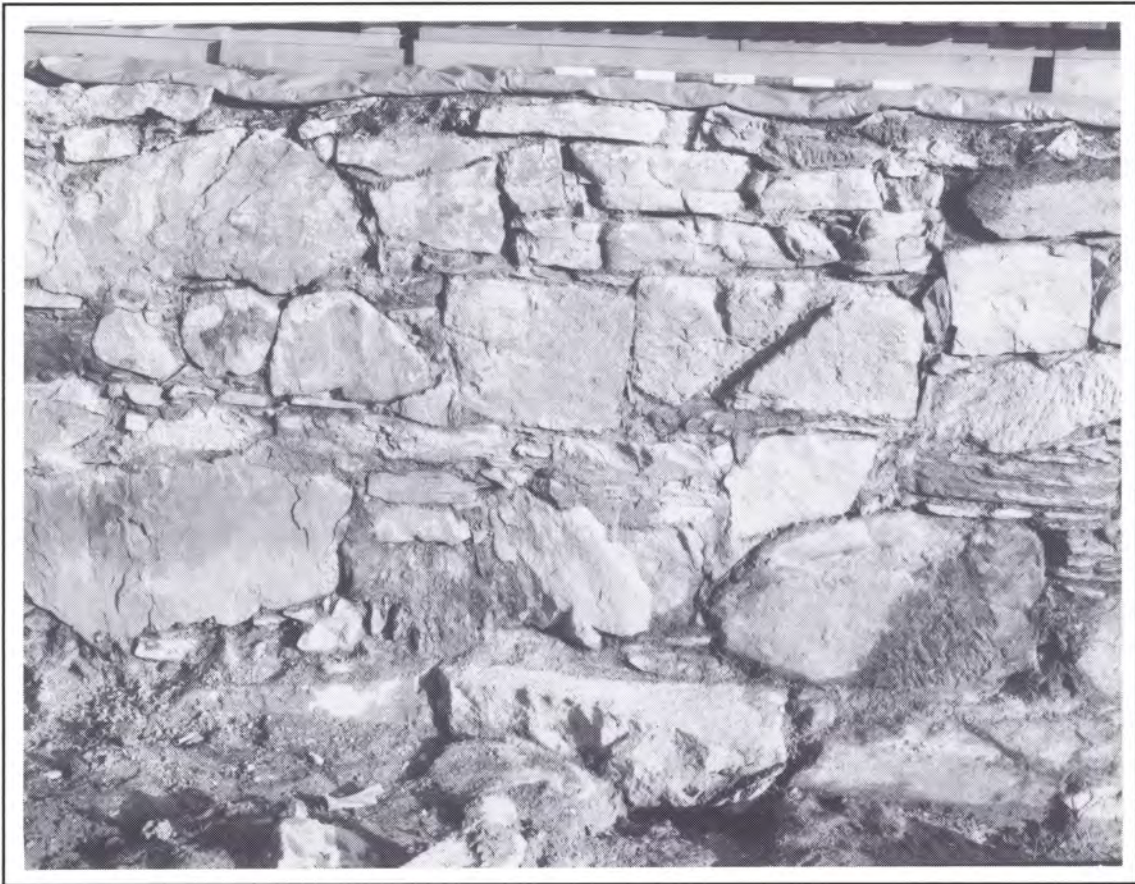
Fig. 10 Curtain wall AK2=BK1: detail of west facing showing oblique slot (cf. fig. 9).

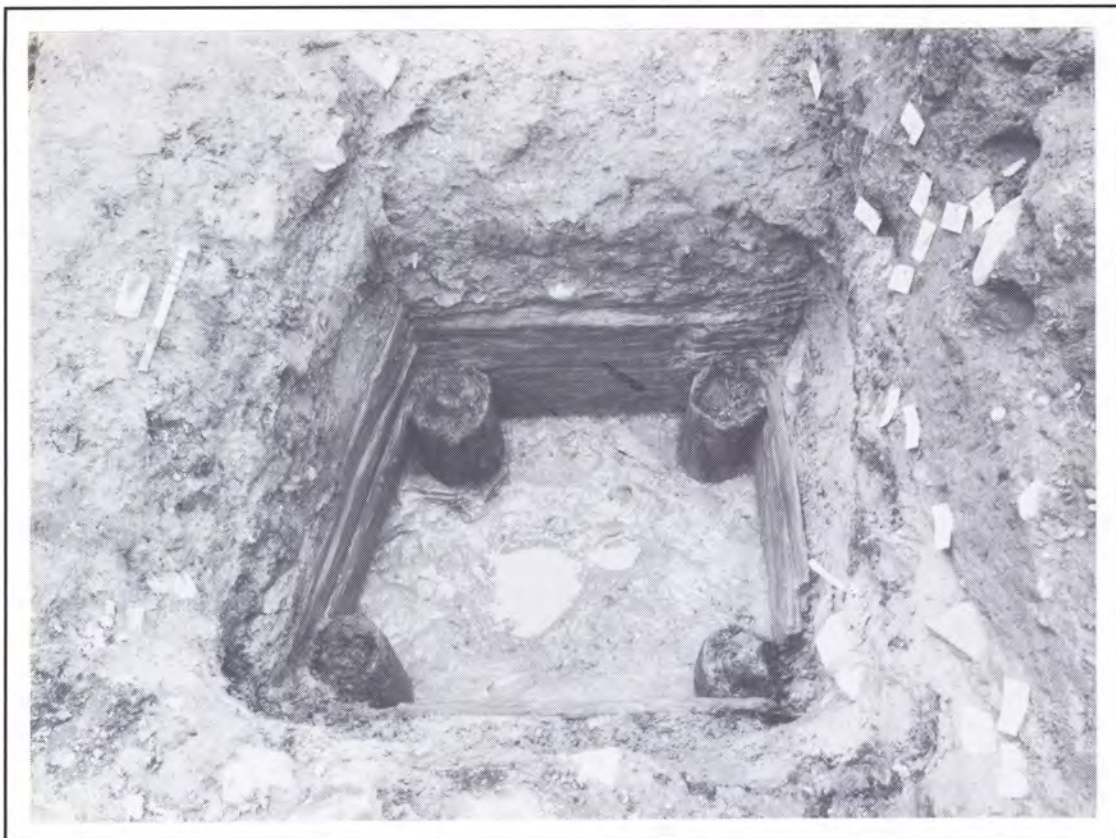
*Fig. 11 Wood-lined pit K5 (looking S.)*

Construction pit **401** appeared to be roughly oval, with its longest diameter aligned roughly E-W, its western edge actually lying beyond the limit of excavation. It was c. 1.5m wide N-S and at least 2m wide E-W. Collapse of the pit sides and the overhanging section made excavation unsafe and the feature was therefore not properly excavated, however it appeared to cut the surface of layer **622**, with surface **658** contemporary. The bottom of the pit was cut to a depth of 1.4m below **622**, with a bottom level of 13.3 m.a.s.l.. The pit contained an asymmetric wooden box-structure, with the eastern face aligned very closely to the orientation of drain **K6**, that is NNE-SSW, while the other faces were more or less aligned N-S and E-W (see **figure 11**). Corner posts **494**, **495**, **496** and **497** were cut from round timbers with traces of bark still present on them. They varied in diameter between 0.33m for **495** to 0.2m for **497**. All were sawn flat, with **495** having additionally a chamfered edge. They were anchored in clay, with **495** again standing alone in that it rested on a flat stone. They revetted planking **498**, which consisted of planks 0.06m thick, between 0.25 and 0.30m wide and of varying length: the northern face being 1.4m long, the southern 1.2m, the western 1.1m and the eastern 1.2m. The gap between the wooden lining and the construction pit was packed with rammed down clay and stones **532**. None of the planks appears to have been re-used from elsewhere. Dendrochronological samples were taken from the planking and one of the posts.

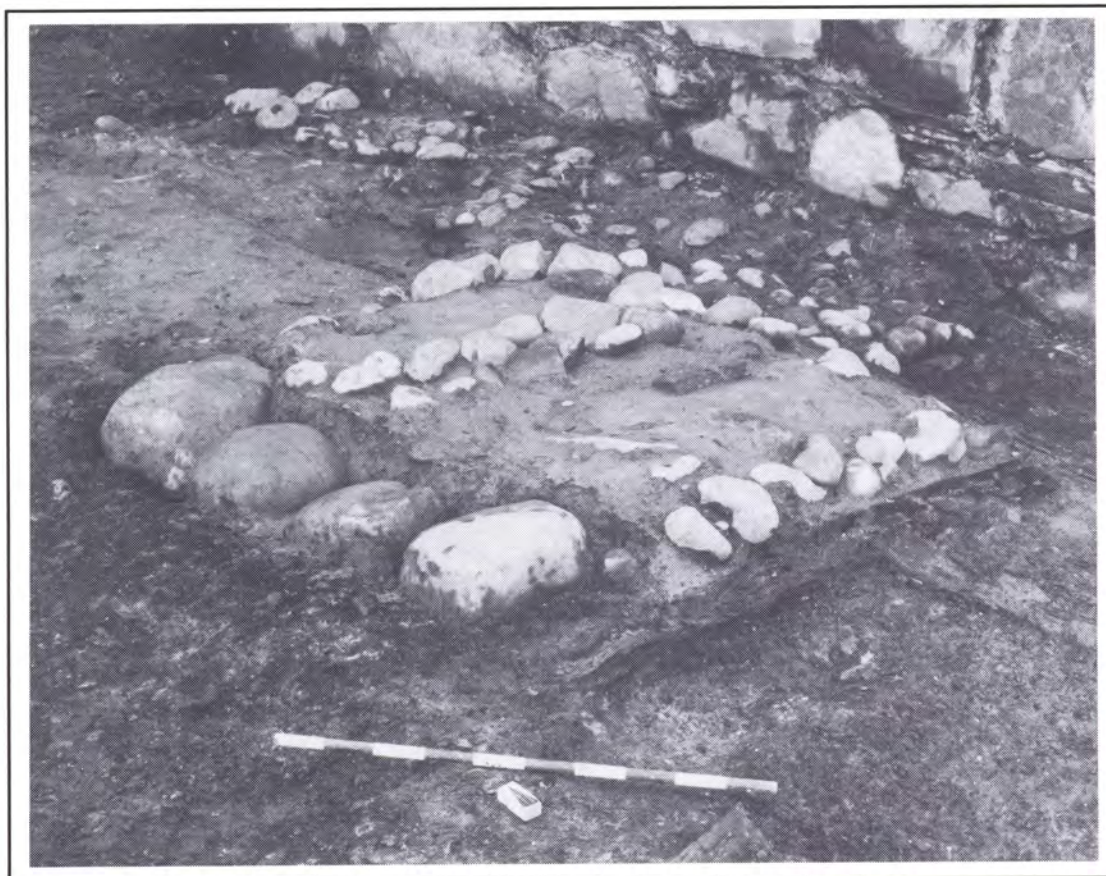
*Fig. 13 K10 clay-packed stone platform, timbers K9 and cobbles K11 (looking NE.)*

Lying immediately on **592** was a rectangular plan building apparently extending across the site A and B boundary, although the evidence in site B is extremely fragmentary. In site A it consisted of a number of badly rotted wooden joists with traces of planking **K9**. The joists partly lay on a hard clay surface **581** deposited over **592** presumably as local levelling (no site B equivalent). To the immediate south of **K9** was a massive clay packed stone platform **K10** of unknown function. Immediately south east of **K10** in site B was the circular stone feature **BK10** mentioned above, and possibly incorporated into the building (see **figure 13**). Further south in site B were impressions of rotted or robbed out wooden beams on the correct alignment to form part of the building.

Between Building B and the curtain wall was a thin strip of cobbling **K11**. It may have originally extended right the way along the inside of the curtain wall to the north of the precinct (perhaps suggesting an entrance to the conjectured building beyond the northern limit of the site). This construction lay on top of dumps **614** and **643**, which were presumably deposited to level up the depression left in the construction trench for the curtain wall.

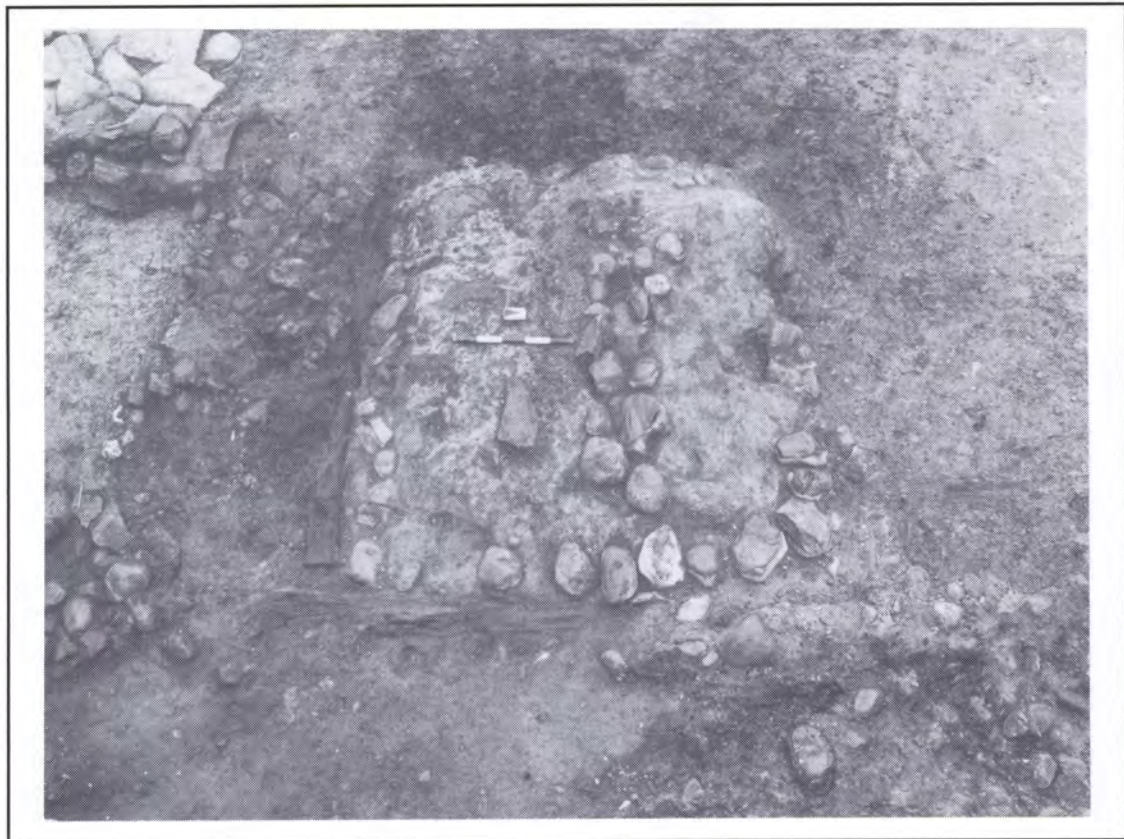
*Fig. 16 K10 clay-packed stone platform exposed (looking W.)*

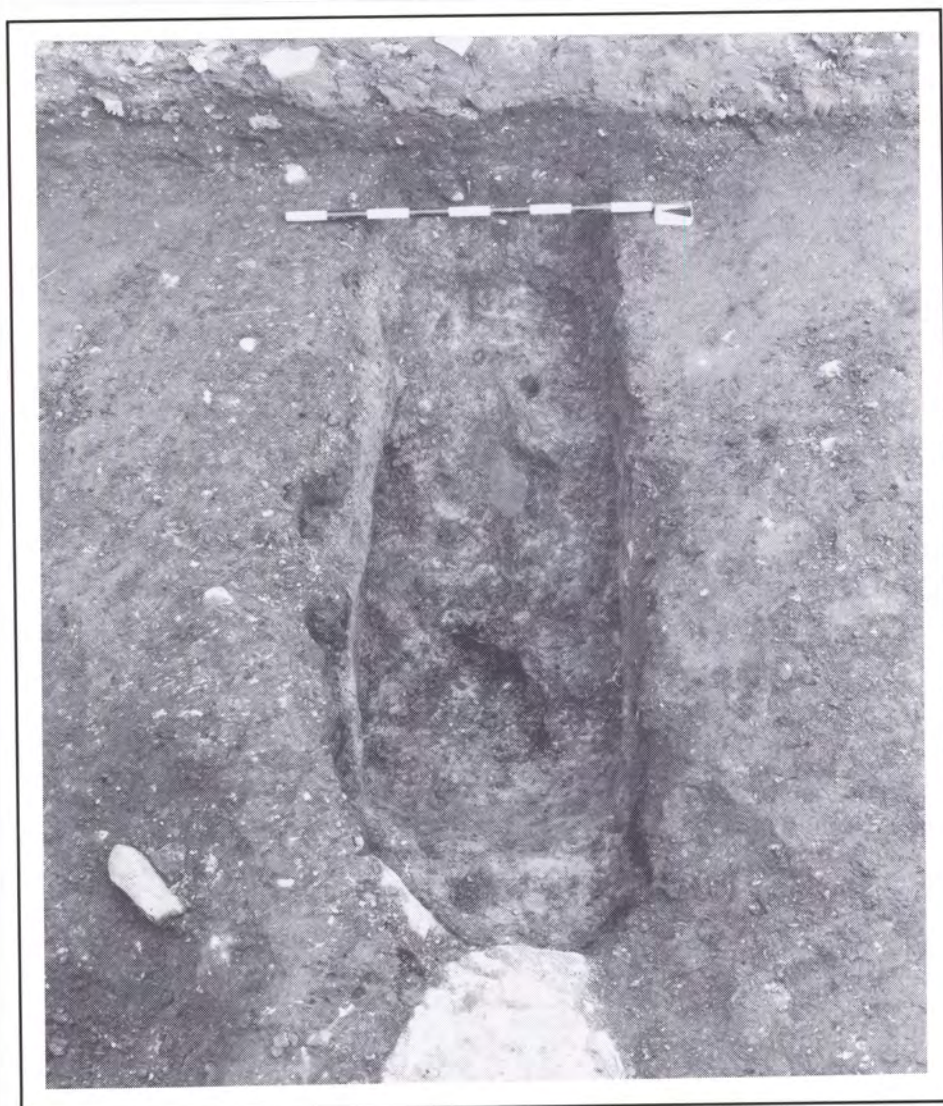
*Fig. 17 Pit K66 (looking E.)*

See **figure 17**. Pit **194** was sub-rectangular, just over 2m long E-W, and 0.6m wide N-S. It was vertically sided, with an irregular bottom. The deeper area in its middle had a depth of 0.46m, while the "shelves" at the northern and southern ends had a depth of around 0.3m. It had some traces of charcoal at its base. It had two fills; the primary fill **195** being rather more clayey than the secondary fill **150**, a clayey silt. The function of the pit is unknown. Its dimensions and orientation suggest a grave-cut.

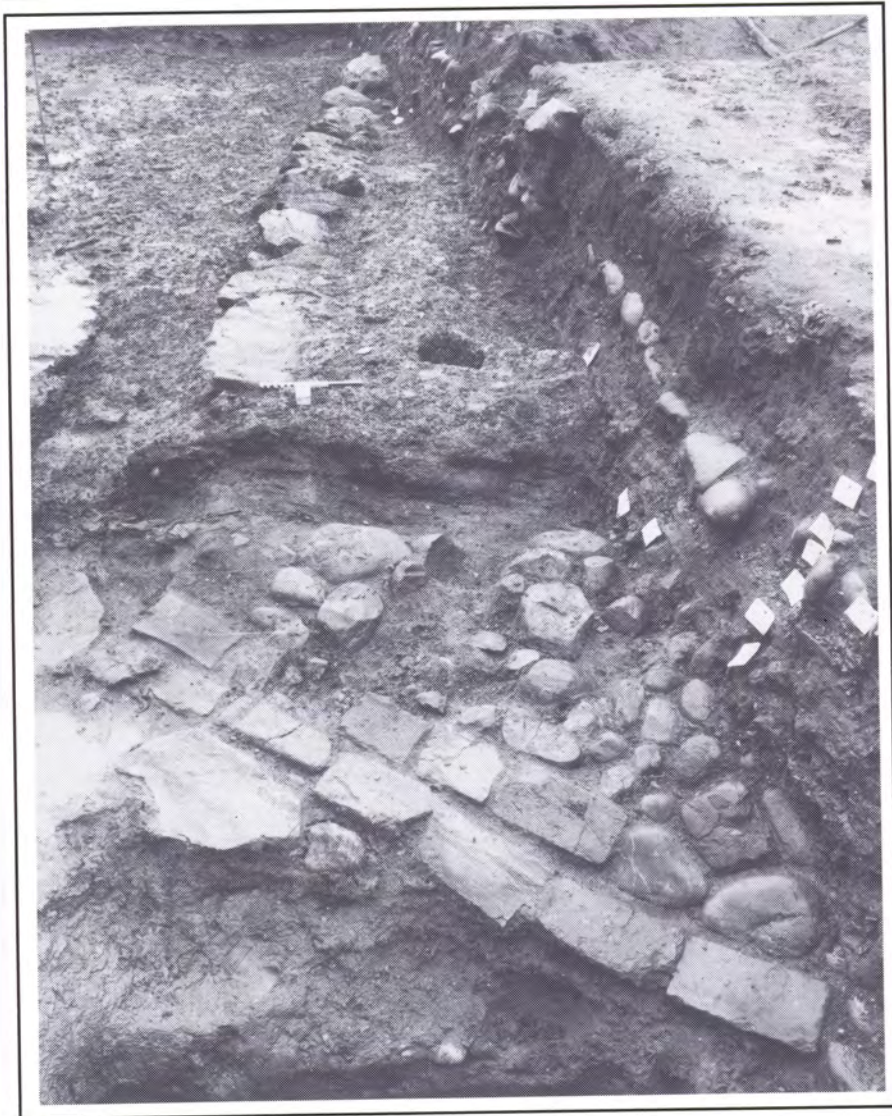
Fig. 18 Cobbles/bricks K13 and BUILDING C (looking S.)

See figure 18. Sand **480** overlay clay **638**. It bedded cobbles **449** and a gutter **481**, composed partly of large bricks and partly of rectangular stones. The gutter was aligned NW-SE, which was not orthogonal to any features or building boundaries. The cobbles abutted **K12** to the south, and appeared to have been contemporary with the use of latrine **K14**: they bounded it to the south and west and perhaps originally completely surrounded it. The northern edge of the cobbling was ragged and ill-defined, and its original extent uncertain. The cobbling extends beyond the western limit of excavation and is interrupted to the east by a modern intrusion. The gutter was likewise interrupted by the modern intrusion to the east and extended beyond the limit of excavation to the west. Later slump in the area around latrine **K14** made it impossible to say in which direction it was intended to channel water, but its south eastern terminus would have been very close to the north east corner of Building C, and it may have been intended to carry away water from a gutter running parallel to the eastern wall of the building below its drip line. Evidence for whether any such gutter existed alongside Building C was destroyed by the modern intrusion in the area. The cobbles **449** had been partly robbed out. Those remaining were scorched. The sand left in areas of robbing also appeared scorched. The area was sealed by destruction deposit **450**.

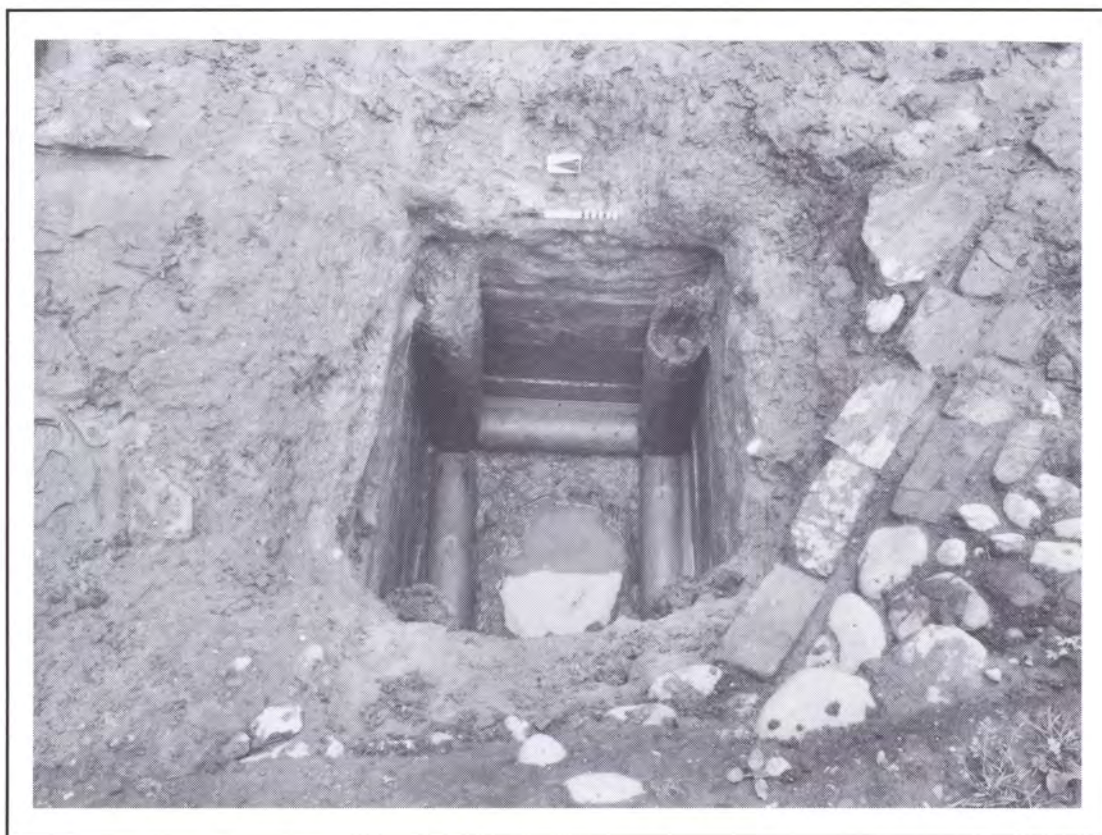
*Fig. 19 Wood-lined pit K14 (looking E.)*

See figure 19. The construction pit 395 apparently cut layer 638 but may have cut an earlier layer, specifically 622. Full excavation of the pit was not possible because of collapse, but it had a roughly square shaped plan, aligned N-S, with a maximum width of around 1.6m. The depth of the cut below 638 was also around 1.6m, the bottom having a height of 13.1 m.a.s.l.. The construction pit appeared to have almost vertical sides.

Inside the pit was a box-construction of timber planks, the gap between it and the side of the pit being filled with a hard packed clay and stone fill **565**. The wooden lining was very stoutly constructed, forming a rectangle aligned orthogonally to Building C, its southern edge being 1.2m north of **K12**. Its internal dimensions were 1.15m E-W by 0.9m N-S. It was made up of four posts, **487**, **488**, **489** and **491**, cut from round timbers c. 0.2m in diameter. These were flat-bottomed and rested on natural clay at the bottom of the construction pit. Apart from their sawn ends, none showed working except **489**, which was slightly wider than the other three posts and had been worked around its base (with an axe or adze?) to produce a narrower diameter. None of the posts survived more than 0.8m high, their tops having completely rotted away. They were braced at their bases by horizontal props **514**, **515**, **516** and **517** which were halved round timbers with their ends worked to produce concave faces which fitted flush to the posts. **514** and **516** were split halves of the same timber, as were **515** and **517**. **514** and **516** were the southern and northern props and were 0.70m and 0.75m long respectively. **515** and **517** were the western and eastern props and were 0.60m and 0.55m long. It is therefore apparent that the ends had been worked after the timbers were split, presumably being cut to fit as the final elements of the construction. On constructional grounds it seems highly likely that these base props were matched by props at the top of the structure, but any trace of these had been lost.

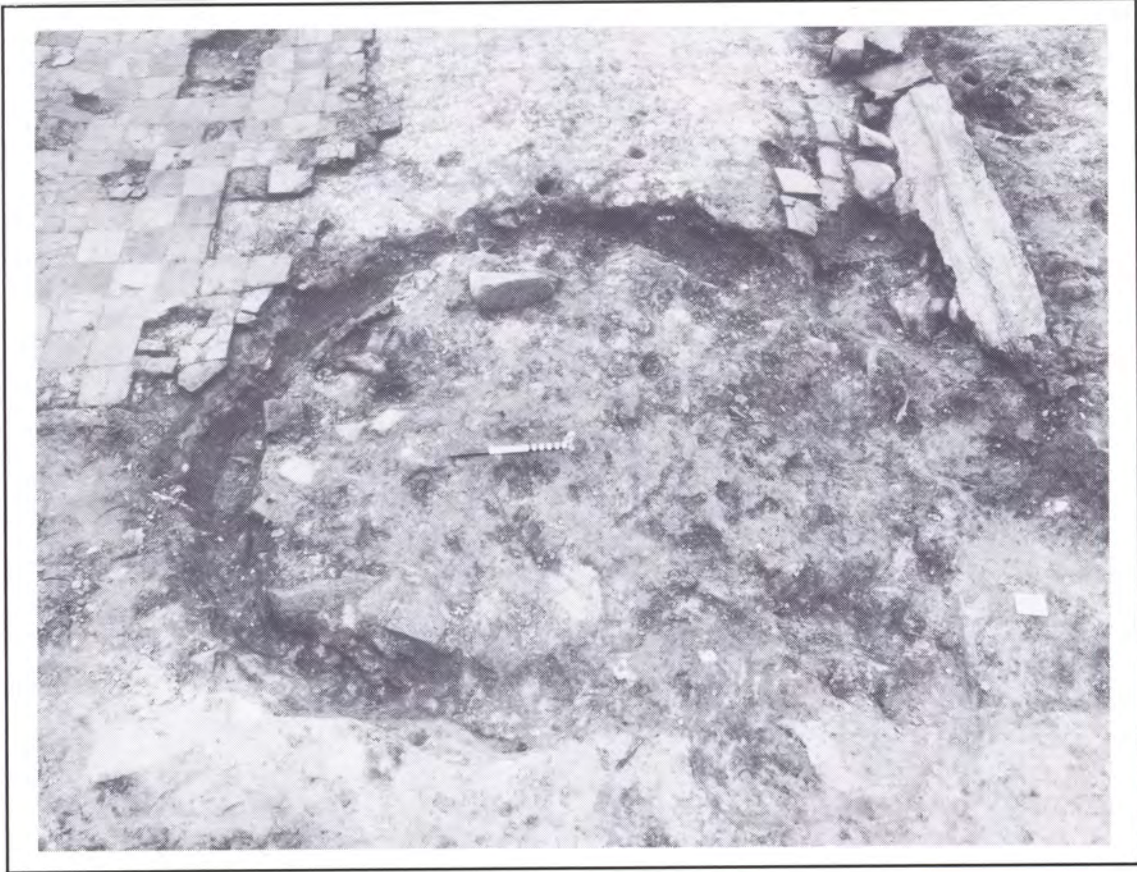
*Fig. 22 Circular feature K45 (looking S.)*

Circular cut feature **361**. The cut was an incomplete, slightly irregular circle with a diameter of c. 1.8m (see **figure 22**). It was partly cut through the tiled floor of Building G. The "open" part of the circle was in the north west, outside the northern limit of Building G, and the depth to the bottom of the cut from the surface increased to a maximum in the south east (from a level of 14.81 m.a.s.l. on its bottom in the north west to one of 14.62 m.a.s.l. in the

south east. The edges of the cut were very neat; where it cut through tiled floor **K26** of Building G the tiles were not badly disturbed, simply broken along the line of the cut. The backfill of the feature, **429=413** was a is a clayey silt with wood chips perhaps related to the disuse of the feature. It was suggestive of a waterlain deposit. The function of the feature is unknown (but see discussion below).

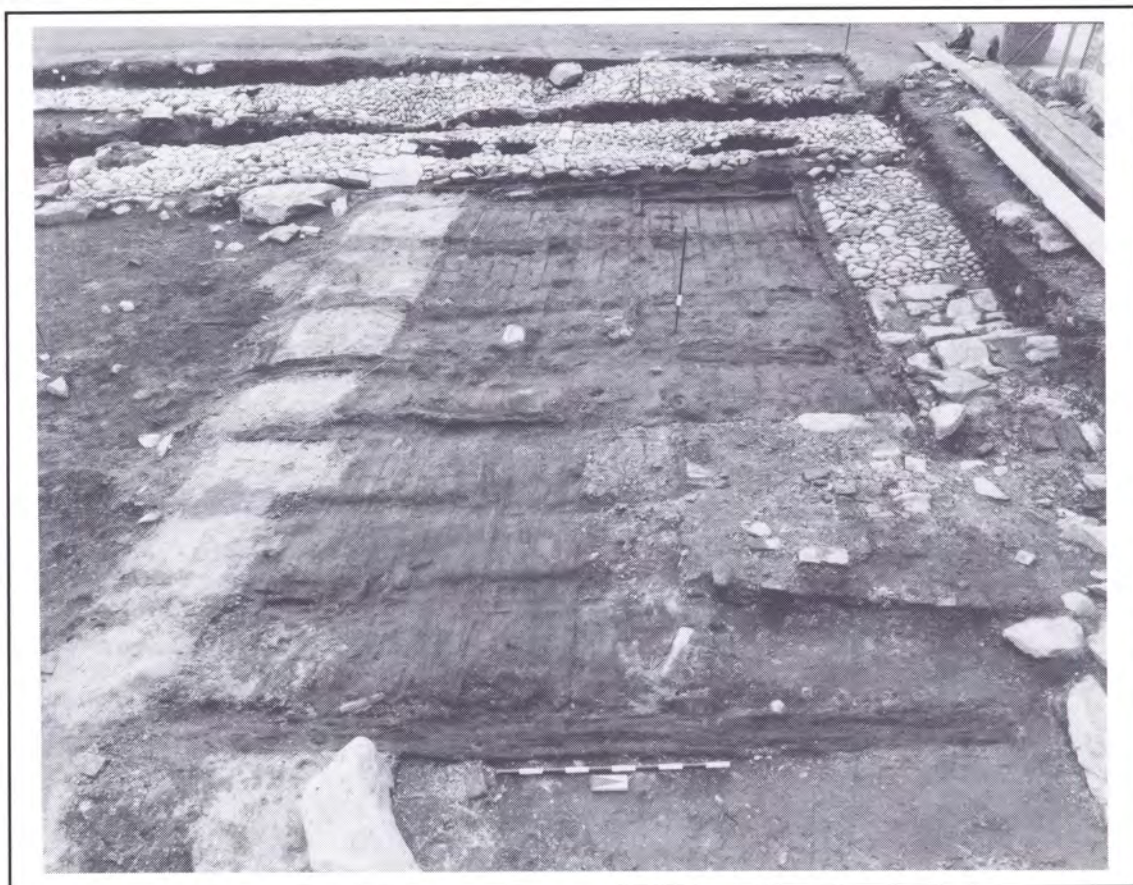
*Fig. 24 Plank floor K54 (looking W.)*

See **figure 24**. A total of ten joists were present beneath the plank floor. Nine in all ran north-south, with a longest surviving length of around 8m, but they had originally almost certainly continued further south. The joists were **173, 214, 220, 221, 222, 229, 313, 209** and **210**. The tenth joist **191**, ran east-west from wall **K53** for a distance of about 3m. It overlay the north-south joists. The joists overlay a series of dump deposits over construction layer **99**. The gaps between the joists were filled with gravel **169**. The function of this gravel appears to have been to settle the beams and hold them in place. The joists supported planking **168**. The planks making up **168** ran east-west across the joists with an average width of around 0.3m and a length of around 3m. A consolidated mortar surface associated with chimney **K56** was also covered by planking **168**. Planking **168** extended east from the western external wall **K53** to the joist **209** just east of the chimney **K56**, and south from the sleeper beam bounding cobbled area **K55** to almost the southern limit of excavation.

Some iron nails were recovered from the planking, but it appeared as if the majority of them might have been robbed out; it did not appear that wooden pegs had been used.

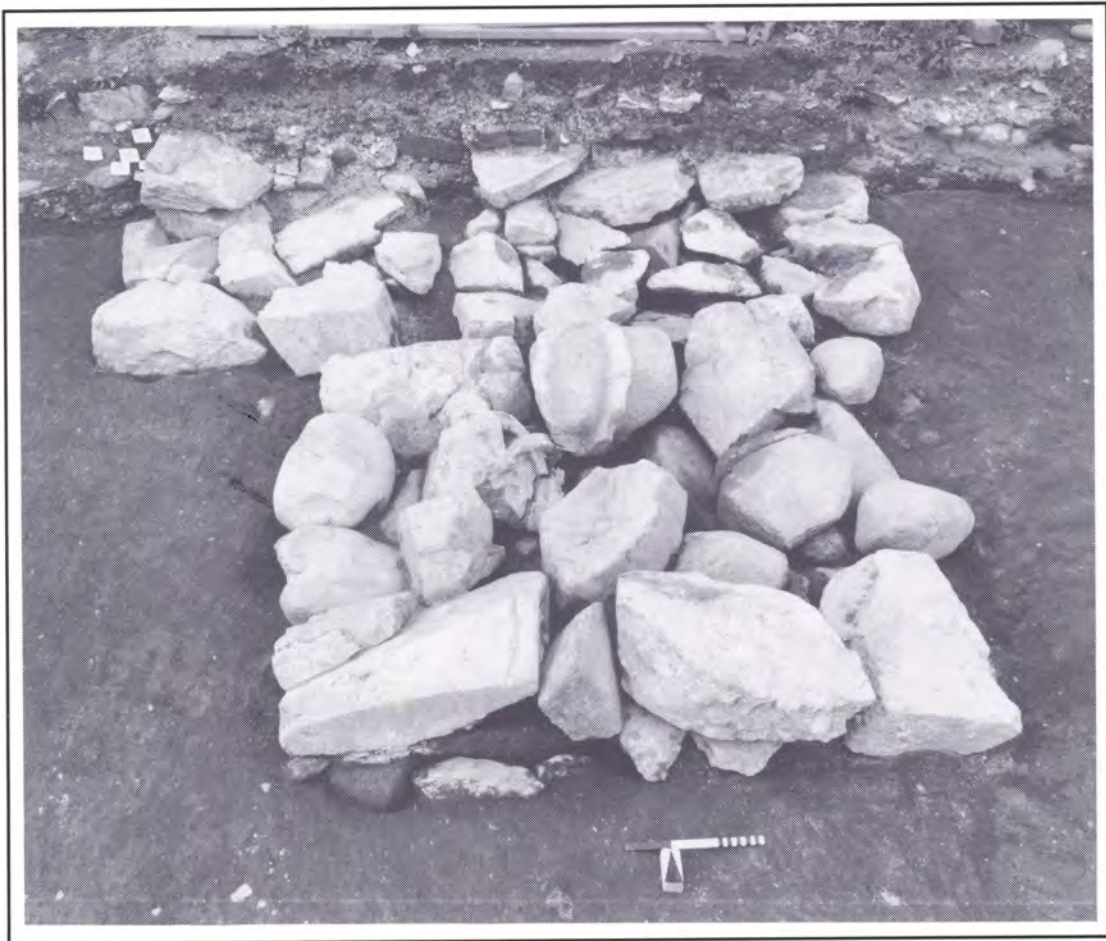
*Fig. 25 Chimney base K56, foundation (looking N.)*

Construction cut **312** appeared to be through make-up layer **223** but might possibly have been through construction layer **99**. The chimney base consisted of a main section, rectangular in shape, 1.6m east-west and at least 2.4m north-south, with its northern limit beyond the excavation boundary, and a subsidiary section. This subsidiary addition to the west met with ramp **159**, being bounded to the south by the wall beam **83**. Filling the main part of cut **312** were sand dumps **339**, **305** and **288** which can essentially be considered to be the same deposit. An internal wooden beam **353** divided the main part of the chimney **64** from the western portion of it. The foundations of the chimney consisted of massive stones, unworked boulders and re-used architectural pieces (see **figure 25**). On excavation most required at least two and on one occasion six men to lift them and carry them off site. To the west of the beam the main bedding material for these foundation stones was a loose mortar **303**, while in the main part of the chimney it was the sand dumps noted above. Above the sand and mortar dumps was a layer of silt **344**, above which was stonework set in mortar in the subsidiary western part, and brickwork over stonework set in mortar in the main part. The bricks consisted of a mix of a number of types of fabric and size. Compare **BK65**.

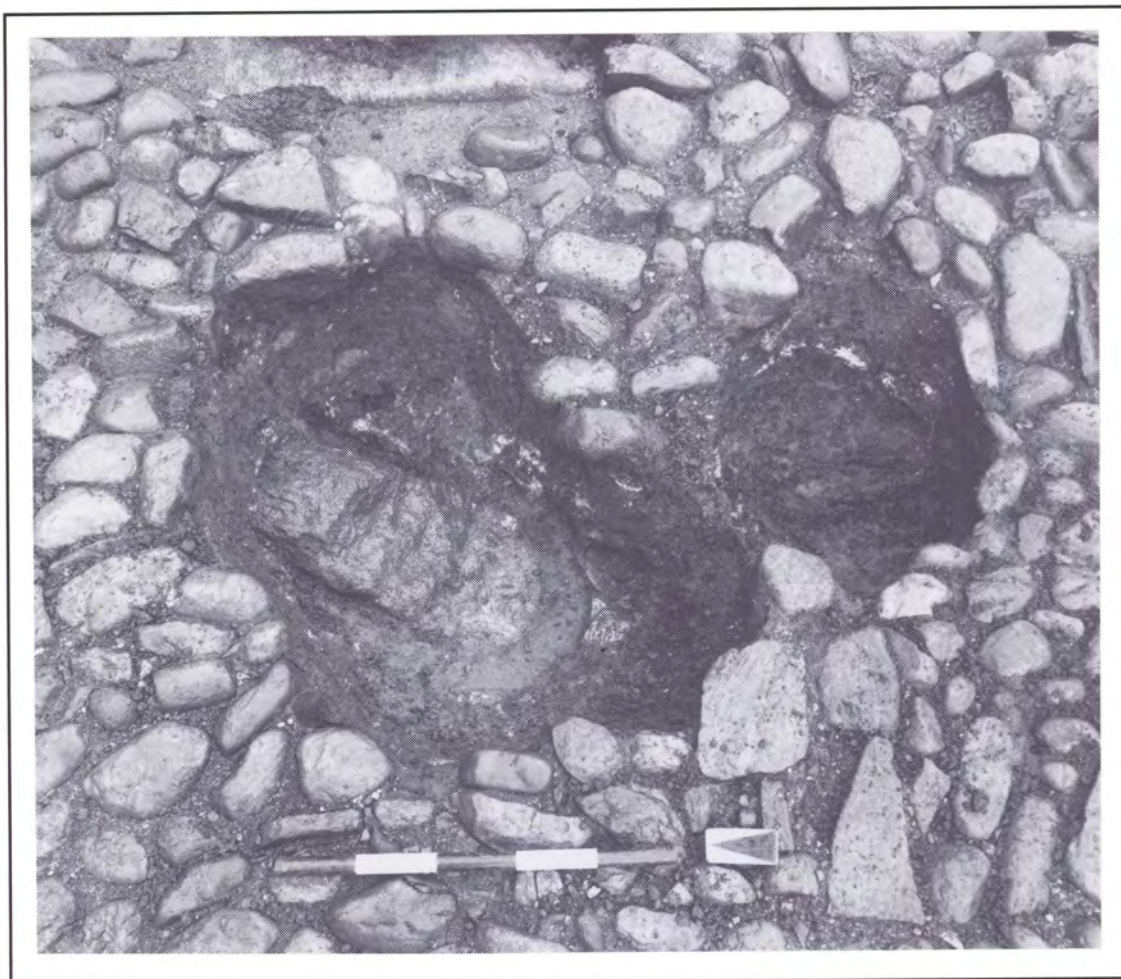
Fig. 26 Postholes 129 and 131, cutting cobbles K52 (see K60) (looking E.)

See **figure 26**. Postholes **60** and **129** went out of use and accumulation deposits **61** and **130** of uncompacted soil filled them; there appears to have been no deliberate back-filling as such. New postholes **272**, **127**, and **131=432** (feature double numbered in error) were cut, with a slightly larger diameter (upto c. 0.6m) and slightly deeper (to a depth on average of 0.4m). They presumably relate to a change in the external structure of Building I.

To the west of the external western wall **K53**, the postholes **60** and **129** in **K52** appear to have gone out of use at some stage, with fills **61** and **130** being very uncompacted and suggesting accumulation

rather than deliberate back-filling. Three new postholes **272**, **127** and **131=432** (double numbered) were cut into the cobbles **58=23**; presumably this represents a reconstruction of the first storey balcony or svalgang, and forms construction **K60**.

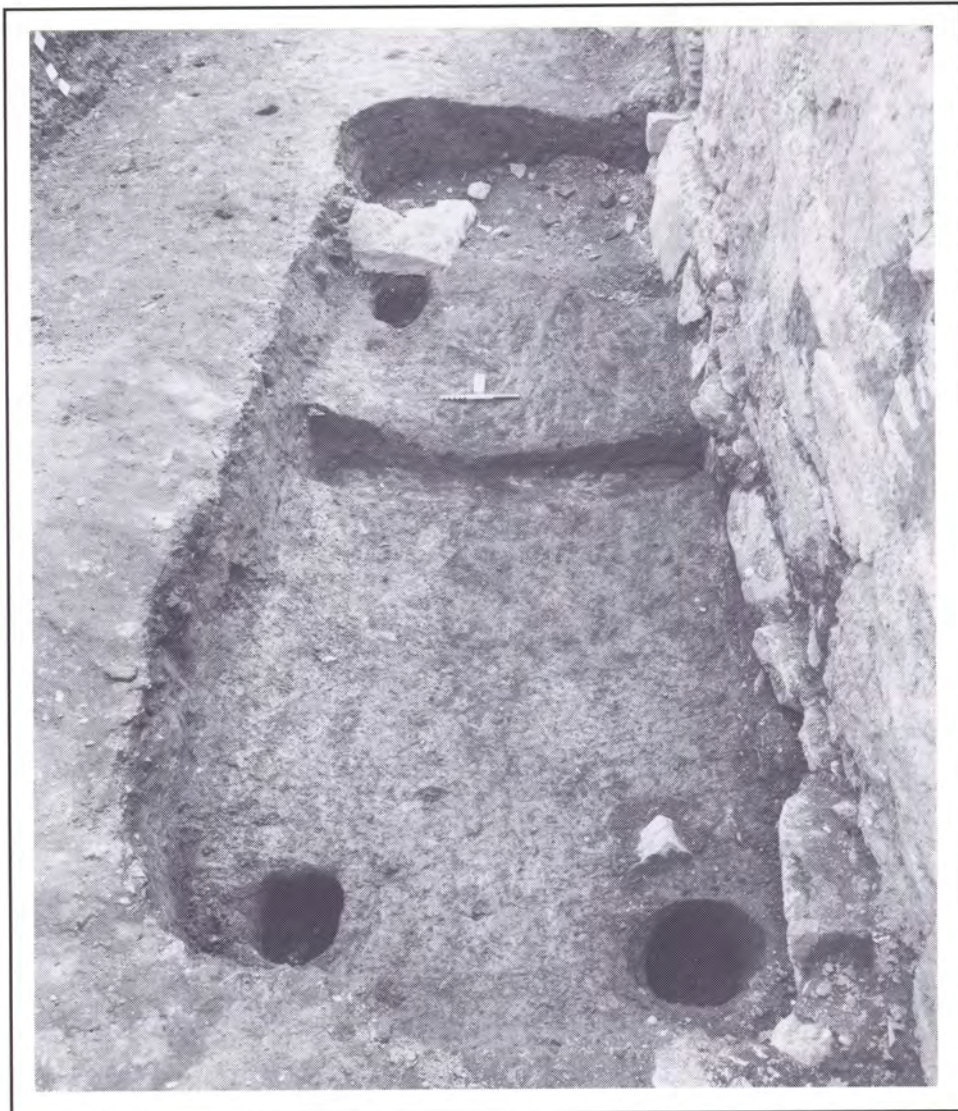
*Fig. 27 Formerly plank-lined pit K67 (looking S.)*

See **figure 27**. Cut **236** appeared to be through the surfaces of **148**, **208** and **211**, but it seems that its original level has been lost by truncation; see the following discussion. It abutted the curtain wall, with a length N-S of 3m and a width E-W of 1.5m. Its extant depth was 0.5m. It was disturbed to the south by a modern intrusion. The four postholes were **238** (SE), **239** (NW), **269** (NE) and **322** (SW). **238** bottomed onto a flat stone. The associated fills were respectively **246**, **247**, **268** and **323**. These did not appear to be deliberate backfills, but were loose accumulation deposits. It is reasonable to suppose that the pit was originally plank-lined even though no completed remains were present, since fill **212** of the cut extended around the sides of the cut with a fairly uniform width of 0.2m, with fragments of wood in places on its inner face; the obvious interpretation being that it formed packing between the plank lining of the pit and the sides of the cut. The primary fill of the pit was **249**, which was a clean gritty/silty clay. Above it were two further fills; **248**, a clayey layer with some brick rubble and mortar fragments, and **237**, a clayey silt also with some brick fragments and some stones. The bottom layers appeared to have some organic component, and analysis of **249** showed that it contained raspberry seeds (P. Sandvik, pers. comm.). The function of the pit is obscure.

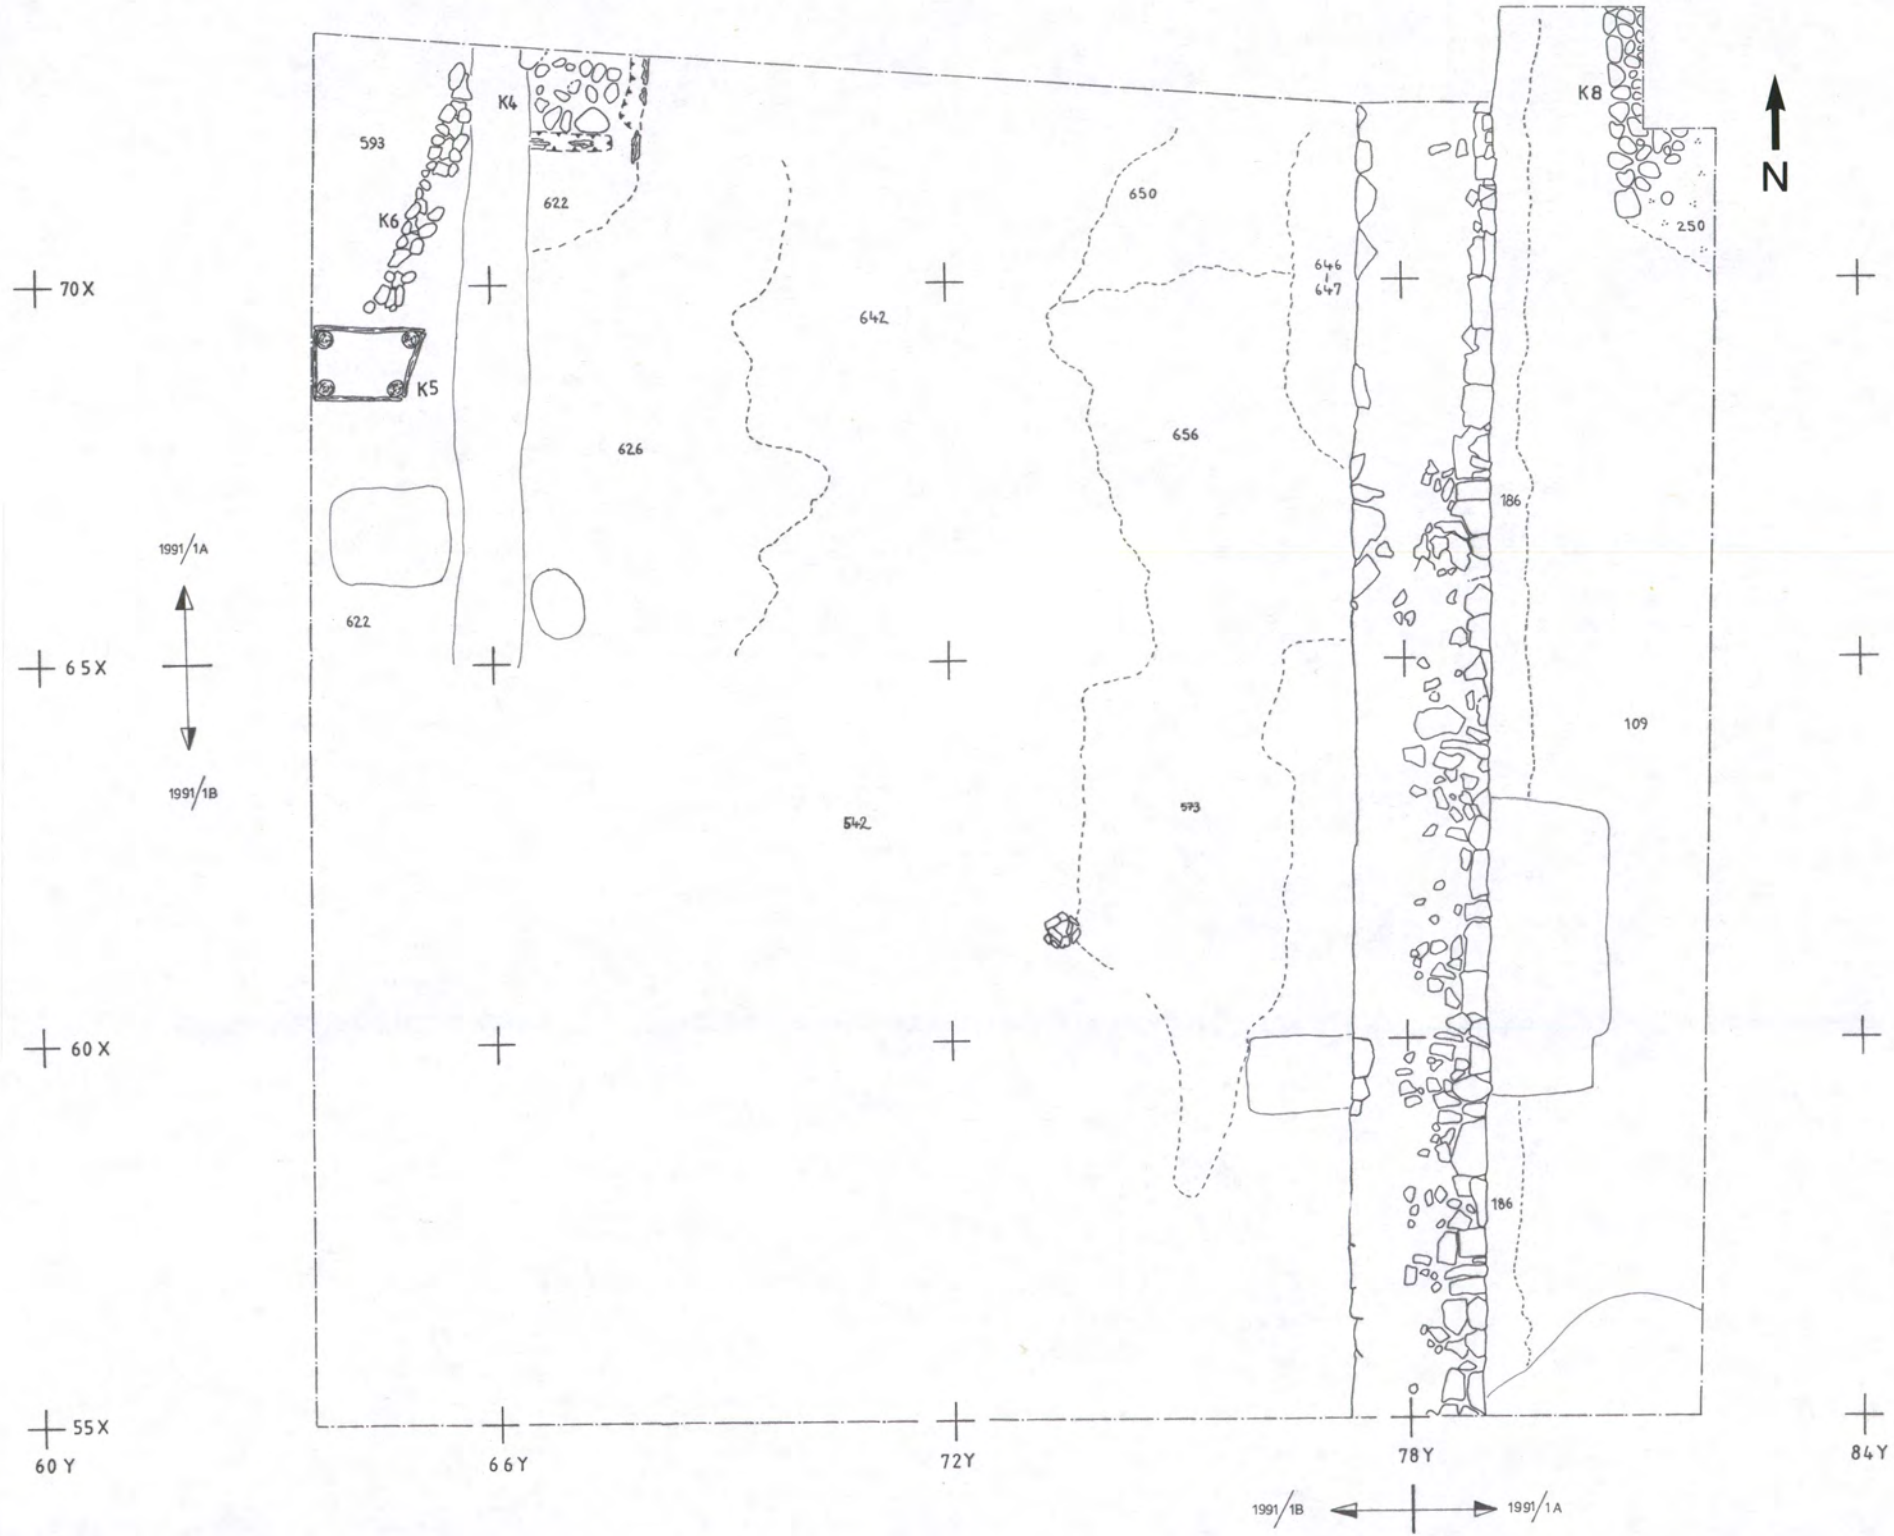
Fig. 1a PHASE I, level a 1:100

This phase (Fig. 1) sees the cutting of a ditch and the insertion within it of the foundation of the massive stone perimeter or **curtain wall (K1)** to the E. of the site, as well as the deposition and levelling-down of the upcast clay from the ditch in the area to the W. of the curtain wall. The phase also encompasses the actual construction of the main body of the curtain wall above its foundation. The phase also includes a thick body of probably redeposited clay into which the curtain wall's foundation trench was dug. This lowest clay above natural is of unknown origin, though its redeposited nature and observed significant thickness suggest that it derived from major earth removal operations in the near vicinity at some point in time prior to the establishment of the curtain wall.

**542** correlates with **A654**, abutting the CW's foundation. This clay, bearing scattered wood chips, stone and red-brick chips and charcoal is interpreted as levelled-down and trampled upcast from the digging of the CW's foundation trench. **542** and a lower cleaner clay, presumably **583**, pressed tightly up against the stone foundation for the CW, as observed in Lunde's trial trench (Fig. 2). Immediately to the W. of the CW, running N-S parallel with it, was a trough-like depression, c. 1.40m-1.80m wide, into which **542** fell. This trough probably represents the splaying out of the upper part of the CW's foundation trench, although since excavation stopped at the level of **542** and localized superimposed deposits here, it was not possible to confirm this. The localized band of deposits above **542** within and just to the W. of this trough included two mortar- and stone-chip laden deposits **573 (=A656)** and **576** separated by a clean silt **575 (=A655)**. These also abutted the plinth foundation (**573** covered it),

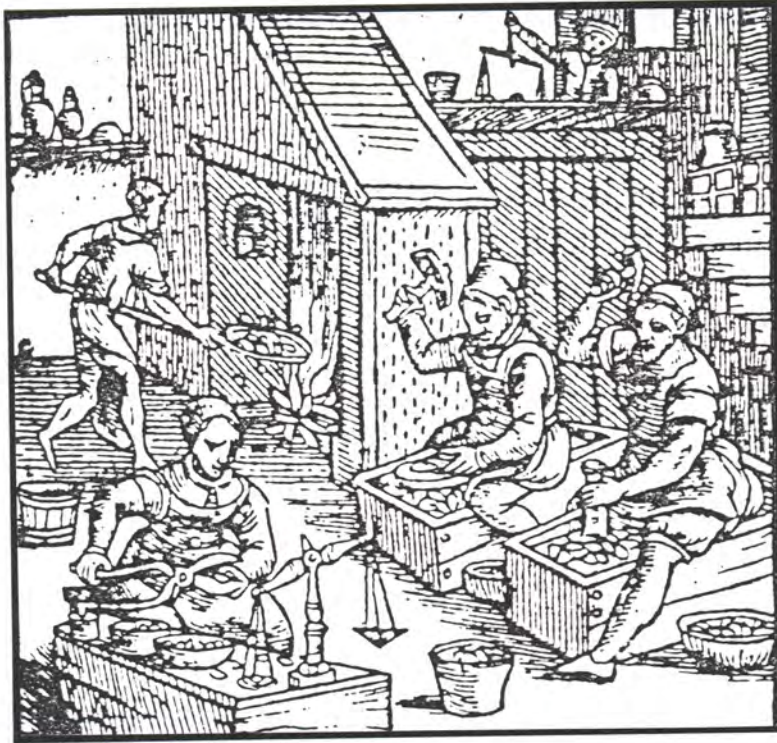
Fig. 8 Woodcut showing mint workshop interior in 1577 (Raphael Hollingswood's *Chronicles*).

*Function:* This room clearly constitutes part of a moneyer's workshop (or mint workshop). This interpretation has been made on the basis of contemporary wood-cuts of interiors (see Fig. 8) which show internal arrangements which can be equated directly with the excavated features within the interior. Likewise, associated artefacts (coin blanks and offcuts, a weight, crucible fragments, and in particular, an iron coin die) confirm the function. The structure has been preserved as revealed and recorded, awaiting future conservation.
