EXCAVATIONS IN ERKEBISPEGÅRDEN 1991  
Areas 1A and 1B: Stratigraphy and phasing

**EXCAVATIONS IN ERKEBISPEGÅRDEN 1991**  
**AREAS 1A AND 1B: STRATIGRAPHY AND PHASING**

Riksantikvaren, Utgravningskontoret for Trondheim

Trondheim 1993

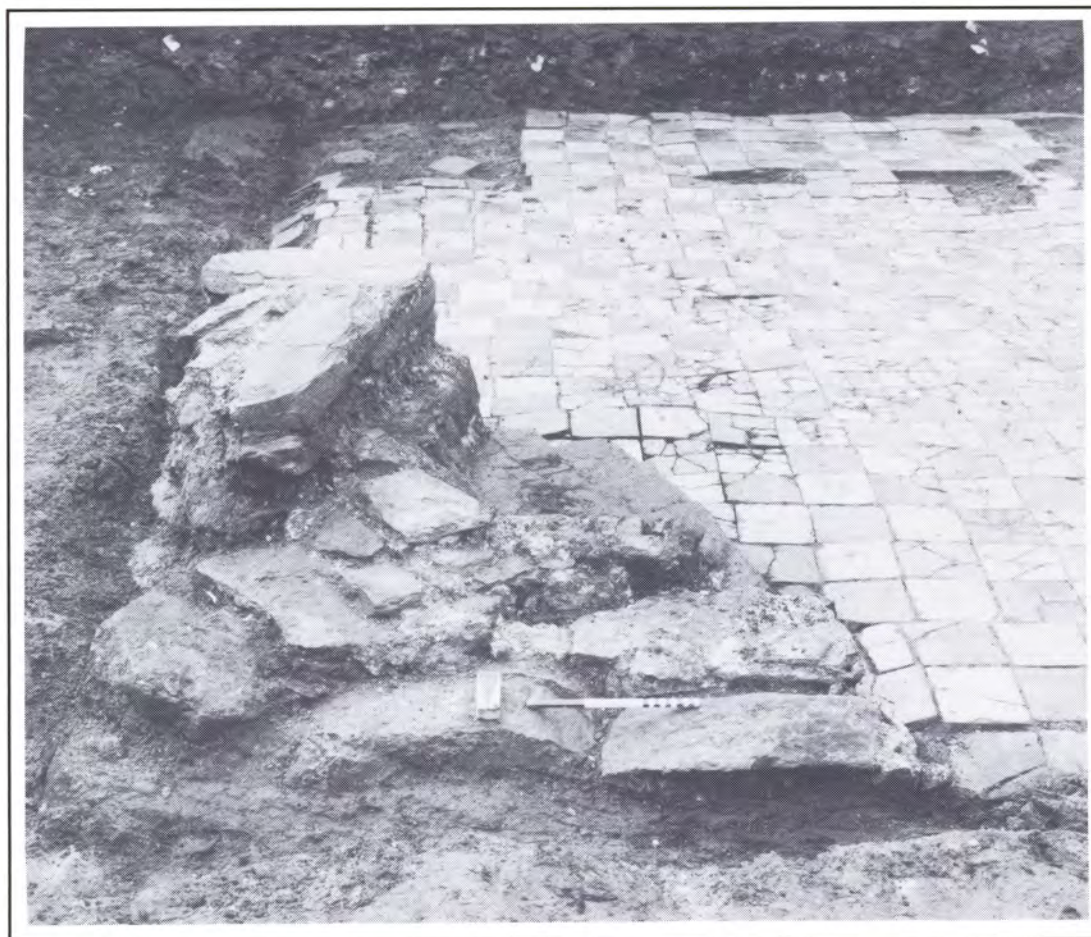
*Fig. 9      Hearth K4 (looking E.)*

Fig. 9. Placed in the NE. corner of the building. The base of a brick-lined stone hearth, demolished, though preserved to a height of c. 0.5m to E. Quasi-triangular plan. A large basal fire-cracked slab formed the actual fireplace, only c. 0.11m above floor level. The back wall was built up to N. and E. of mortared stone blocks and slabs (at least 5 courses preserved to E. above the basal slab, and two parallel courses abutting the basal slab to N.). The fireplace interior above the basal slab was lined with mortared brickwork, very friable and fire-cracked.

The fireplace interior was quite small, and its capacity cannot have been great. Might it have been the lowest fireplace in a two-tiered structure as shown in contemporary wood-cuts?

539 comprised a number of deposits associated with the fireplace interior, and probably represent the final hearth accumulations prior to the building's demolition. All were sampled. There were three superimposed deposits contained within this context; from the top: a spread of friable black gritty sand with charcoal, over; reddish-brown burnt sand, magnetic reaction (hammerscale present), over; pure charcoal, magnetic reaction, spilled out over tiles.

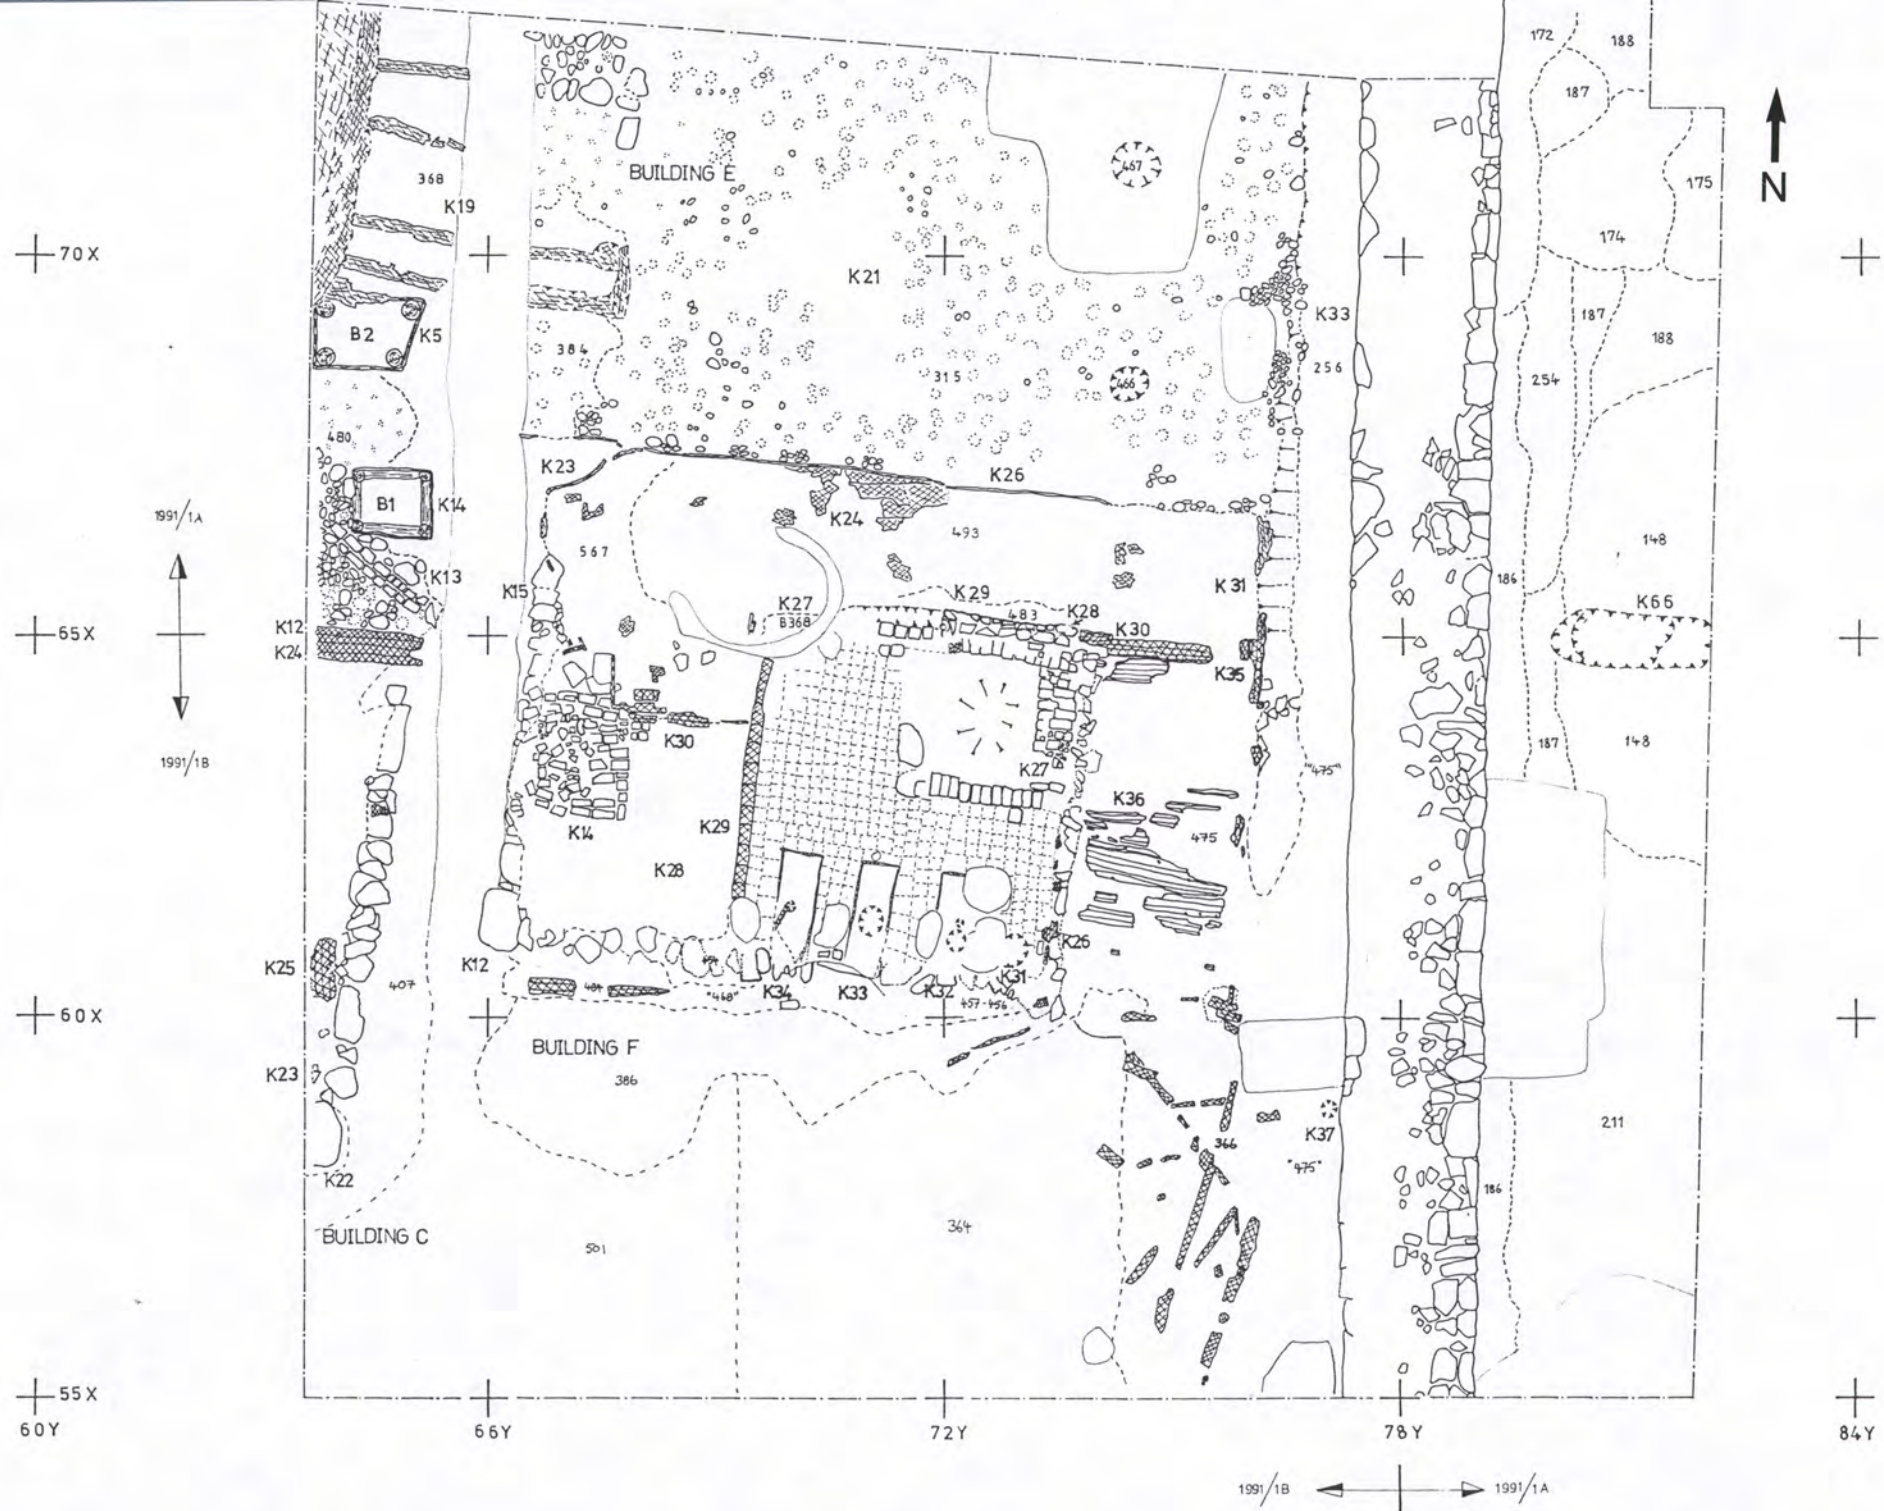
Fig. 12 PHASE 3, level b 1:100

The individual elements which make up Building D are described in detail under Constructions (below). However, a resumé of the stratigraphy is necessary here. The following presents the deposits and structures which existed prior to a destructive fire and the subsequent establishment of Building F on the same lines.

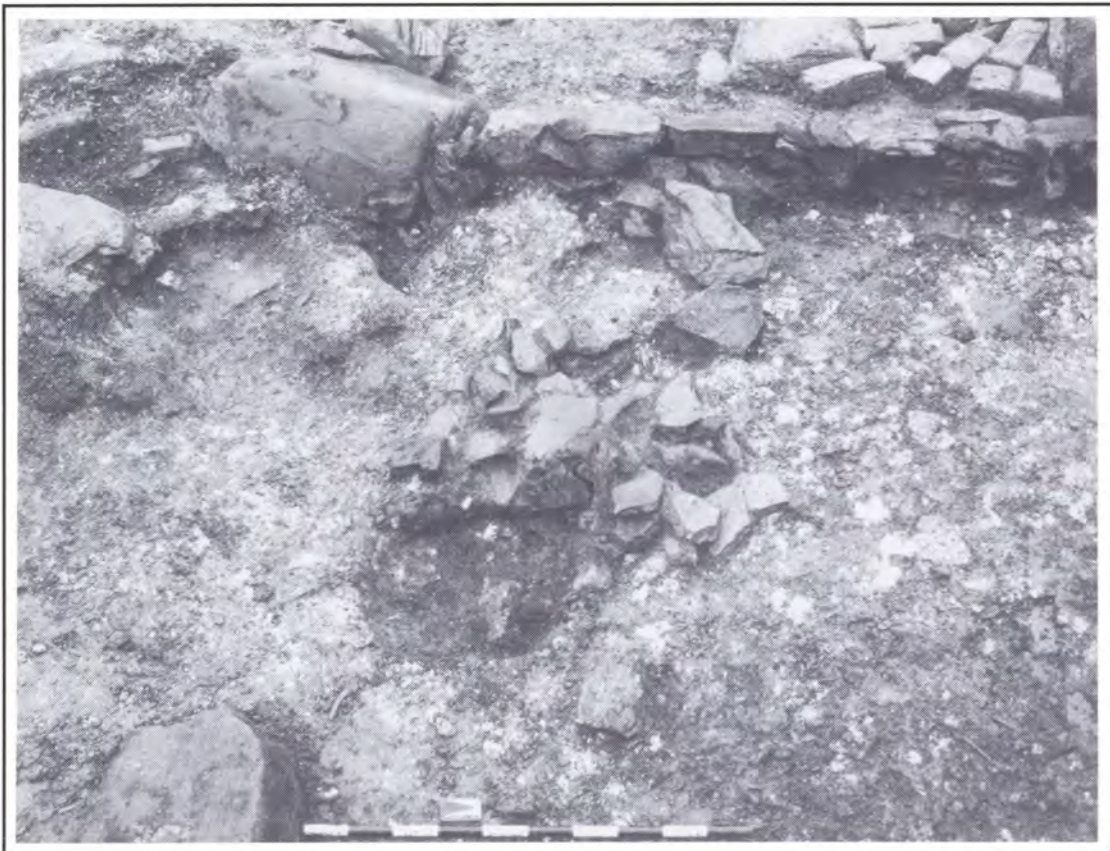
Fig. 14     *Hearth K19 (looking W.)*

To the E. of groundwall **439** an annexe was established, adding an extra room to the building. It is clear on stratigraphical grounds that this was in use with Building F; it is uncertain whether it was already in existence with Building D. A case can be made for the annexe's establishment with Building F (see *Eastern Annexe*, below). All that would appear to have been here to the E. of Building D's groundwalls was a small temporary hearth, **490 K19** (Fig. 14). **K19** comprised a subcircular bowl-like pit. Surrounding it to N.,E. and W. was a scatter of angular stone rubble and red brick fragments, forming a small mound in a matrix of green clay which mingled with the annexe's flooring medium, clay **478**. This rubble probably represents the remains of some form of collapsed stone-and-clay superstructure formerly placed over the pit. **K19** is provisionally interpreted as a low hearth, either domestic or industrial: it may have been used for on-site smithing, or simply for the cooking of food.

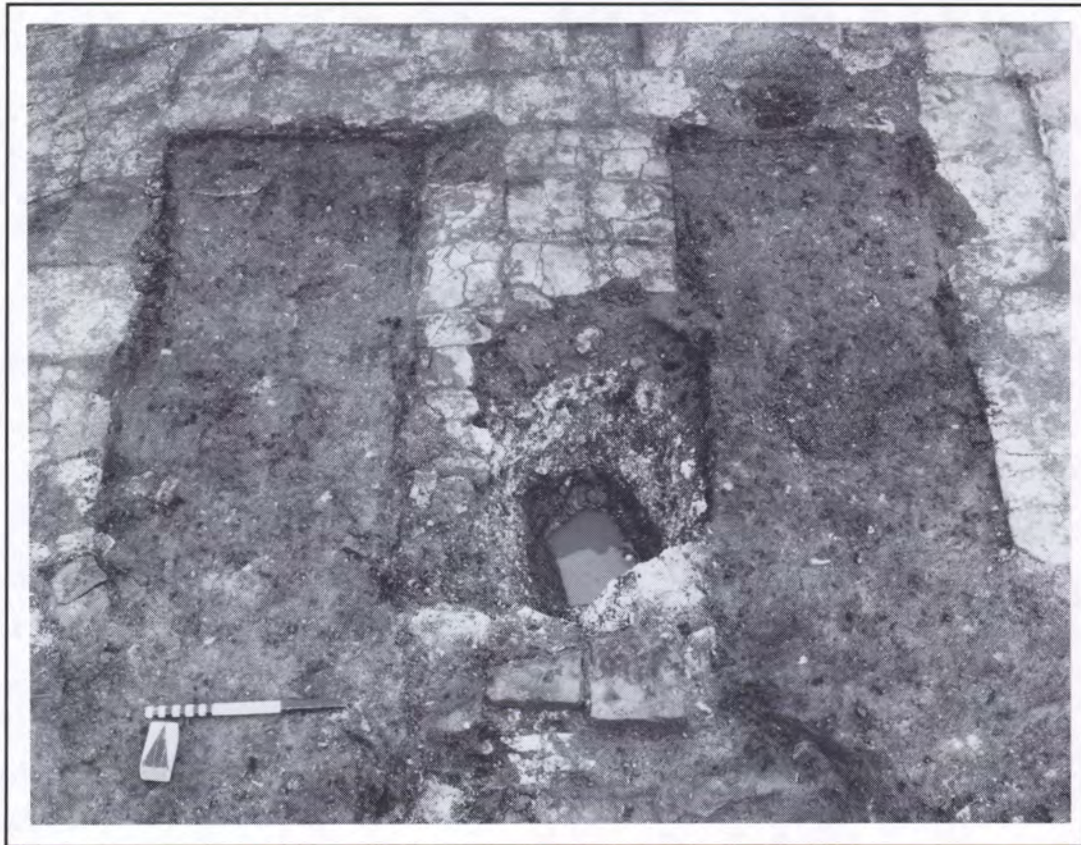
*Fig. 16a Workbenches/striking benches K34 and K33 (looking N.)*

The three workbenches (**K32 K33 K34**) aligned in a row to the S. of the building were beyond doubt incorporated into Building F's floor (Figs. 16a and 16b). Given the presence of the pit **486 K16** in association with Building D, the question arises as to whether these workbenches existed with Building D and were subsequently reconstructed in Building F. All three subrectangular pits appear to have been cut (like **K16**) from the level of **460** mortar. However, when one examines their internal arrangements and relationships with the various bedding media, it is quite certain that their present fills and associated timber elements were established with Building F's floor (see section drawings on layer cards). The sequence of their construction as observed seems to be as follows: firstly, three subrectangular pits were dug into the surface of **460**, and then the bedding gravel **469** and bedding sand **404** were deposited, probably in unison with the backfilling of the pits and the incorporation within them of near-centrally positioned posts or stakes represented by post-holes **471**, **466**, and **458** and **452** (these latter may suggest two posts, one replacing another within the lifetime of the bench?). This was followed by the simultaneous laying of mortar **368** and establishment of the nailed timber frames for the workbenches. If correct, this unified process would seem to lessen considerably the possibility that Building D possessed such workbenches, at least in completed form. This has important consequences for the interpretation of Building D's status, and with the general lack of other finished internal structures gives weight to the impression that Building D was never fully completed.

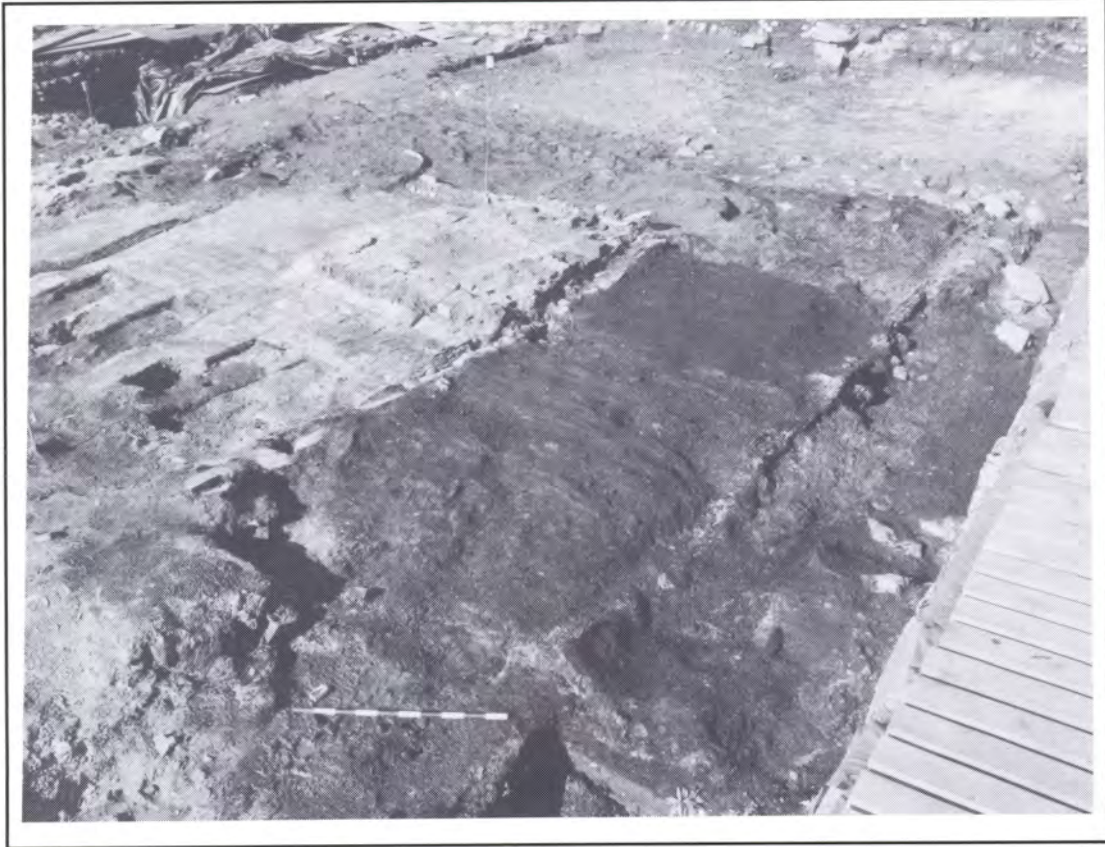
*Fig. 17 BUILDING F, eastern room/annexe (looking NW.)*

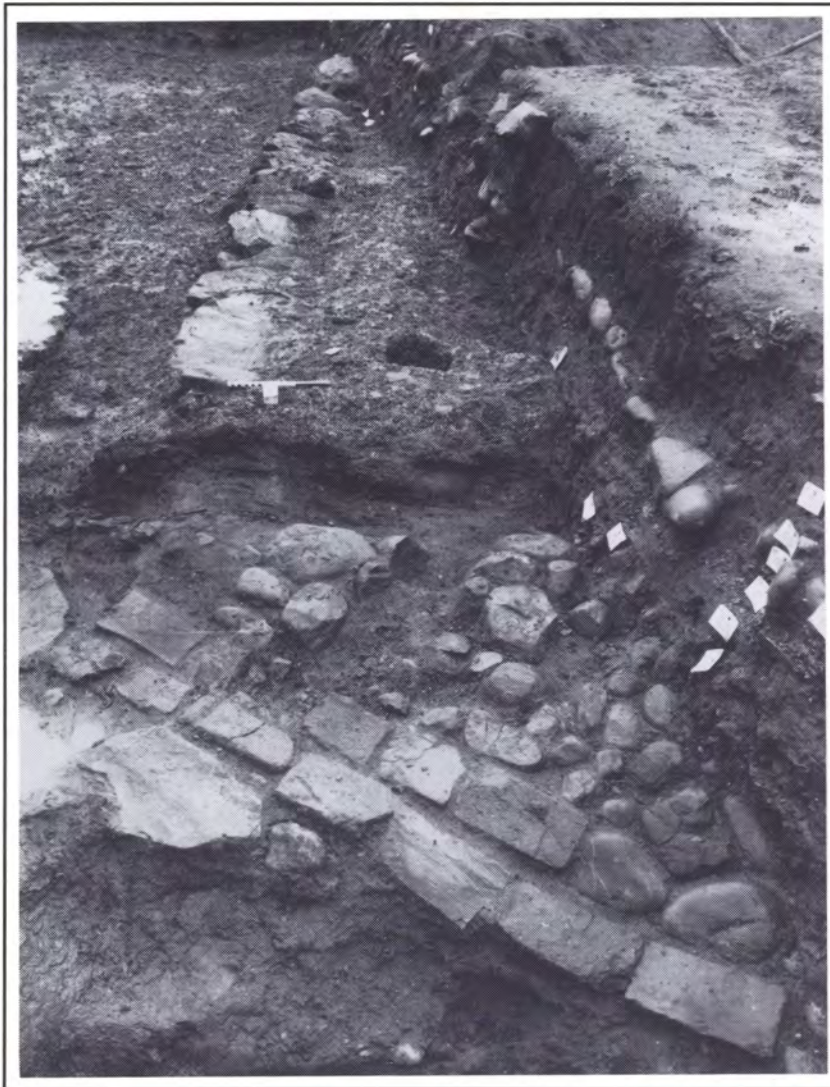
Fig. 18 BUILDING C (looking S.)

#### *Building C (Fig. 18)*

409 rested on both the northernmost stone in wall 408 and on sandy clay 543. The timber sat in a deep trough (Fig. 18) and to the S. its upper edge appeared to rest against the building's internal make-up deposits (which also lay above 543), from the level of the uppermost, 356 down. Consequently, this timber must belong to the building as it stood prior to the fire at that presumed floor level, and prior to its total destruction and sealing with the orange fire debris 355, which also filled the trough (presumably caused by the effects of intense combustion, as in the case of the troughs 361 noted in connection with Building F). 543 correlates with A638, which to the N. underlay the cobbled area A449 AK13: in Site A timber 409 rested on the sand A480 which beds cobbles AK13. There seems to be good correlation here, the cobbled area and the N. timber for Building C probably being established closely in time?

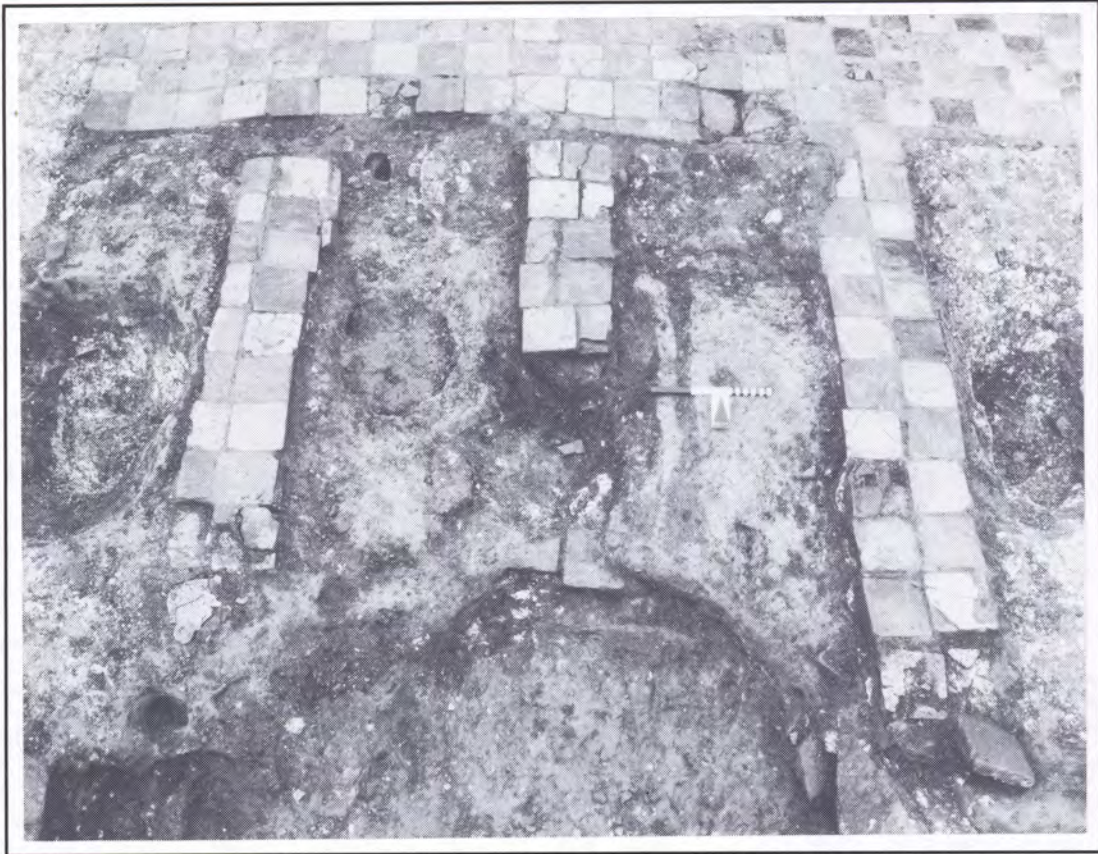
*Fig. 21 Workbenches/striking benches K41, K45, K42, K46, K43 (looking N.)*

It would appear that there were originally 3 workbenches and one associated sunken container: cutting sand **402** were three equidistant subsquare pits **390 K41**, **420 K42** and **387 K43** (Fig. 21) with to the E. of them a (truncated) smaller rounded pit, **423 K44**. Alongside **K41** and **K43** on their E. and W. sides respectively lay intact strips of tiles **400** on mortar **401**, intrinsic to the main area of original flooring to the N. These two subsquare pits were backfilled with **341** and **379** respectively and contained the filled pipes of posts **370** and **392**, sealed at a higher level (see below). **341** appears to have spilled out over the floor following the bench's destruction. No post-pipe was identified in the middle pit **420 K42**: this is probably due to an oversight, though this pit was clearly modified after a time. However, it clearly formerly possessed a wooden superstructure, the slot-like feature **422** representing its former position prior to removal. Indeed, at some point it was decided to increase the number of workbenches to 4 and the sunken containers to 2. This was done by compressing two new benches in between the two outer ones, these latter (**K41** and **K43**) continuing in use (Fig. 21). The central pit **420 K42** was partly covered with an inserted strip of tiles, **413** on brown silt **414**. This served the purpose of subdividing the area into two. However, these two new benches, with the extremely fragmentary remains of their former wooden superstructures abutting the tiles in places, did not possess deeply-dug pits housing central posts: in association with **K45** to the W. was **428**, a shallow depression c. 2cm deep in the surface of sand **402**, and in association with **K46** was a small post-hole **417 K46**. The former probably marks the position of a broad-base object (an anvil/tree-trunk?), rather than a post. Within the area of most of these benches lay patchy mortar/sand-mixed brown silt **412**, deposited during the reorganization as consolidation. Unfortunately two unrelated pieces of timber were numbered **396** in the mistaken belief that they formed two parts of a common timber. That to the E. lay in association with inserted tiles and the easternmost of the two inserted benches, **K46**, probably forming part of its timber superstructure. That to the W. seemed to lie within the original tile floor **400**, though its function is somewhat less clear. A localized patch of replaced tiles sealed a small post-hole **418** just to the NE. of **K46**. This possibly belongs with earlier **K42**.

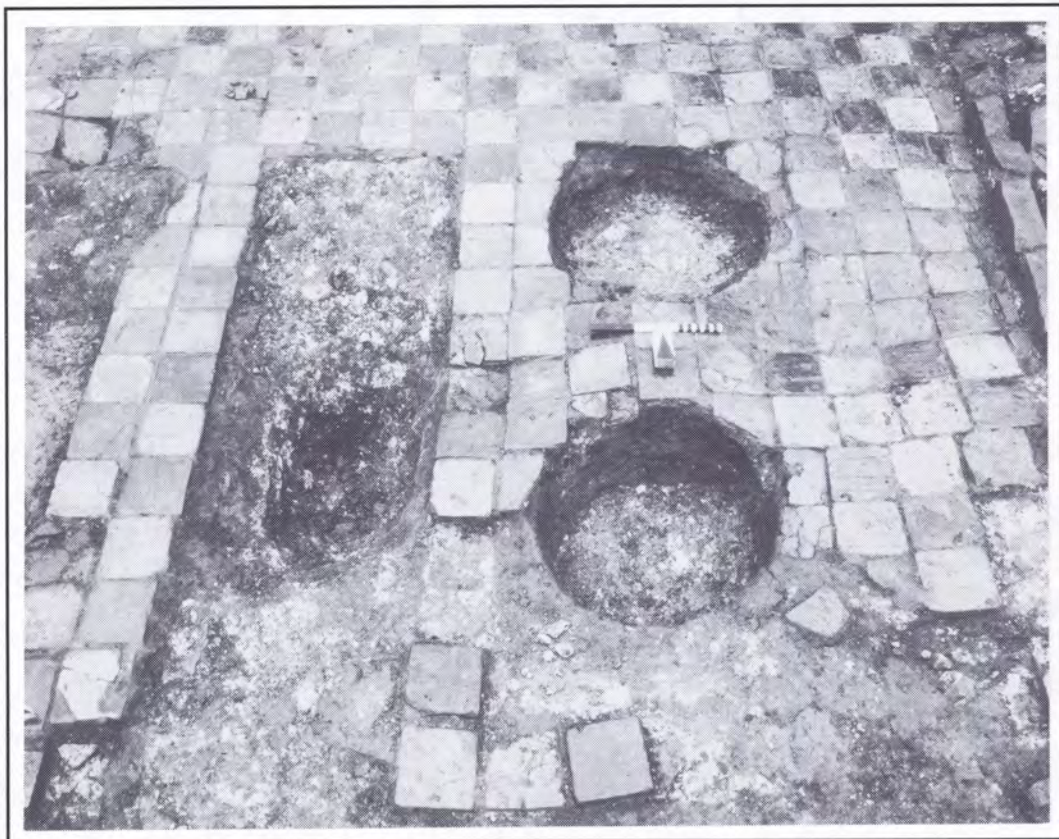
*Fig. 22 Workbench/striking bench K43 and pits K48 and K47 (looking N.)*

To the E. part of the original flooring was removed and two new sunken containers inserted, tiles then being replaced around them (Fig. 22). The northernmost, **K47**, comprised a square pit **421** cut into **402**. It would then appear that a round wooden container, **375**, was inserted into this pit and the gap around it backfilled with **412**. To the S., **K48** was similarly constructed, pit **425** dug (cutting backfilled **423 K44**), **348** inserted, and then the space behind backfilled with **412**. The tiles were then replaced on a spread of **412**, closely arranged around the containers and sealing their host pits.

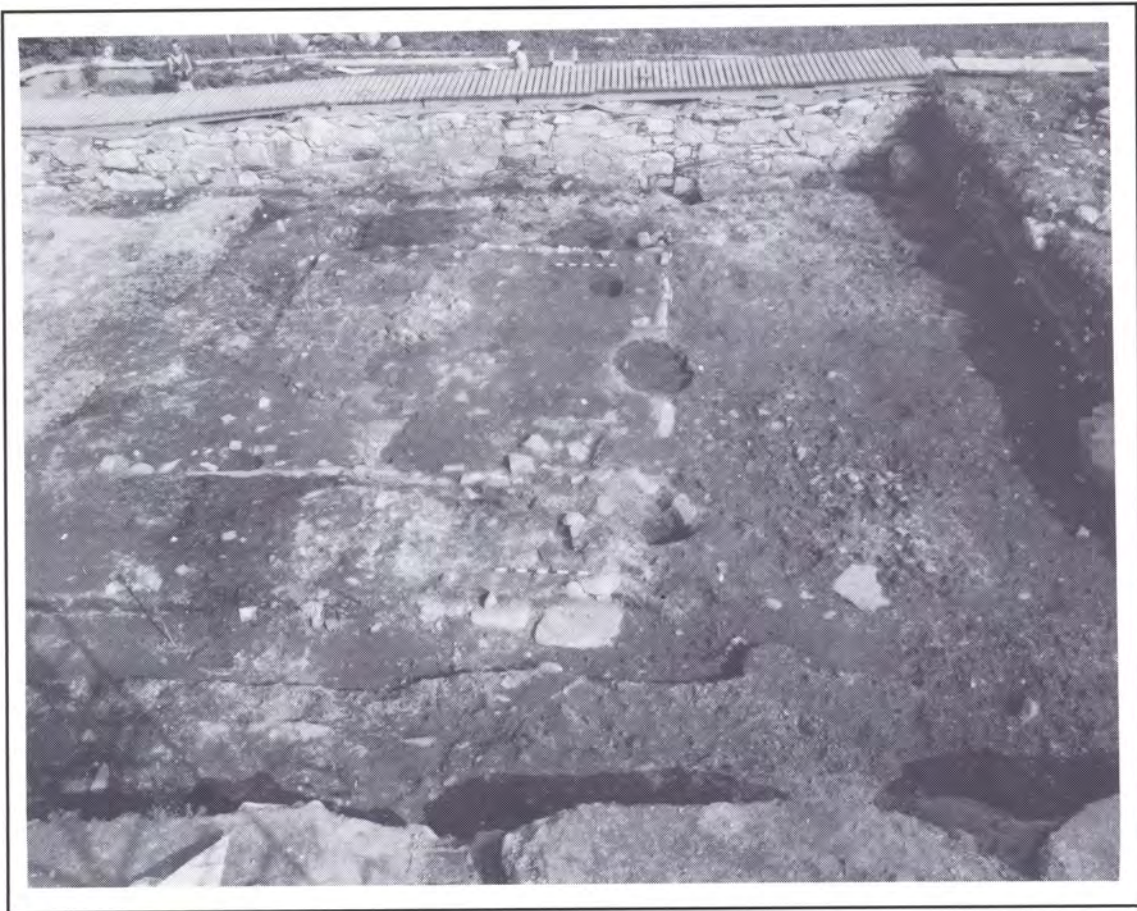
*Fig. 25 PHASE 5, level b (looking E.)*

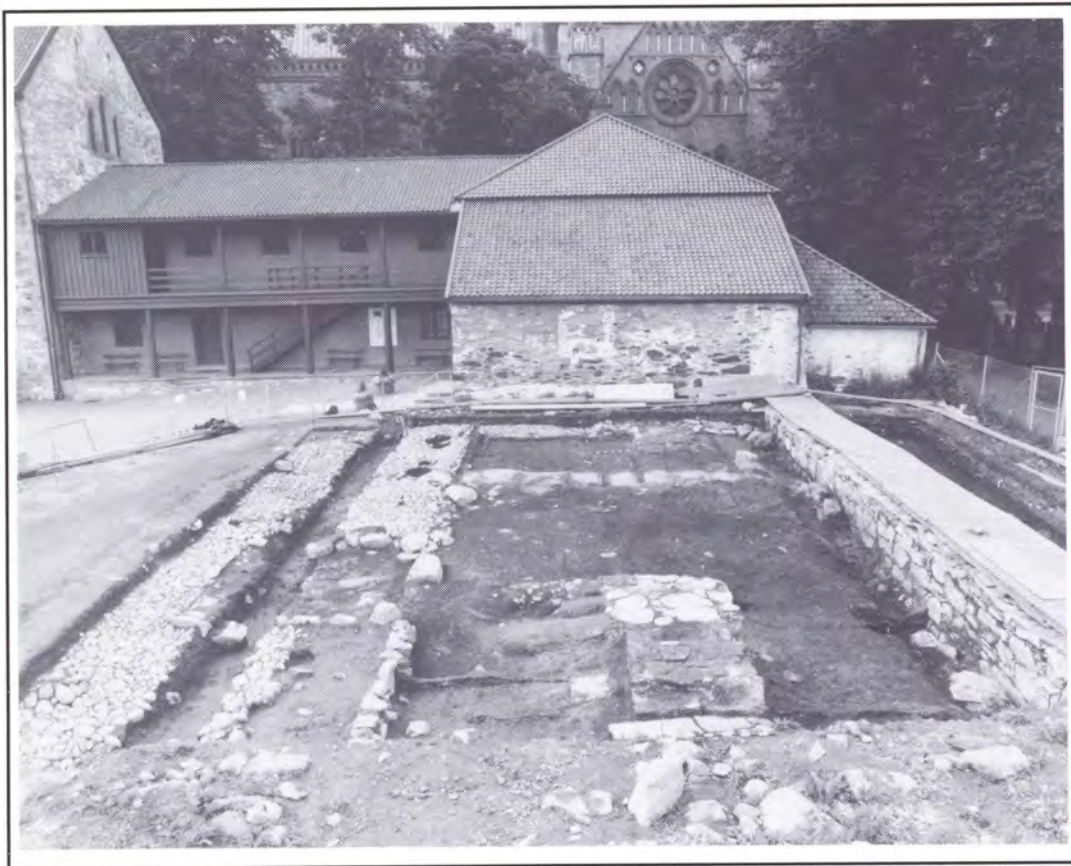
Fig. 27 BUILDING I, Herrehuset (looking N.)

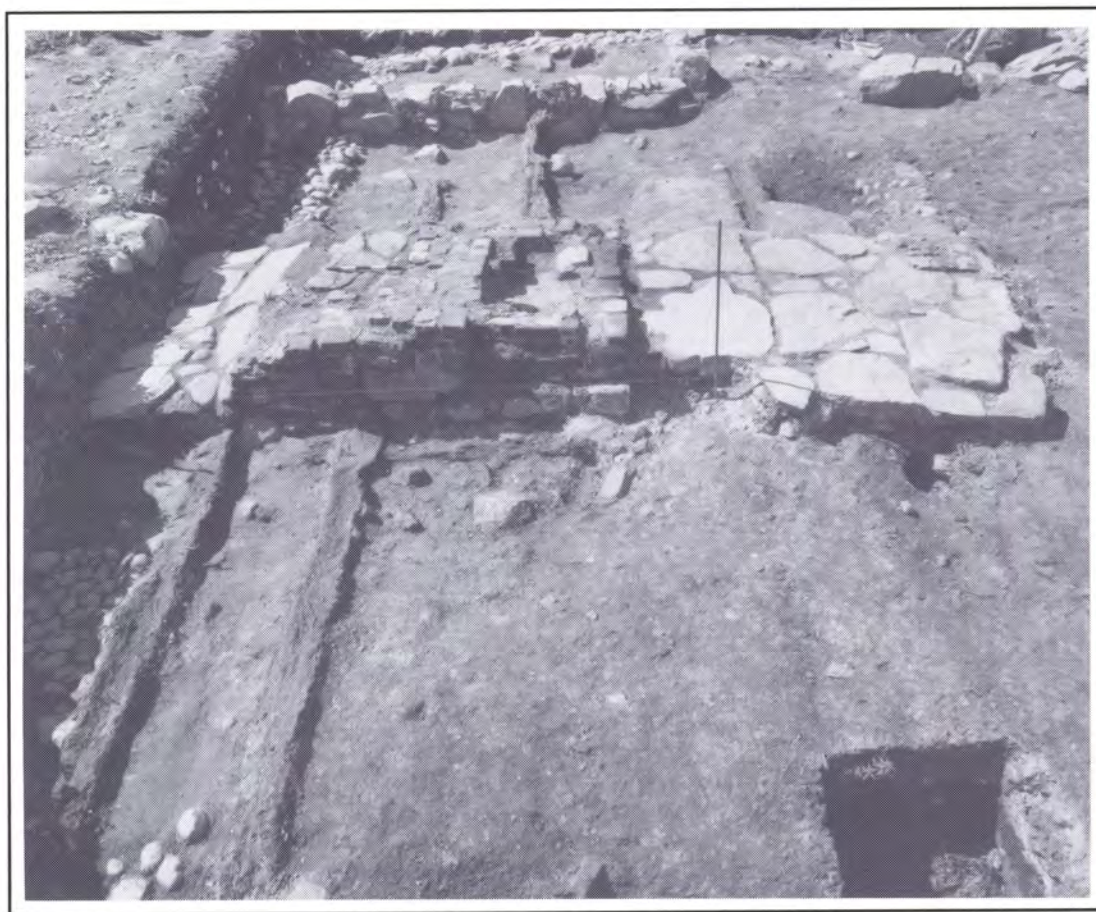
*Fig. 28 BUILDING I, Herrehuset: internal arrangements - cobbles K70, joists K74, chimney elements K65, K68, K69, and groundwall K67 (looking W.)*

### **Flooring (Fig. 28)**

**30:** a slightly irregular rectangular brick-built chimney base, incorporating two opposed fireplaces to N. and S. (see Fig. 28). The northernmost of these comprised a sand-filled chamber (in effect the brickwork simply formed a shell here). There were indications that this chamber was back-filled with sand and mortar, on top of which were laid flat stone slabs (not preserved, since this had been partly emptied in antiquity, although enough traces to suggest the fireplace lay at the same level as that to the S.). The S. half of the chimney base was, in

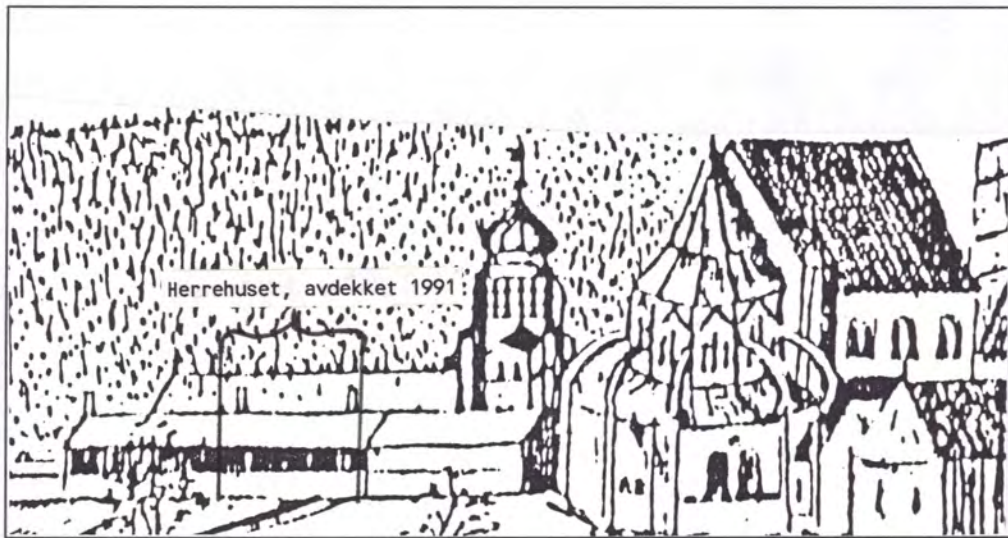
Fig. 29 Detail from Maschius's Prospect dated 1674, showing Herrehuset's E. frontage and chimneys.

chimneys (the N. and central chimneys as shown on Maschius's Prospect - see Fig. 29); variably preserved areas of differentiated flooring, both planked and cobbled; a row of massive low stone rubble pillars against the curtain wall which presumably accommodated the E. wall's sill-beam; and, puncturing an extensive area of cobbled yard fronting the building to the W., a number of post-holes which supported a projecting first-floor external communicating passage (*svalgang*), and which is known to have continued round the S. gable-end and along the E. side, where it was presumably supported on posts based on the specially levelled-down curtain wall (as depicted by Maschius). See Discussion for more details of the building.

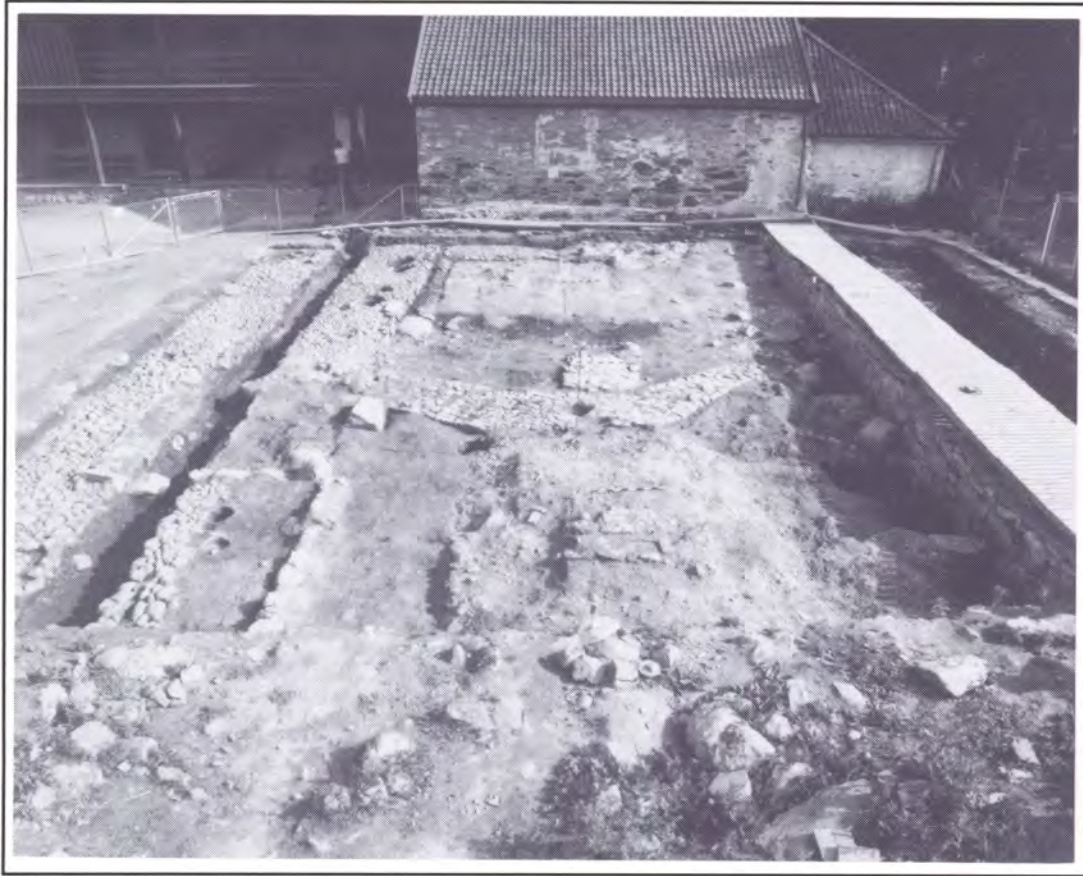
*Fig. 32 PHASE 7 (looking N.)*

This phase (Figs. 31 and 32) is characterized by fresh deposits and features of somewhat enigmatic origin and function, in particular an arrow-shaped area of cobbles/paving **K82**. Stratigraphically, this certainly encroached over the preceding phase's stone ramp **K68**, and appeared to post-date a deposit associated with the partial or complete demolition of the chimney **K65** and the subsequent deposition of sand make-up to the N. and E. On these grounds, it is assumed that **K82** was established after the demolition of Building I, *Herrehuset*. It must be stressed that this is inferred only; the W. cobbles **K79** are respected, and are probably still in use in this phase, and this, together with the known historical evidence for dereliction and partial reconstruction of *Herrehuset* do leave open the alternative possibility that this phase's arrangements comprise part of internal reconstruction during a phase of dereliction. Yet another possibility is that the fragmentary remains form evidence for the insertion, directly within the structural lines of *Herrehuset*, of a new building. It cannot be stated categorically what the function of the arrow-shaped cobbles **K82** was, or indeed whether this structure was incorporated within the old building, or a new building inserted above the partly demolished foundations of Building I (perhaps re-using the W. groundwall, the pillar supports, and/or the curtain wall), or under open sky, forming part of a yard, for example. However, the sum of the evidence (including artefactual evidence) from both sites possibly points to the insertion of a new building of somewhat primitive construction within the same lines as *Herrehuset*. This might best be termed a "shadow" building, **Building J**.

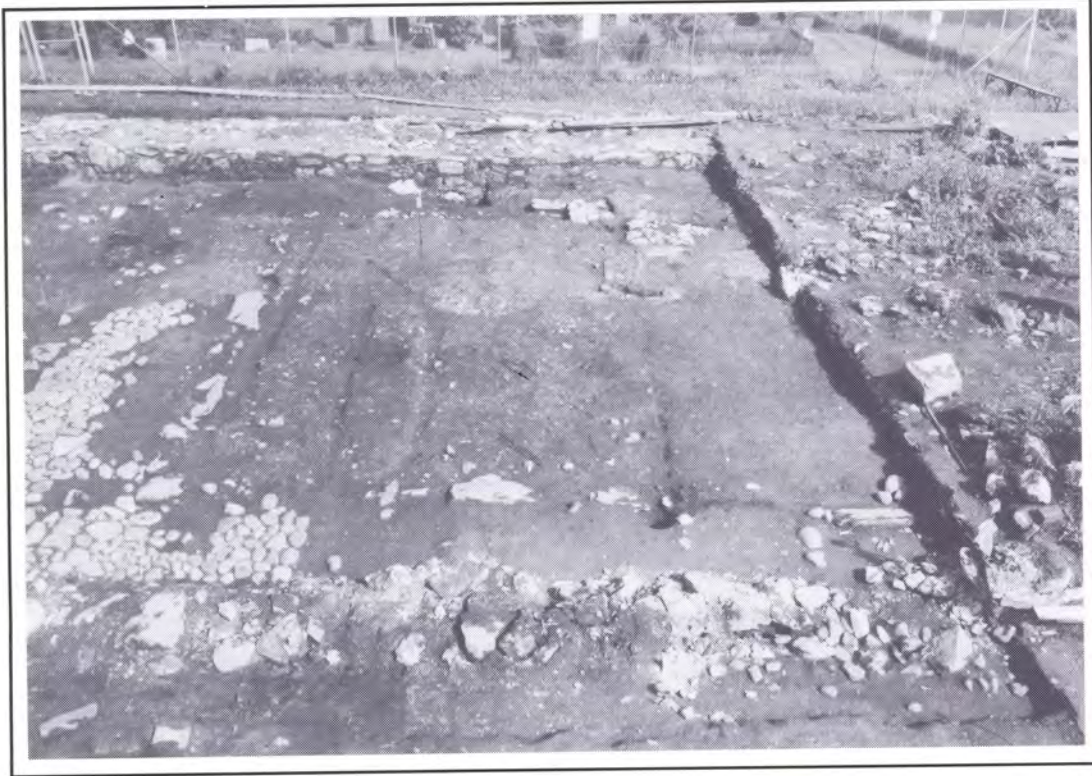
*Fig. 35 BUILDING K (looking E.)*

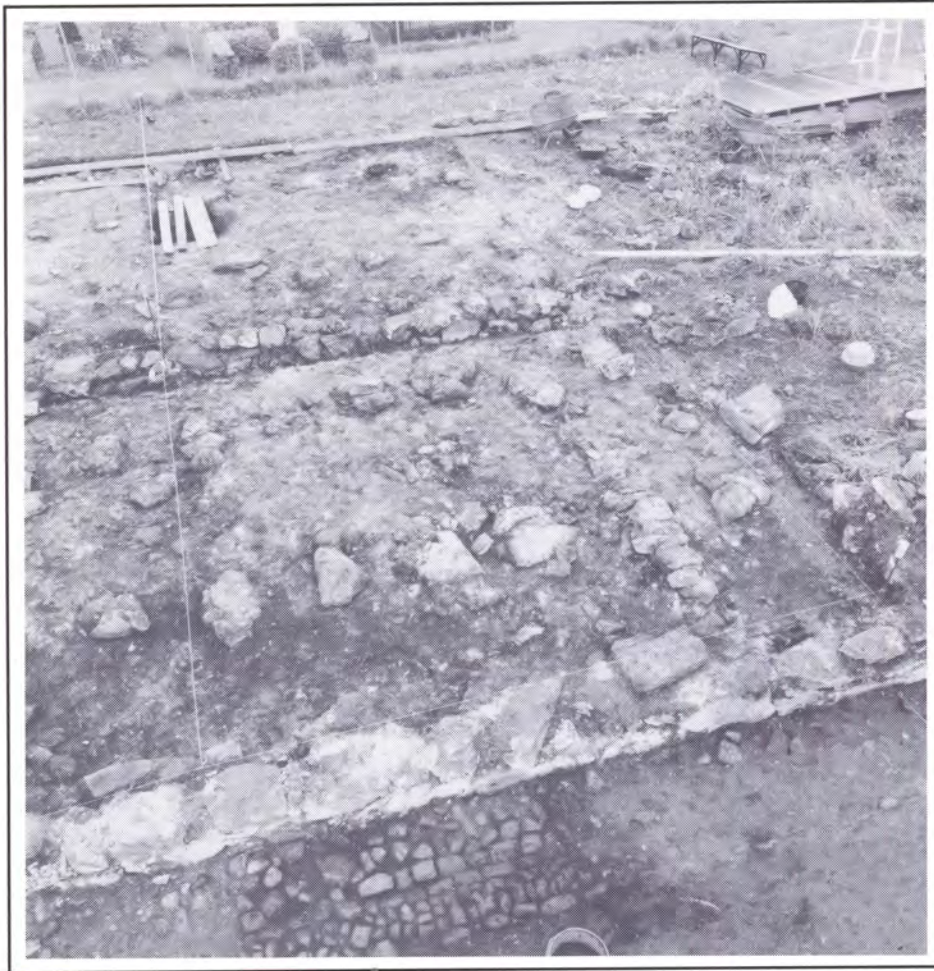
Fig. 42 *BUILDING L, foundation elements K105, K109, K107 in site B (looking N.)*

It was at this level that a number of scattered crudely mortared low stone pillars **6=9 K109 =AK74** were established, forming joist supports. Above these was a patchy deposit of debris- and charcoal-laden gravelly sand, **2=12**, probably the deposit which lay under the burned-out and almost completely removed plank floor (a small area of floor and joists remained to the NW. of Site A). Layer **1** comprised the burnt debris left after the 1983 fire and the subsequent topsoil formation.

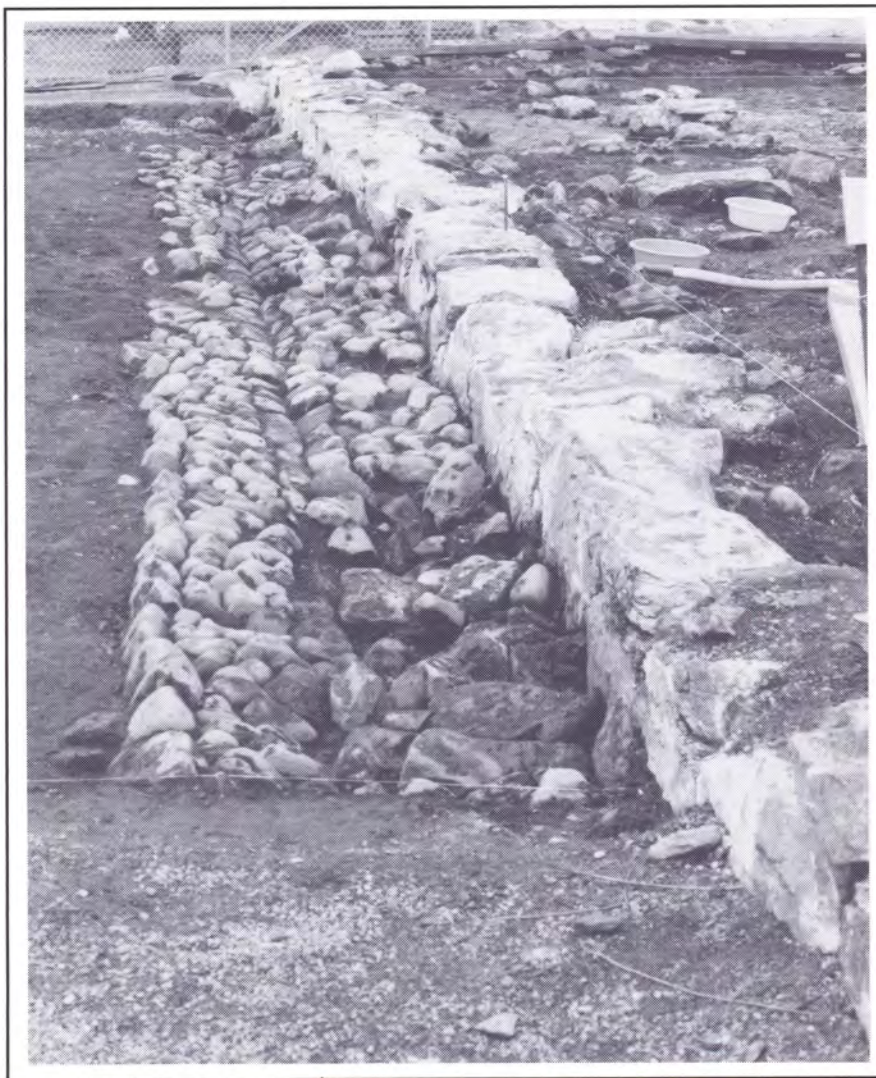
*Fig. 43 BUILDING L, wall AK72=BK105 and cobbles AK70=BK108 (looking N.)*

Abutting the W. of groundwall **K105** were dumps of compact sandy brick-filled make-up (**43=A19, 106, 33, and 42**). A narrow strip of cobbles **5 K108 =AK70** was inserted at this level parallel to the building's frontage. Gravelly **16** abutted this to the W., probably forming a contemporary surface. **4=A12**, gravelly soil, formed the final accumulation here under **1**, concealing the cobbles.
